Subject: TPMS WARNING LIGHT ON	Bulletin No: 02-001/12
	Last Issued: 01/11/2012

APPLICABLE MODEL(S)/VINS

Vehicles produced between March 1, 2007 and May 25, 2010

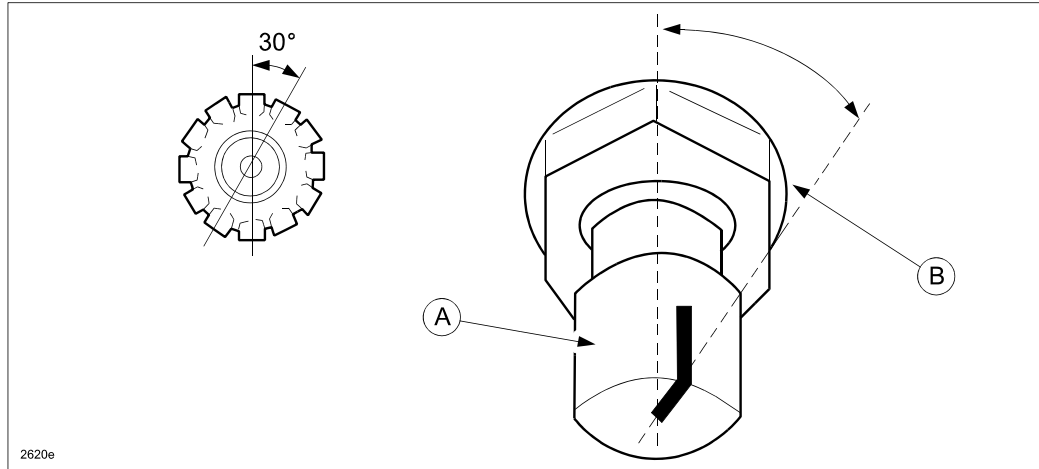
CAUTION: If the marking on the cap (A) turns more than 30 degrees while tightening the valve nut (B), replace the wheel unit with a new one.

3. Install and tighten a new valve nut.

Tightening torque: 7.5 - 8.5 Nm (77 - 86 kgf cm, 67 - 75 in lbf)
