# Service Information

Category <b>R</b>	<b>Technical</b>	Ref. No. E011/12	Page 1 of 2
Coverage <input type="checkbox"/> Distributor only <input checked="" type="checkbox"/> Please inform your dealers		Date Issued June 14, 2012	
Please convey this information to your <input type="checkbox"/> Director <input checked="" type="checkbox"/> General Manager <input checked="" type="checkbox"/> Warranty Dept. <input checked="" type="checkbox"/> Parts Dept. <input checked="" type="checkbox"/> Training Dept. <input checked="" type="checkbox"/> Field Rep.		Date Revised	
Applicable Model Mazda 2 (DE); Mazda 3 (BL); Mazda 5 (CW); Mazda 6 (GH); CX-5 (KE)		Applicable Countries or Specifications Europe

## Subject: Portions of welding seams at front and/or rear suspension appear as corroded

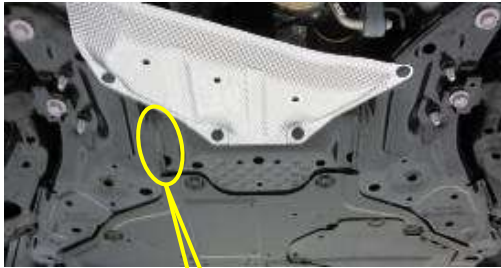
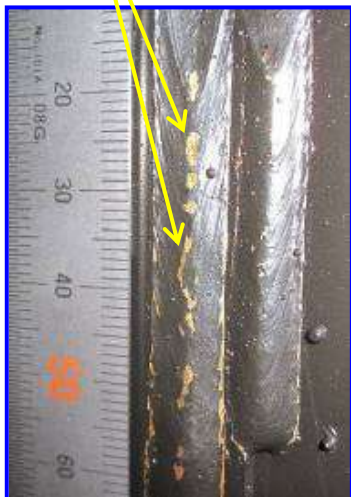
#### Front cross-member

Some welding seams at front and/or rear suspension may exhibit an incomplete electrostatic coating (black). Due to the visible reddish color of the welding seam, it gives the impression of already corroded places. This reddish color is no indicator for real corrosion, but happening by chemical conversion of the ingredients in the welding material. Therefore, no repair is necessary.

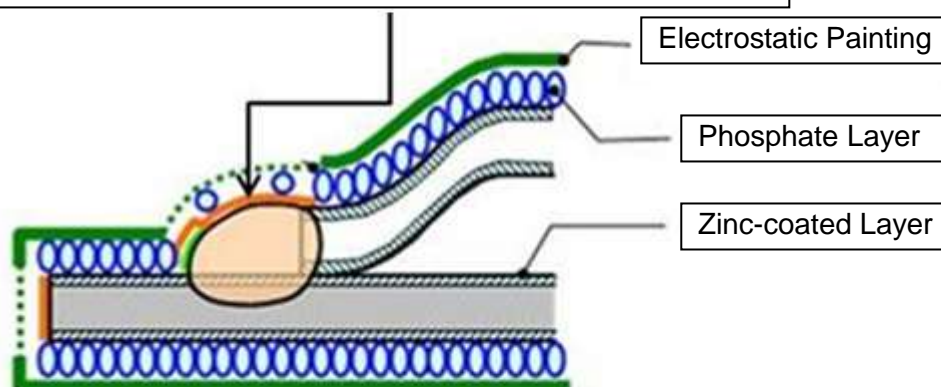
As explained in point 1, welding seams are covered with a thin layer of silicon oxide. Silicon oxide is hard like glass and has a low electrical conductivity. These are a bad conditions for proper electrostatic coating on top and near the bed of the welding seam and explains the patchy appearance of the black coating in areas of welding seams. In areas where the black paint is missing, the welding seam and the areas nearby are protected by the existing silicon oxide layer against further corrosion.

Oxide layer is formed only on top of welding seam and phosphate layer is formed on top and nearby the welding, inhibiting further corrosion even if the black ED-Coat is missing.
