Service Bulletin

Subject:	Βι	ulletin No:	01-004/05
	La	ast Issued:	12/1/2005

2004-2005 RX-8

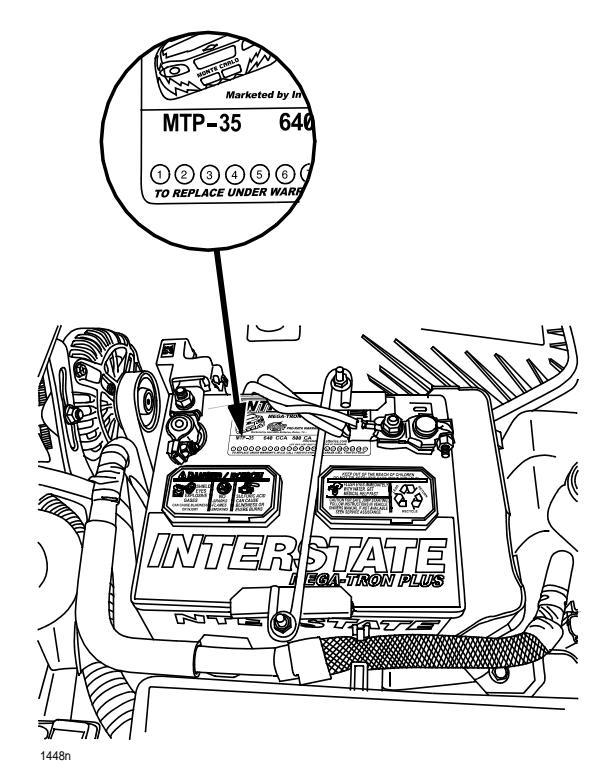
Some vehicles will require battery replacement depending on VIN / production range, and / or visual identification. 2005 Model Year vehicles DO NOT require battery replacement unless battery fails testing. Use the inspection procedure below to determine if battery replacement is necessary.

- a. Is the vehicle built after June 1, 2004 (starting with VIN JM1FE17*****139714)
 - YES Battery type is OK (Panasonic JIS 75D23L), go to STEP 2.
 - NO Battery inspection is required, proceed to STEP 1b.
- b. Remove battery cover and inspect battery label. The following batteries are approved and DO NOT require replacement. If the vehicle's battery type matches one of the following descriptions, proceed to STEP 2.
 - OEM Panasonic battery JIS specification "75D23L"
 - Mazda Genuine replacement battery part number 0000-80-6535-WB
 - Interstate brand "MTP35" battery.
 - If the vehicle's battery type matches one of the following descriptions, proceed to STEP 2.
 - If the vehicles battery type does not match the above descriptions, replace with Mazda Genuine replacement battery # 0000-80-6535-WB. Proceed to STEP 3 after battery replacement.
