Subject: AUDIO FUSE (15A) INSTALLATION AT PDI	Bulletin No: 09-033/12
	Last Issued: 08/08/2012

2013 CX-5 vehicles with VINs beginning with JM3KE*****138048 (produced on or after July 23, 2012)

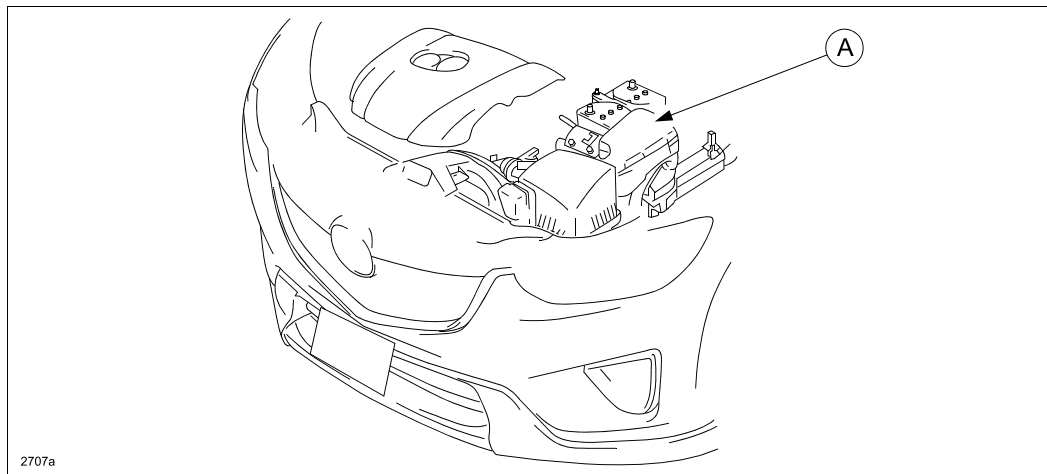
In order to minimize the reduction of battery capacity by dark current draw during new vehicle transportation, vehicles produced on or after July 23, 2012 are shipped from the plant with the AUDIO1 fuse (15A) removed from the relay and fuse block (A).

When vehicles arrive at your dealer without the AUDIO1 fuse (15A) installed, be sure to install it at PDI according to the following procedure.

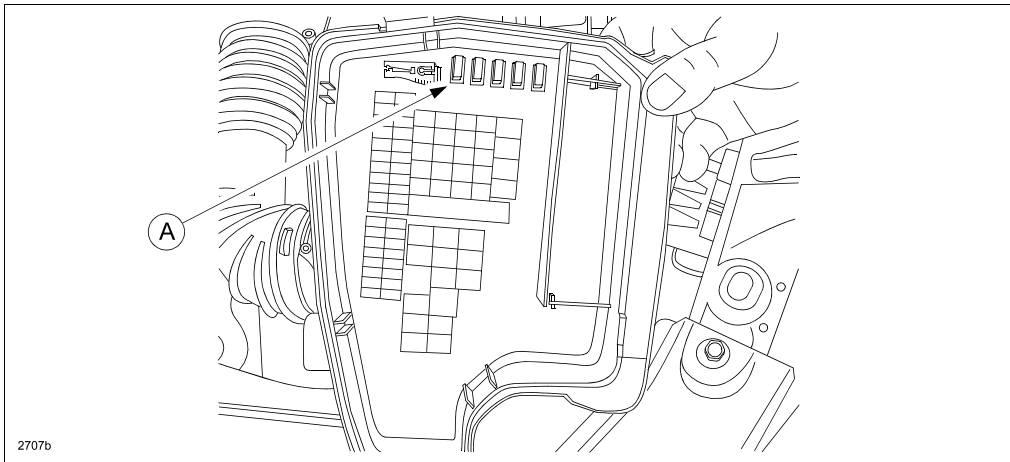
1. Turn the ignition OFF.
2. Remove the relay and fuse block cover.
NOTE: The AUDIO1 fuse (15A) which was removed at the plant is now in the spare fuse holder in the relay and fuse block cover.
3. Remove the fuse (A) from the relay and fuse block cover.

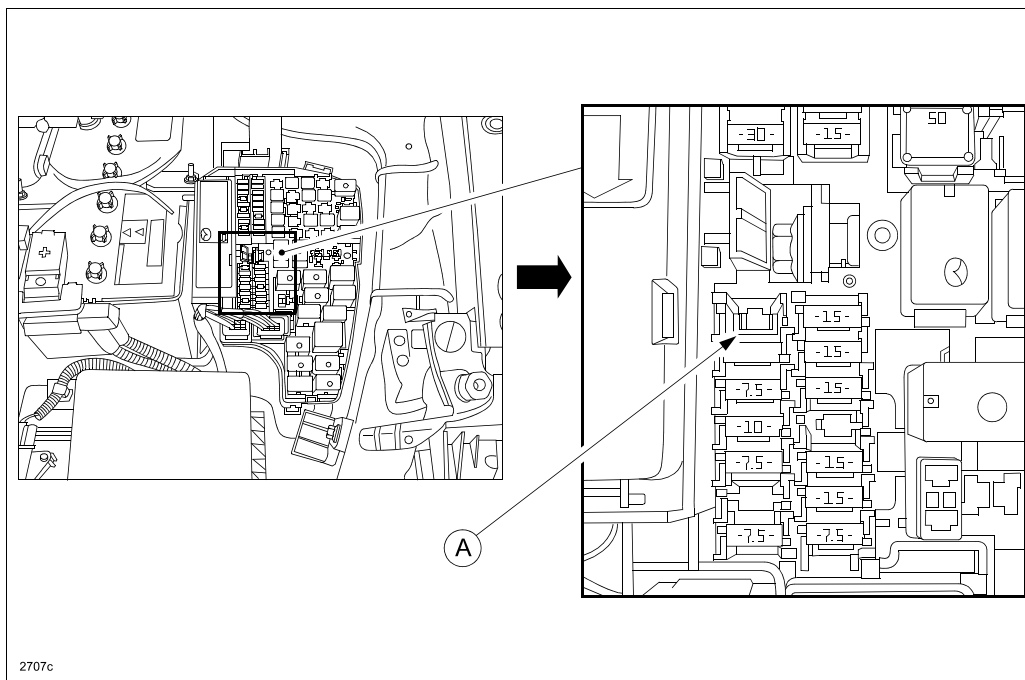
4. Install the fuse in the AUDIO1 fuse cavity (A) in the relay and fuse block.

5. Verify the audio system operates properly after fuse installation.
