Service Information

Category S	Repair Guidance	Ref. No. R093/12	Page 1 of 5
Coverage <input type="checkbox"/> Distributor only <input checked="" type="checkbox"/> Please inform your dealers		Date Issued December 19, 2012	
Please convey this information to your <input type="checkbox"/> Director <input checked="" type="checkbox"/> General Manager <input checked="" type="checkbox"/> Warranty Dept. <input checked="" type="checkbox"/> Parts Dept. <input checked="" type="checkbox"/> Training Dept. <input checked="" type="checkbox"/> Field Rep.		Date Revised	
Applicable Model Mazda6 (GH) with seat warmer	Applicable Countries or Specifications Europe

Subject: Establishment of Driver Seat Cushion Warmer as Service Part

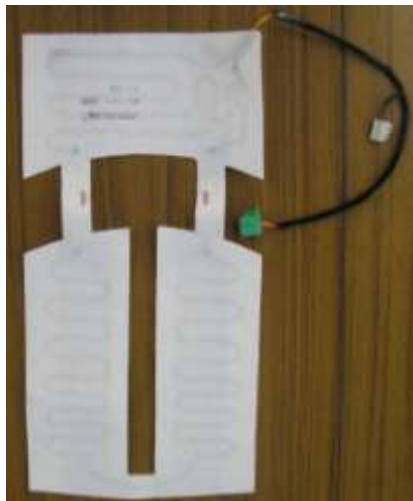
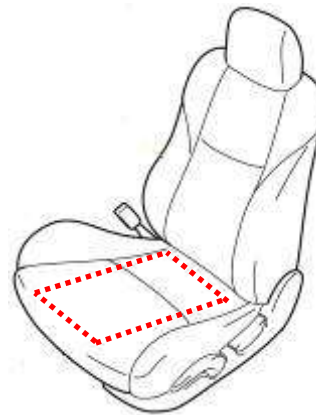
Seat cushion warmer

The driver seat cushion warmer has been newly established as a service part. Therefore, when the driver seat cushion warmer has failed, replace it by the single unit and NOT by the cushion pad assembly.

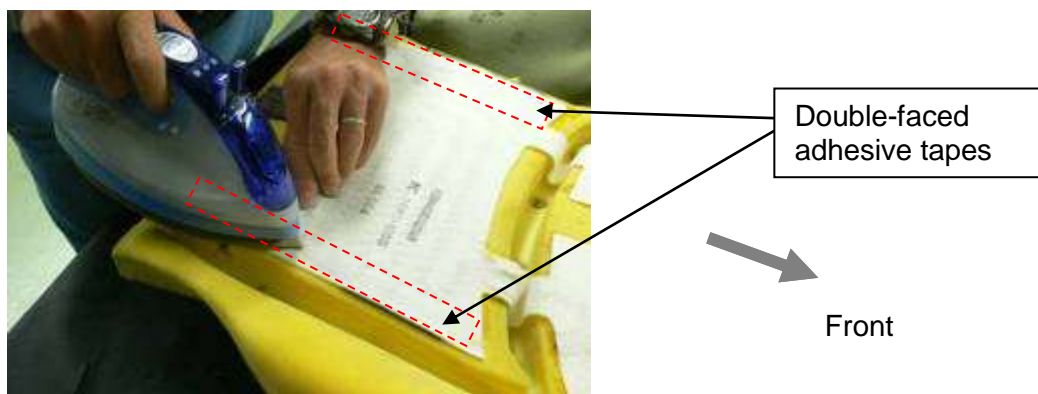
Using an iron, heat the spots of seat cushion trim where the double-faced adhesive tapes are attached, then peel off the adhesive tapes.

- Use an iron with temperatures 140~150°C.
- Peel off all tapes including the ones not shown in the figure by the same procedure.

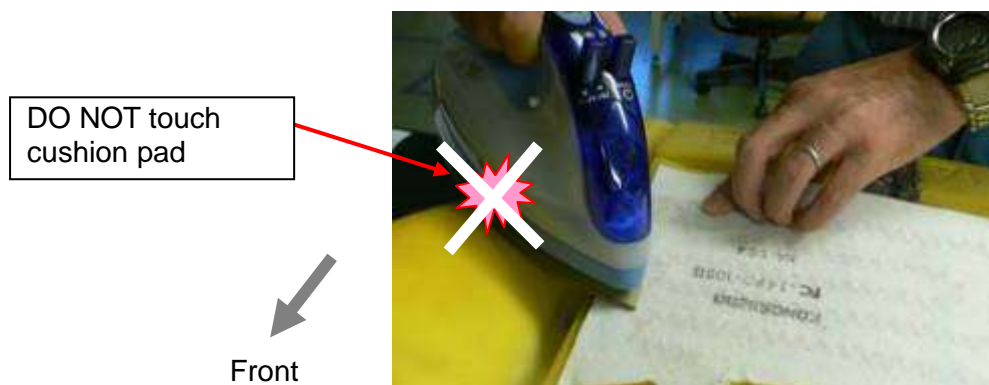
- DO NOT touch the cushion pad directly by the iron, or the cushion pad will melt.

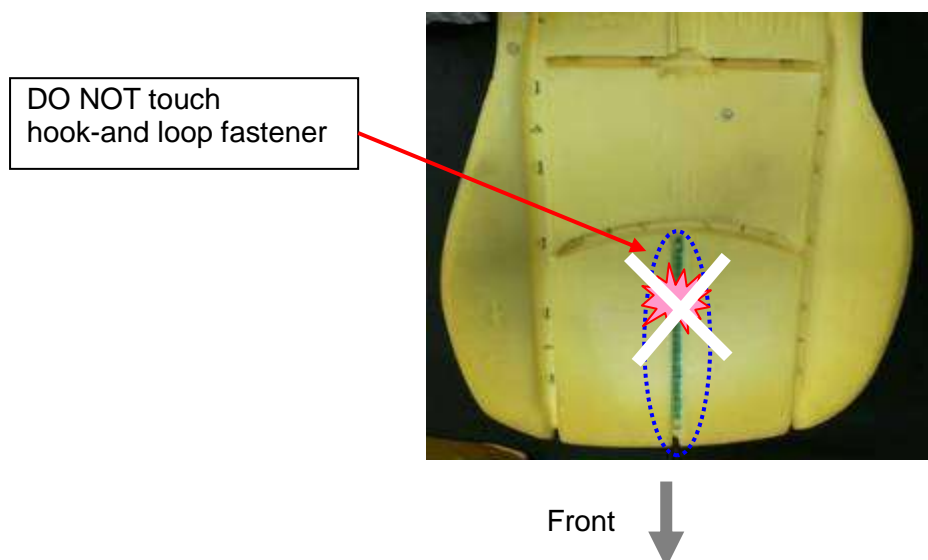
- DO NOT touch the hook-and-loop fastener directly by the iron, or it will be damaged and the trim cannot be affixed.

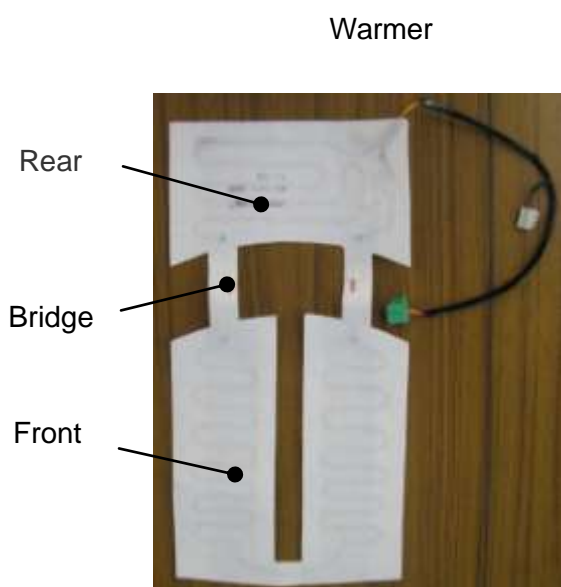
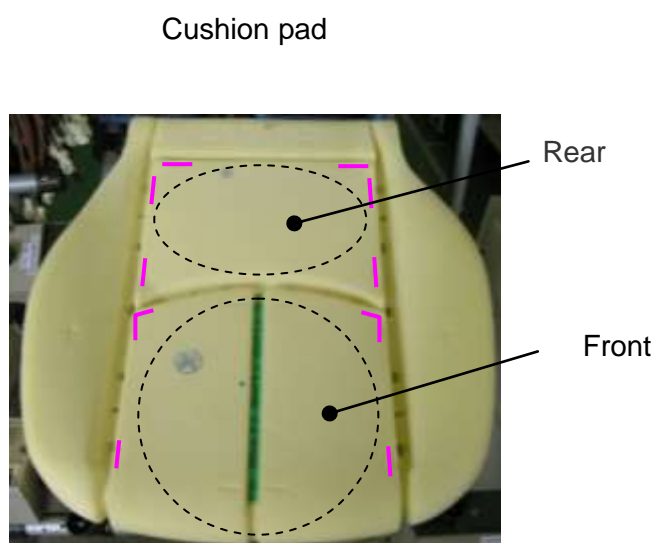
1. Take off the protective film of the double-faced adhesive tapes at the back of new seat warmer.
2. Affix the rear part of warmer on the rear of cushion pad.
Note:
DO NOT cover the grooves for trim installation by the warmer.

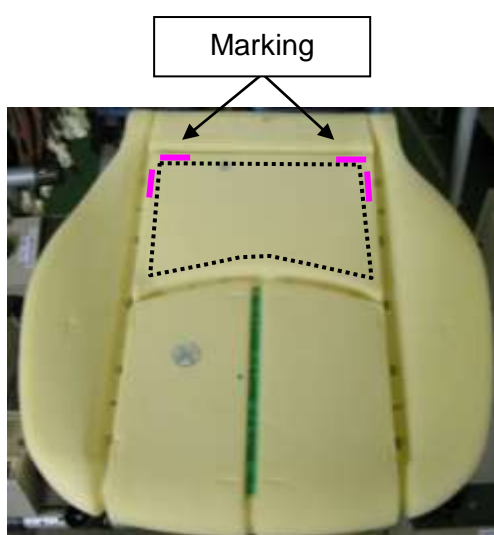
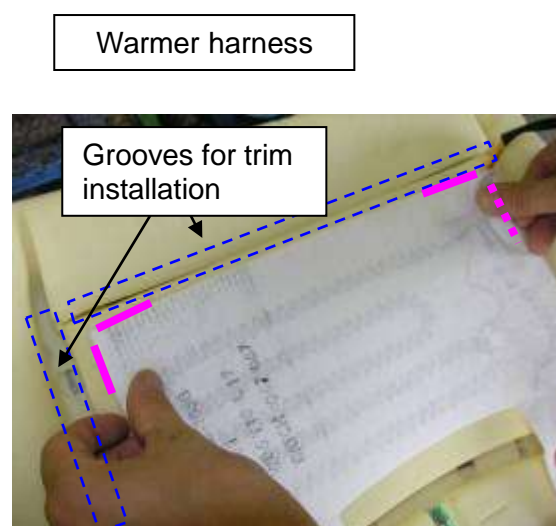
3. Affix the warmer straightly toward the front taking caution not to misalign to the right or left.

4. Affix the two separate fronts of warmer on the front part of the cushion pad.
- (1) Align the rear edge of two separate parts of warmer and the marking on the rear of cushion pad front.

- DO NOT cover the grooves for trim installation by the warmer.
- DO NOT cover the hook-and-loop fastener by the warmer.

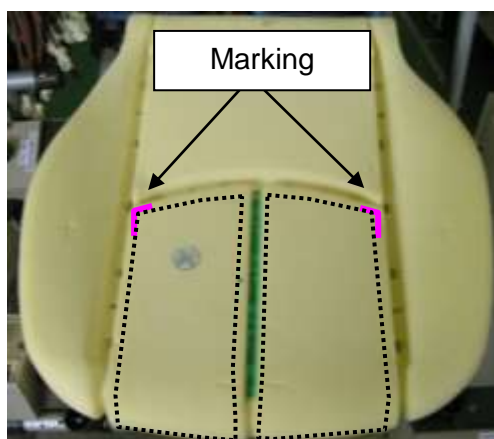
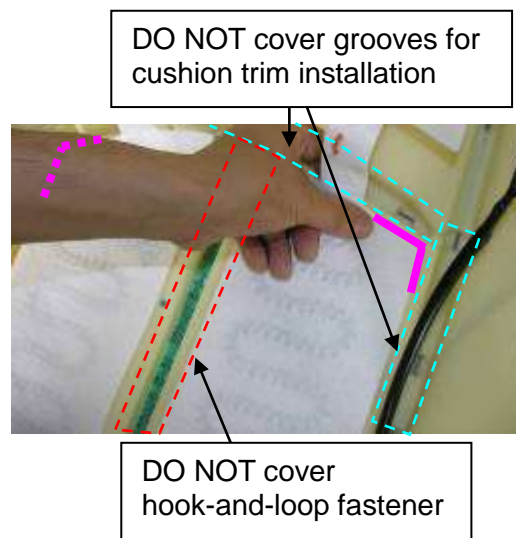
- (2) Affix the warmer straightly toward the front taking caution not to misalign it.

Note: DO NOT cover the right and left trim by the warmer.

- (3) Affix the front part of warmer along the round of cushion pad.

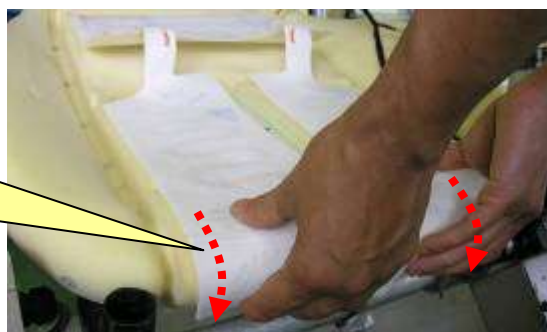
Affix the warmer along the round shape of cushion pad.

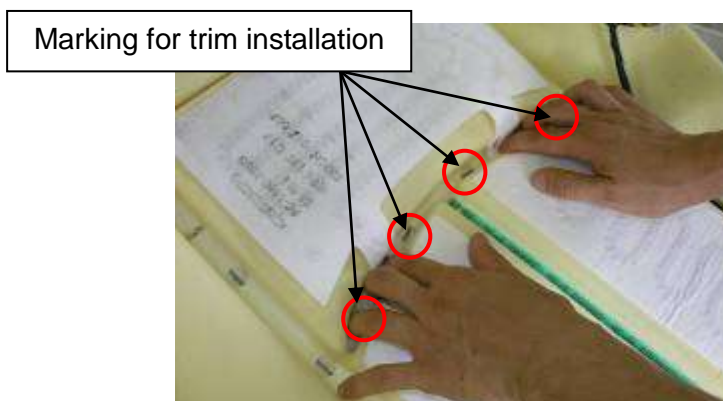
5. Insert the right and left bridge of warmer to the bottom of groove of cushion trim.

DO NOT cover the marking on cushion trim by the warmer or the trim cannot be installed later.

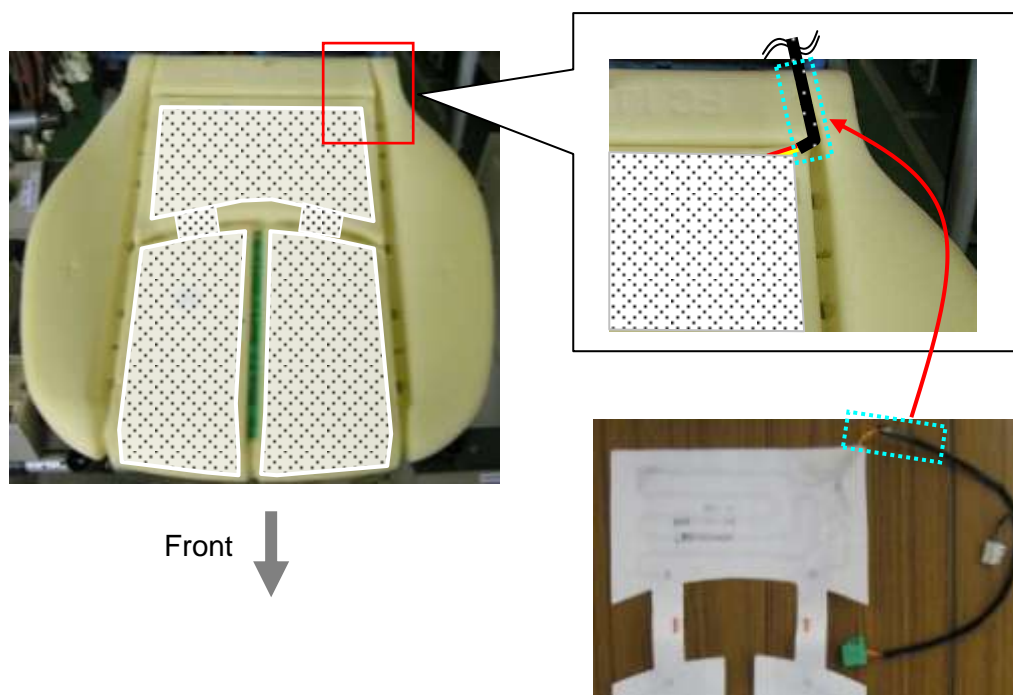
6. Fit the warmer harness in the groove of cushion pad.
