Service Information

Category R	Technical	Ref. No. E010/13	Page 1 of 1
Coverage <input type="checkbox"/> Distributor only <input checked="" type="checkbox"/> Please inform your dealers		Date Issued May 28, 2013	
Please convey this information to your <input type="checkbox"/> Director <input checked="" type="checkbox"/> General Manager <input checked="" type="checkbox"/> Warranty Dept. <input checked="" type="checkbox"/> Parts Dept. <input checked="" type="checkbox"/> Training Dept. <input checked="" type="checkbox"/> Field Rep.		Date Revised	
Applicable Model CX-5(KE), Mazda6(GJ)		Applicable Countries or Specifications Worldwide

Subject: Stabilizer Bush of Front and Rear

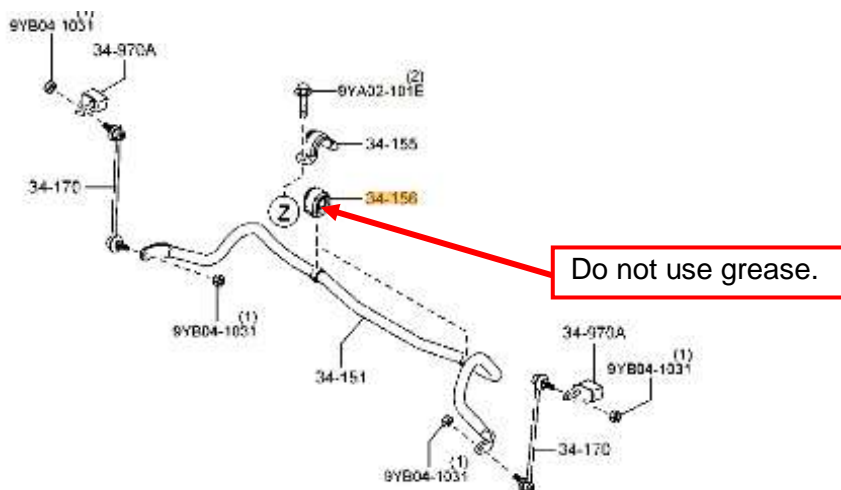
To prevent noise from stabilizer bush, do not apply grease on the bushes of front and rear stabilizer. (Example below shows CX-5 front stabilizer bush)

For the newly developed models from CX-5, grip type bushes are installed to prevent noise. If you apply grease mistakenly, a noise due to slipping may occur. Therefore, please do not apply any grease to the bushes of front and rear stabilizer.
