Service Information

Category D	Repair Guidance	Ref. No. R092/13	Page 1 of 11
Coverage <input type="checkbox"/> Distributor only <input checked="" type="checkbox"/> Please inform your dealers		Date Issued November 12, 2013	
Please convey this information to your <input type="checkbox"/> Director <input checked="" type="checkbox"/> General Manager <input checked="" type="checkbox"/> Warranty Dept. <input checked="" type="checkbox"/> Parts Dept. <input checked="" type="checkbox"/> Training Dept. <input checked="" type="checkbox"/> Field Rep.		Date Revised	
Applicable Model CX-5 (KE) with SKYACTIV - D 2.2	Applicable Countries or Specifications Europe (Except for Russia)

Subject: Check Engine Light illuminates with DTC P06DD:00

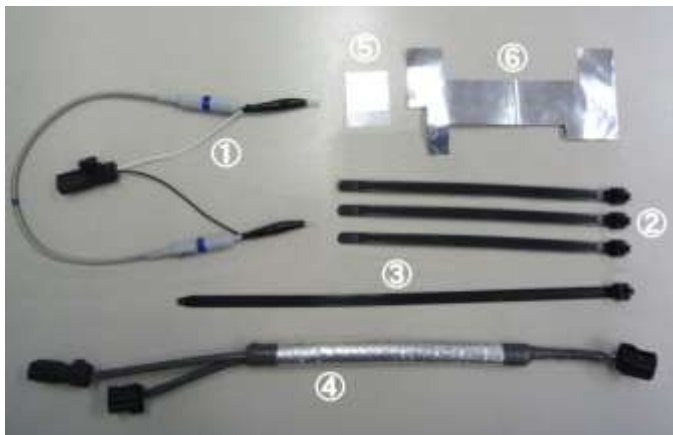
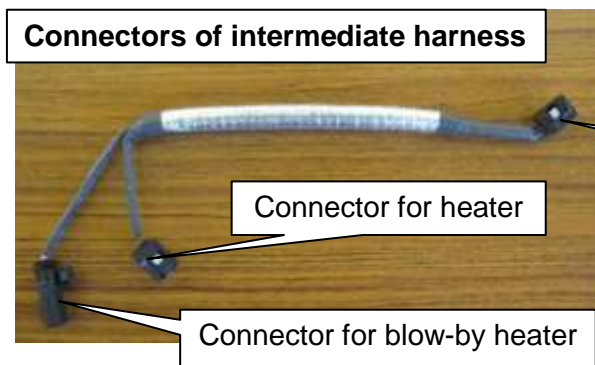
The following parts are included in kit

No.	Parts Name	Q'ty
(1)	Heater wire	1
(2)	Band	3
(3)	Band(Long)	1
(4)	Intermediate Harness	1
(5)	Aluminum Tape(Small)	1
(6)	Aluminum Tape(Large)	1

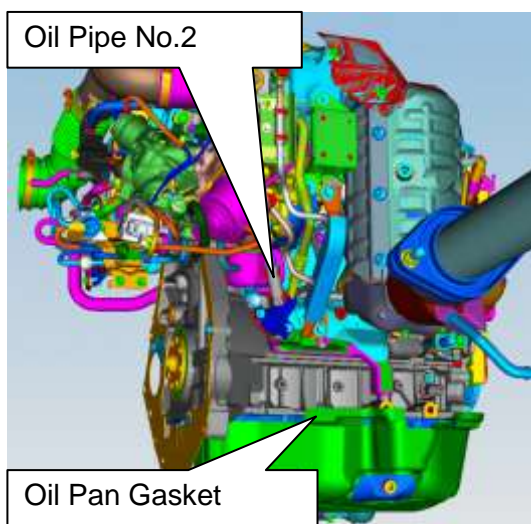
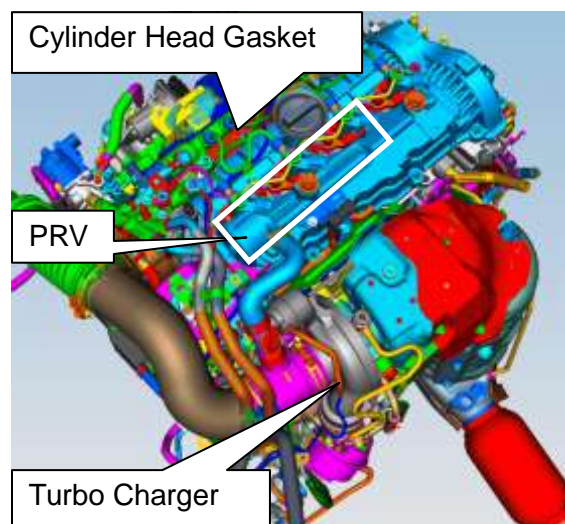
1. Verify the oil seepage from the following parts. If there is oil seepage, repair it referring to workshop manual. Go to next step
(1) Oil pipe No. 2 (2) Oil pan gasket. (3) Cylinder head gasket (4) PRV (5) Turbo charger

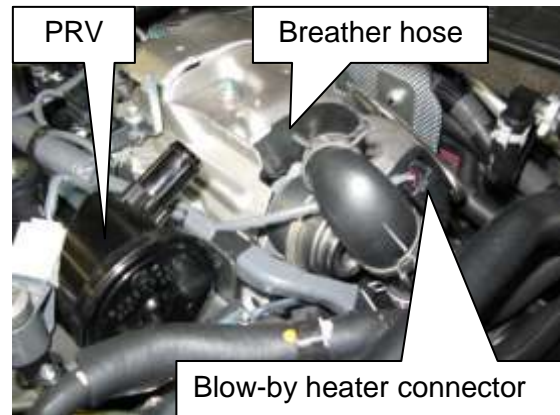
1. Disconnect the negative battery cable.(Refer to workshop manual)
2. Remove the engine cover and insulator.
3. Disconnect the connector of blow-by heater.
4. Disconnect the breather hose from PRV.

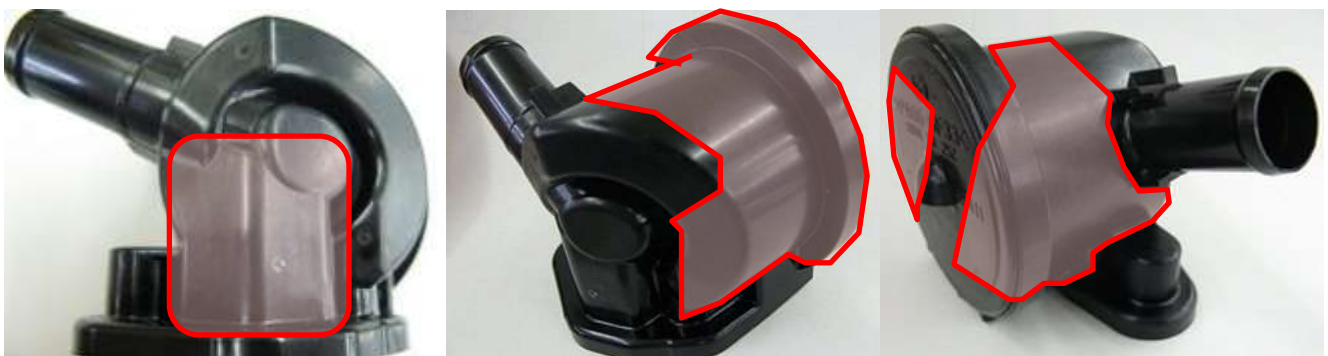
5. Degrease the surface of the PRV using a new clean cloth with parts cleaner.

- * After washing hands, perform the next step.
- * Especially degrease the red area to attach aluminum tape.

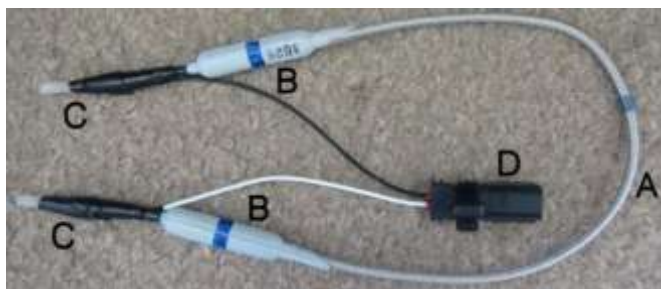
6. Install the heater wire.

A	Heater
B	Heater connection
C	Butyl and Tape
D	Connector

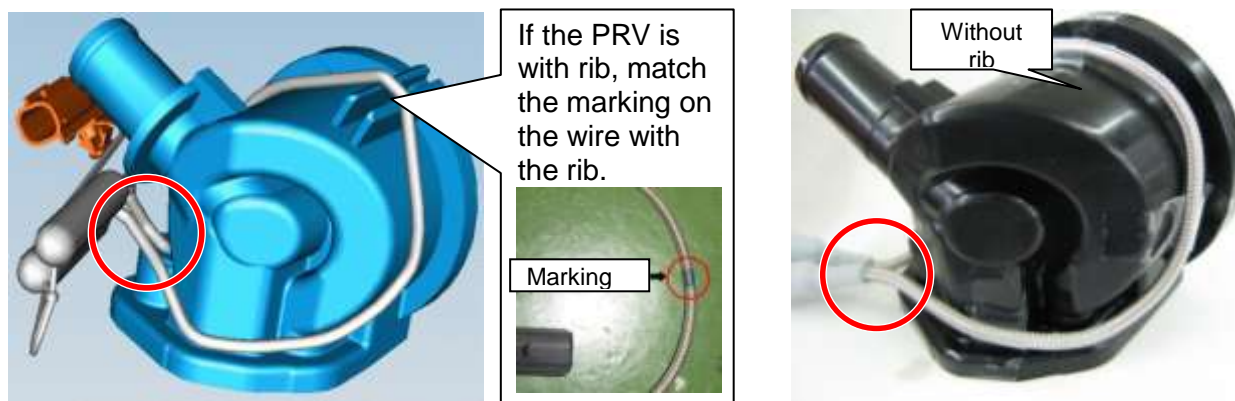
* The procedure will be different depending on the shape of PRV.

(1) Install the heater wire with the connector area being located under the vent hose pipe. (red circle in below picture)

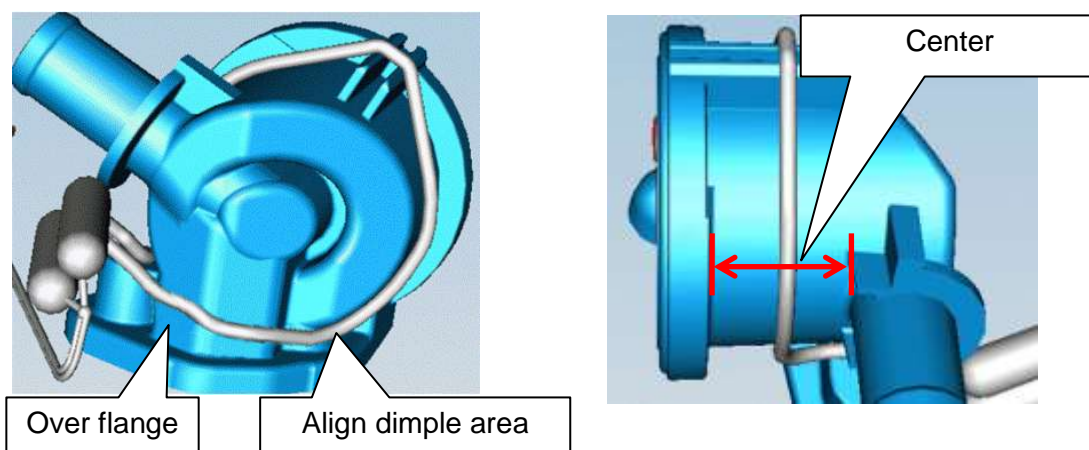
(2) Route the heater wire as per below picture.

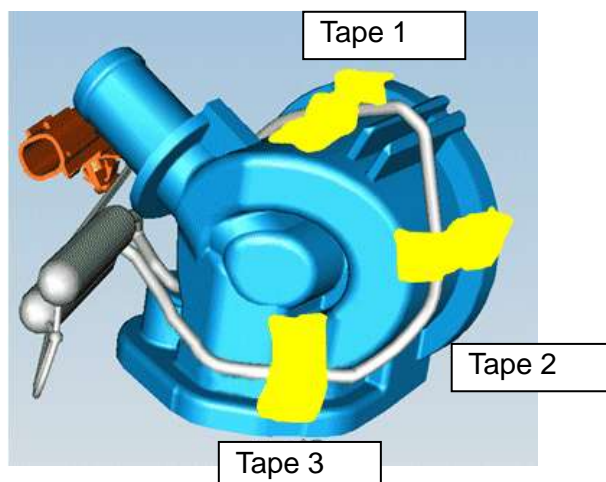
(3) Temporarily fix the heater at 3 places by tape.

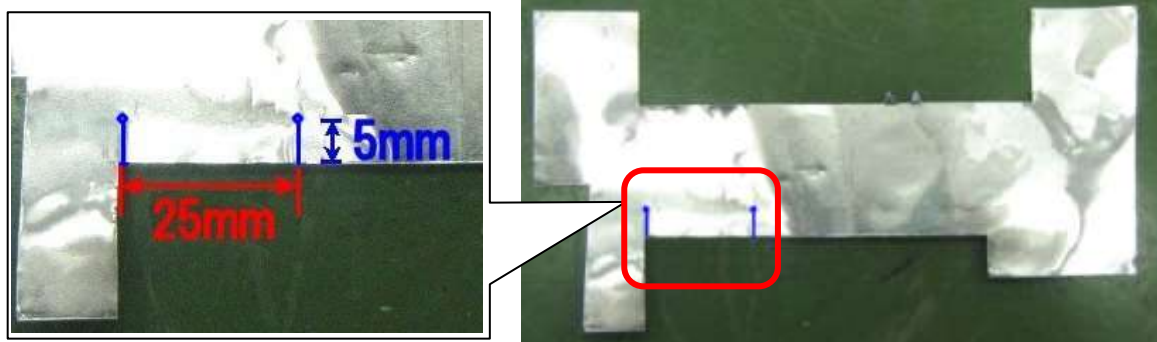
< Aluminum tape (large) adhering procedure >

Cut in the aluminum tape (large) at 2 places for 5 mm in a distance of 25 mm as per following pictures.

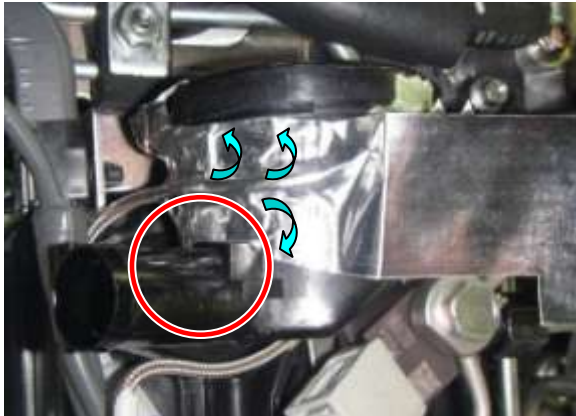
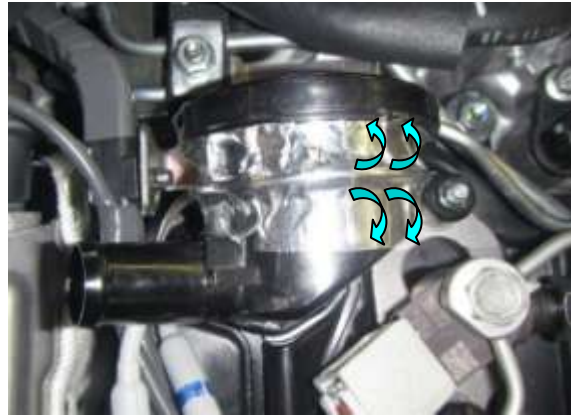
How to adhere the aluminum tape (large) to the PRV without rib

- * Remove the protective sheet on the cutting area of aluminum tape.
- * Set the cutting area of aluminum tape to the pipe area of PRV as below picture (red circle).
- * Adhere the aluminum tape from center to outside.
- * Remove the remaining protective sheet.
- * Remove the temporary tape (1) & (2), and adhere the aluminum tape from center to outside little by little.

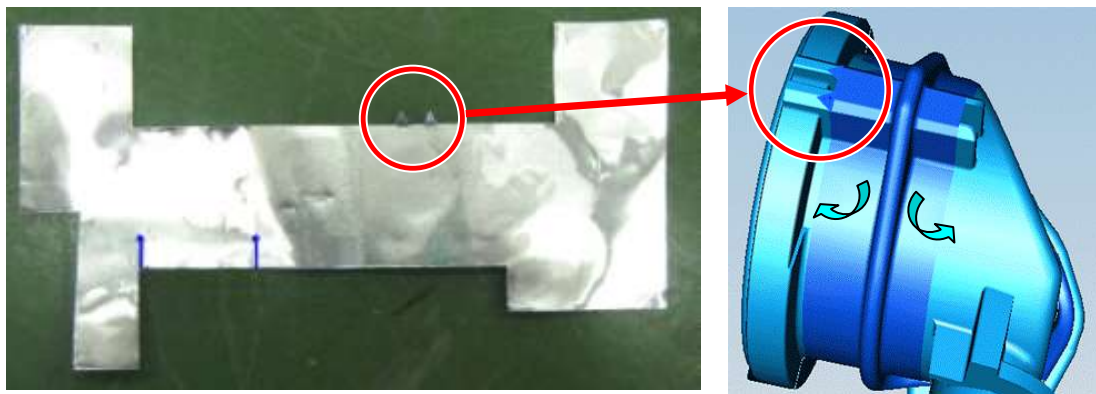
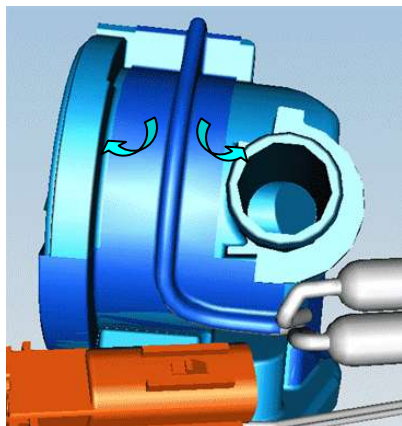
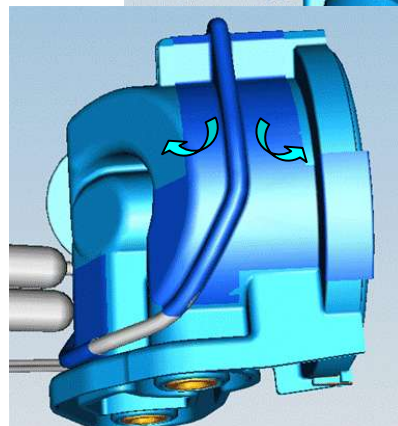
How to adhere the aluminum tape (large) to the PRV with rib

- * Remove the protective sheet from the area with 2 projections (refer to red circle in below picture).
- * Align the 2 projections of the aluminum tape with the rib of PRV, and adhere it.
- * Remove the temporary tape (1) & (2), and adhere the aluminum tape from center to outside little by little.
- * Remove the remaining protective sheet.
- * Adhere the aluminum tape from center to outside little by little.

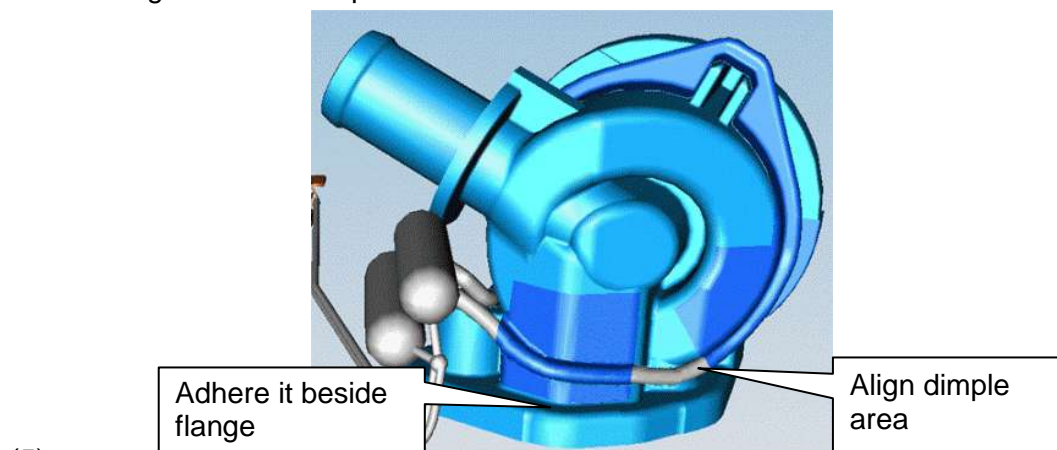
How to adhere the aluminum tape (small) to the PRV

* Remove the temporary tape (3), and adhere the aluminum tape with the heater following the round shape on the PRV lower area.

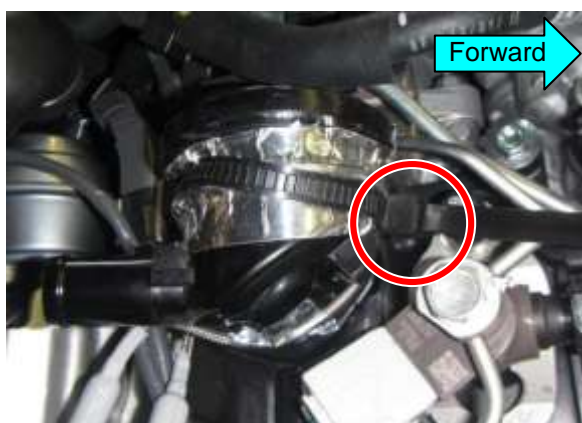
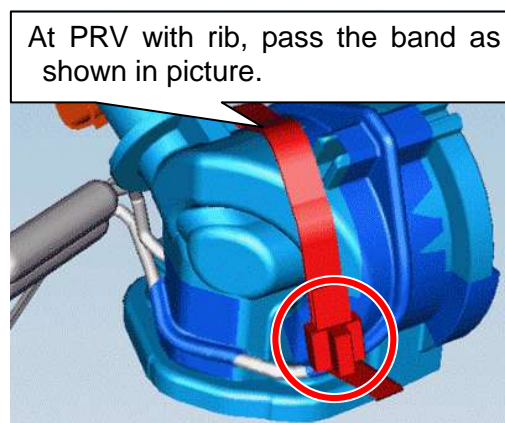
7. Tighten the heater by band (long) as per following pictures with the band connector (red circle) facing forward.

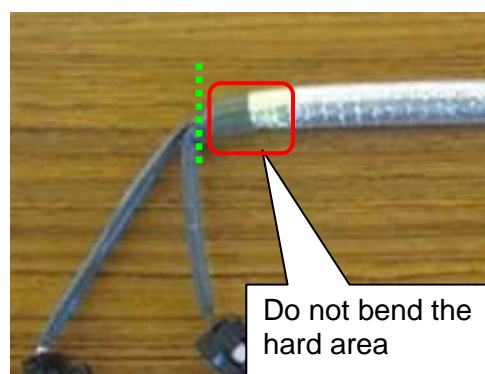
9. Bend the wires of the intermediate harness as shown in the picture.

* **Do not bend the hard area which is water proof plastic. If it is bent, the water may enter inside. So please bend it at soft area.**

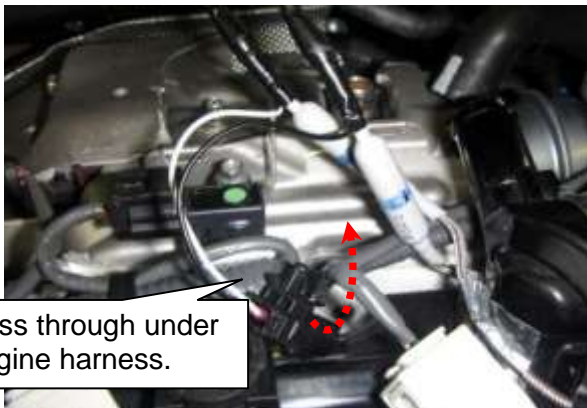
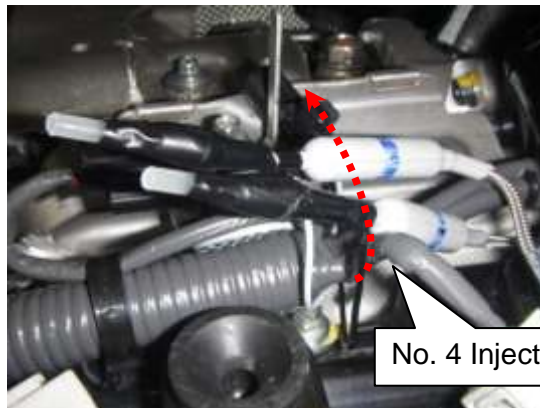
10. Pass the heater wire connector through under engine harness.

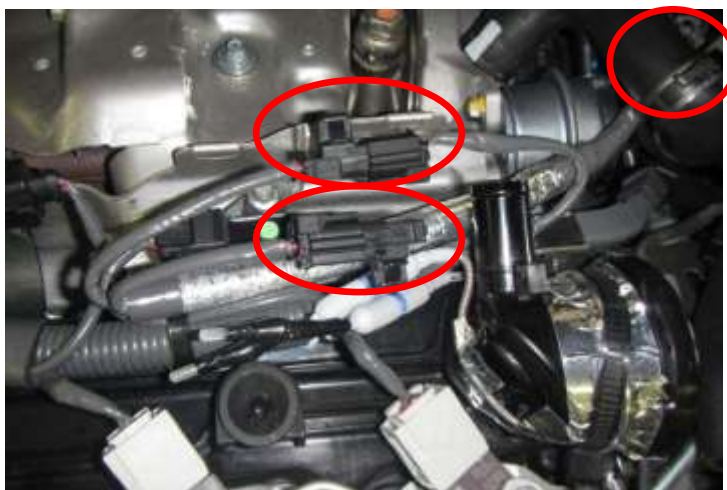
11. Connect the connector of intermediate harness to heater wire connector and blow by heater connector.

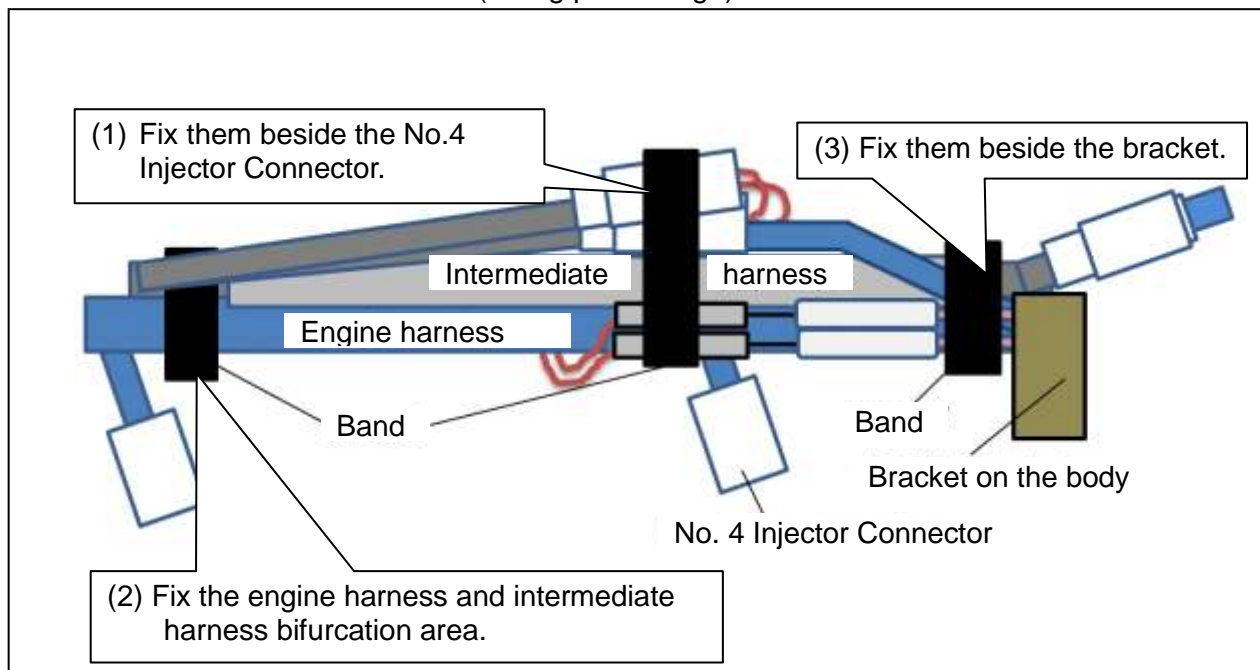
(Fixing point image)

12. Fix the intermediate harness and engine harness by band in numbered order.

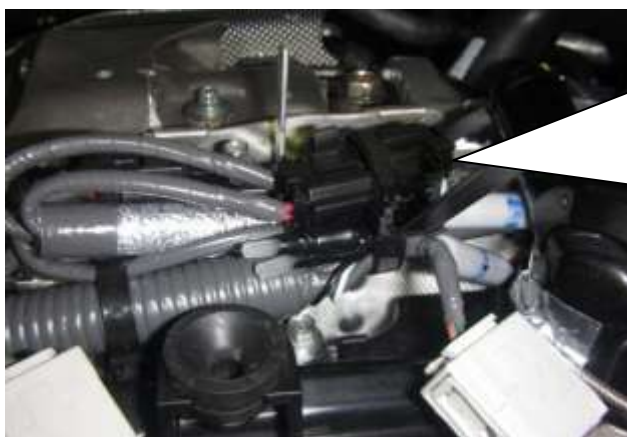
(1)

(Fixing condition)

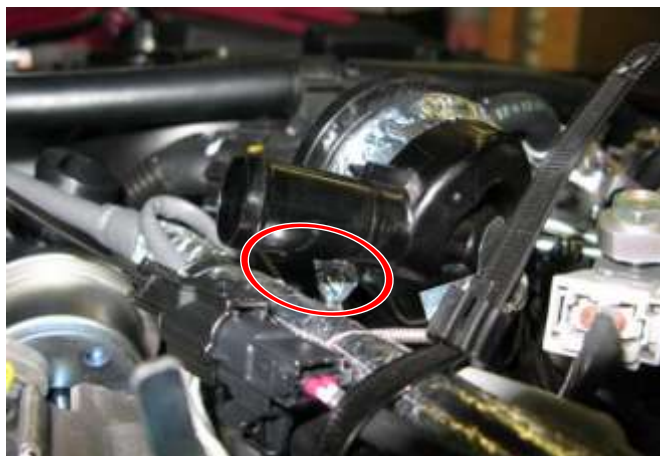
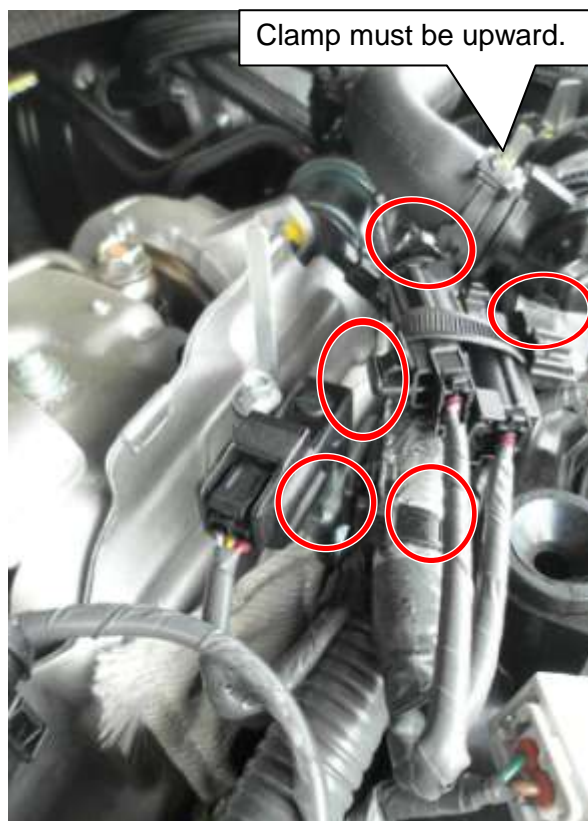
14. Install the breather hose and confirm that there is no interference between each part.

* **Confirm there is no interference between connector of intermediate harness and breather hose.**

* **Be sure that there is no interference between hose clamp and each wire.**

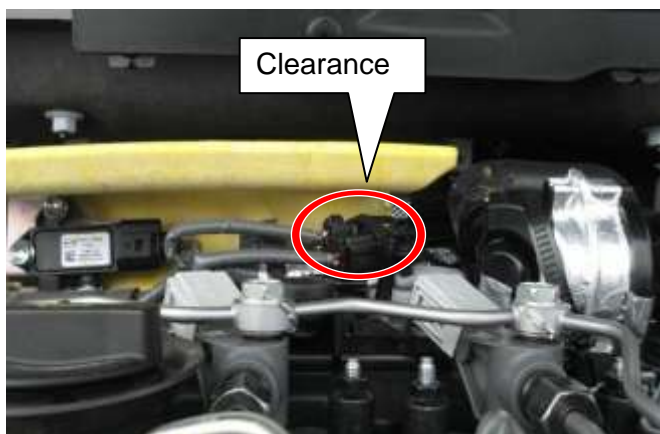
15. Install the insulator and engine cover.
