Service Information

Category S	Repair Guidance	Ref. No. R083/13	Page 1 of 4
Coverage <input type="checkbox"/> Distributor only <input checked="" type="checkbox"/> Please inform your dealers		Date Issued November 19, 2013	
Please convey this information to your <input type="checkbox"/> Director <input checked="" type="checkbox"/> General Manager <input checked="" type="checkbox"/> Warranty Dept. <input checked="" type="checkbox"/> Parts Dept. <input checked="" type="checkbox"/> Training Dept. <input checked="" type="checkbox"/> Field Rep.		Date Revised	
Applicable Model CX-5 (KE)		Applicable Countries or Specifications Worldwide

Subject: White Stains under Power Outer Mirror Base

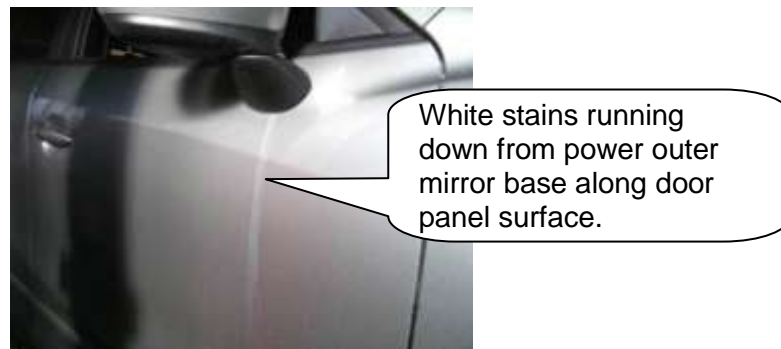
Some vehicles may exhibit white stains running down from inside the power outer mirror base along the front door panel surface.

Since it is designed to drain water from inside the power outer mirror to outside the door, water containing white corrosion generated inside the power outer mirror base runs down along the door panel surface, causing poor appearance.

The shape of the gasket for the outer door mirror base has been changed so that water drains to inside the door.

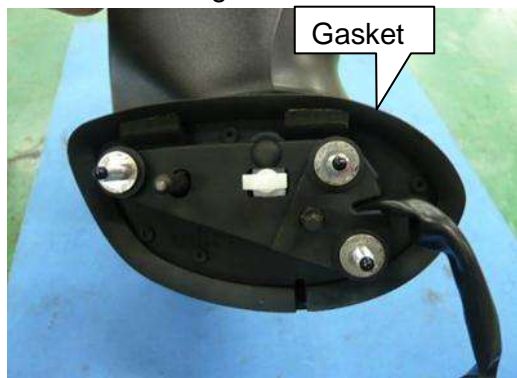
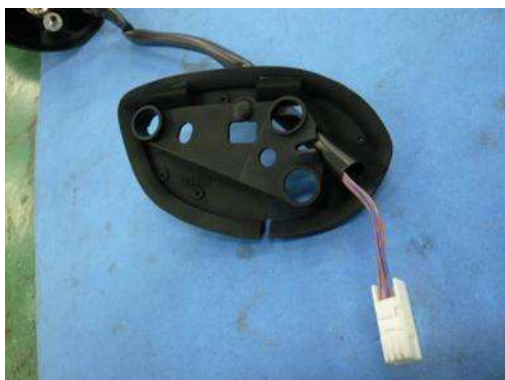
1. Remove the power outer mirror (both sides) according to the instructions in Workshop Manual "POWER OUTER MIRROR REMOVAL/INSTALLATION".
2. Remove the gasket from the mirror base.

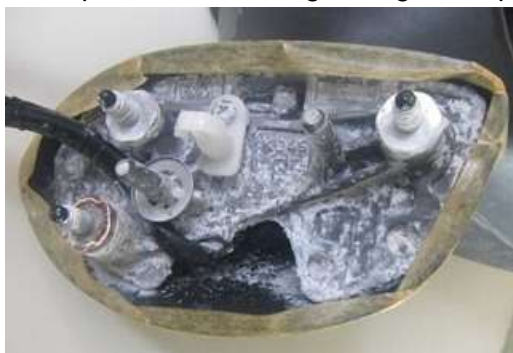
3. To prevent scratching during work, put masking tape to the mirror base cover as shown in figure.

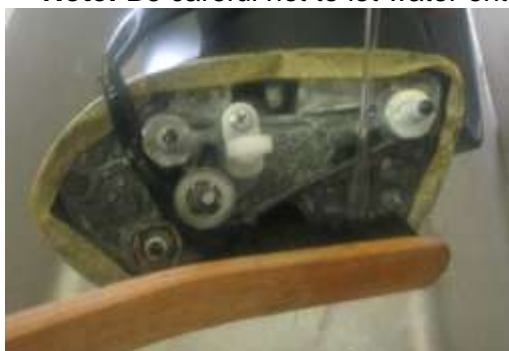
4. Using a soft brush and water, wash away white corrosion at the bottom of the mirror base
Note: Be careful not to let water enter inside the mirror base.

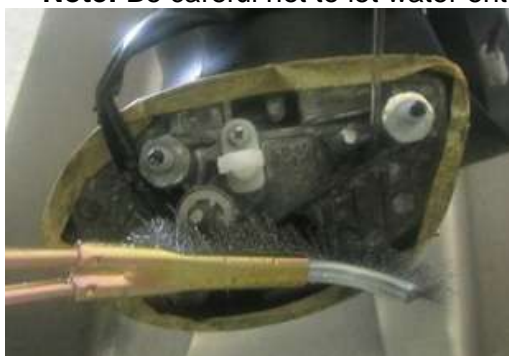
5. Using a wire brush and water, lightly wash off the bottom of the mirror base.
Note: Be careful not to let water enter inside the mirror base.

Note: It is not necessary to remove white corrosion completely from the bottom of the mirror base as it does not cause adverse effect on function and durability of the power outer mirror. It is sufficient to remove white corrosion to the extent that it can be removed by slightly scrubbing with a wire brush.

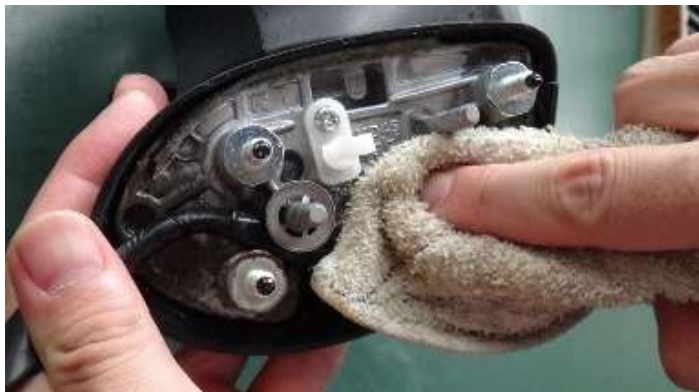
6. Remove the masking tape and then wipe water off the mirror base and let it dry.

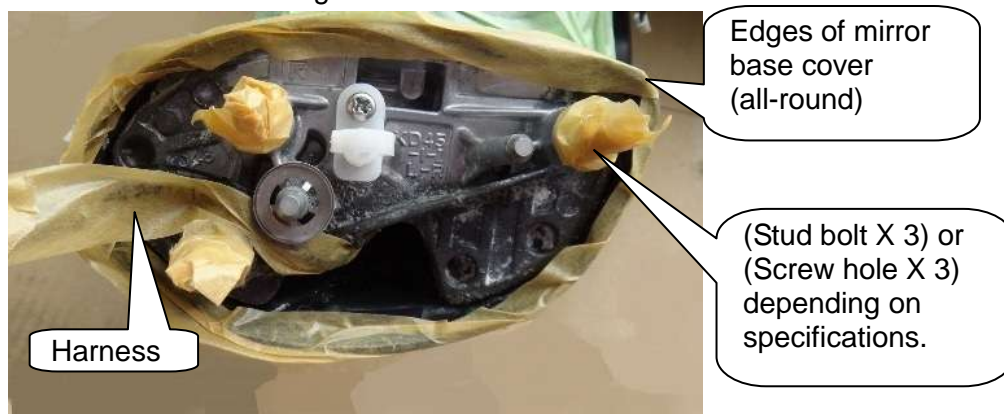
7. To prevent applying wax to the base cover, stud bolt and harness, put masking tape to the mirror base as shown in figure.

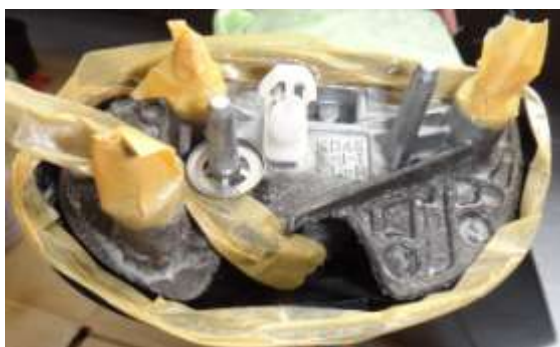
8. Apply anti-corrosion wax to the mirror base.
Recommended anti-corrosion wax: Wurth Protective Wax Transparent (0893 082) or equivalent

9. Let the anti-corrosion wax dry naturally.
10. Remove the masking tape.

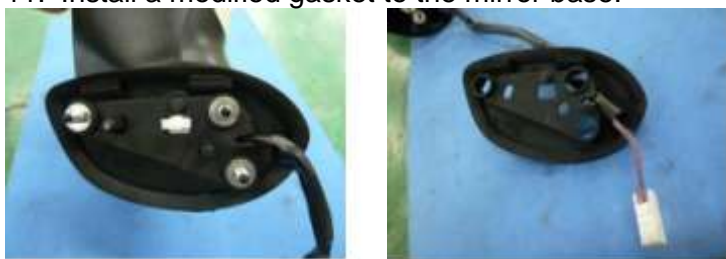
11. Install a modified gasket to the mirror base.
