Category F	Repair Guidance	Ref. No. R046/14	Page 1 of 4
Coverage <input type="checkbox"/> Distributor only <input checked="" type="checkbox"/> Please inform your dealers		Date Issued May 29, 2014	
Please convey this information to your <input type="checkbox"/> Director <input checked="" type="checkbox"/> General Manager <input checked="" type="checkbox"/> Warranty Dept. <input checked="" type="checkbox"/> Parts Dept. <input checked="" type="checkbox"/> Training Dept. <input checked="" type="checkbox"/> Field Rep.		Date Revised	
Applicable Model Mazda3(BM) with Gasoline Engine	Applicable Countries or Specifications Worldwide (Except US spec.)

Subject: Clicking Noise from under Rear Seat area

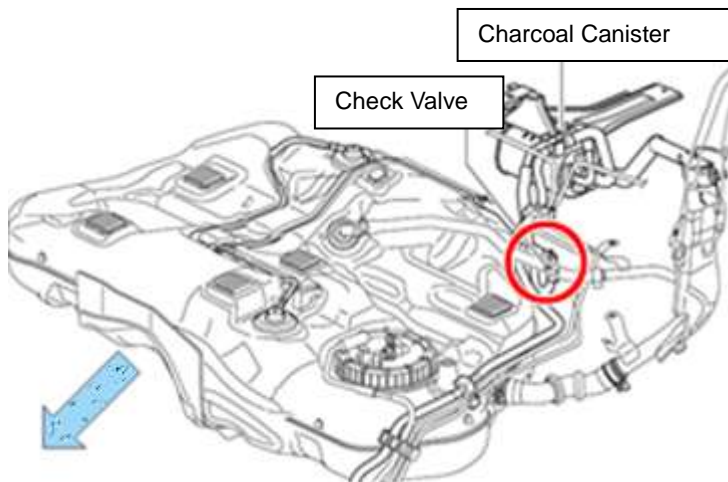
Some vehicles may exhibit a clicking noise which is heard under the rear seat (around the fuel tank) when the engine is idling.

This may be originated from the check valve operating noise during the time of purge control operation. The noise is transmitted from the fuel tank strap, where the check valve is installed, to the vehicle body. Inside the cabin it is heard as a clicking noise.

When you encounter a customer complaint on this concern, insulate the noise by wrapping the check valve with an EPT sealer using the following procedure.
