## DIY Mazda RX8 2005 Series 1 Automatic Sport Suspension 60K Maintenance (Fuel Line [Update 11/11/2017](#))

## DIY RX8 2005 Series 1 60K Maintenance Notes

## DIY 2005 RX8 4-Port Automatic Fuel Injectors Remove & Replace

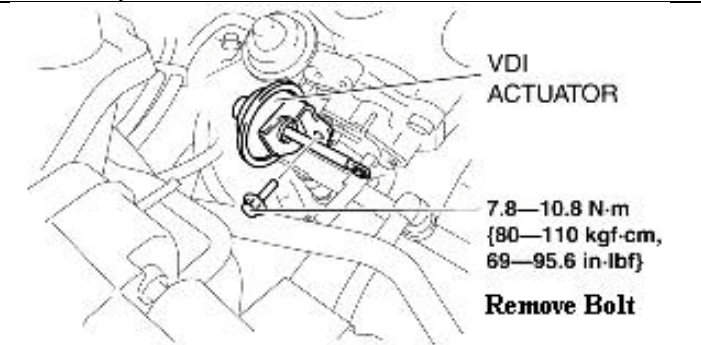
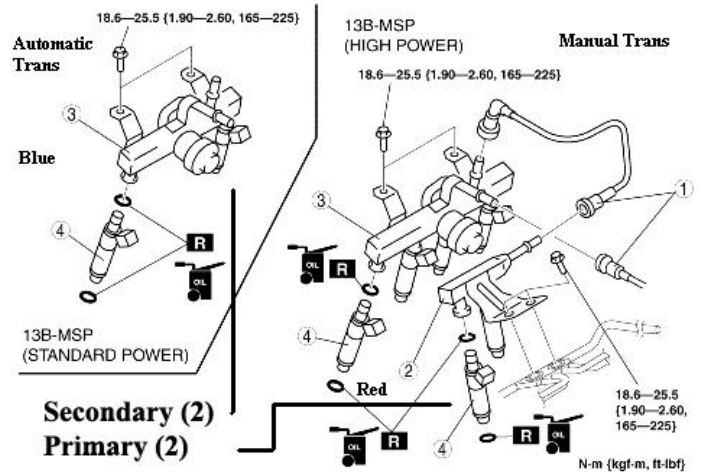
## DIY 2005 RX8 Automatic Fuel Injector R&R

Remove entire upper intake manifold. Remove the bolt holding the VDI actuator in place and swing it out of the way. Remove the hoses on the fuel rails. Remove the two bolts holding the fuel rail in place. Wiggle the fuel rail out and pull the injectors out of the rail and Lower Intake Manifold (LIM). Write down where wires went or mark the wire harness. Remove primary injectors from the second fuel rail.

1. Disconnect the negative battery cable
2. Remove Air Intake and Throttle Body (7)
3. Remove extension manifold (upper) (8)
4. Remove extension manifold (lower) (Not 2005 AT)
5. Remove the VDI actuator bracket installation bolt
6. Position the VDI actuator out of the way
7. Disconnect the fuel injector connector
8. Quick release connector
9. Fuel rail distributor (housing side)
8. Fuel rail distributor (intake manifold side)
10. Fuel injectors

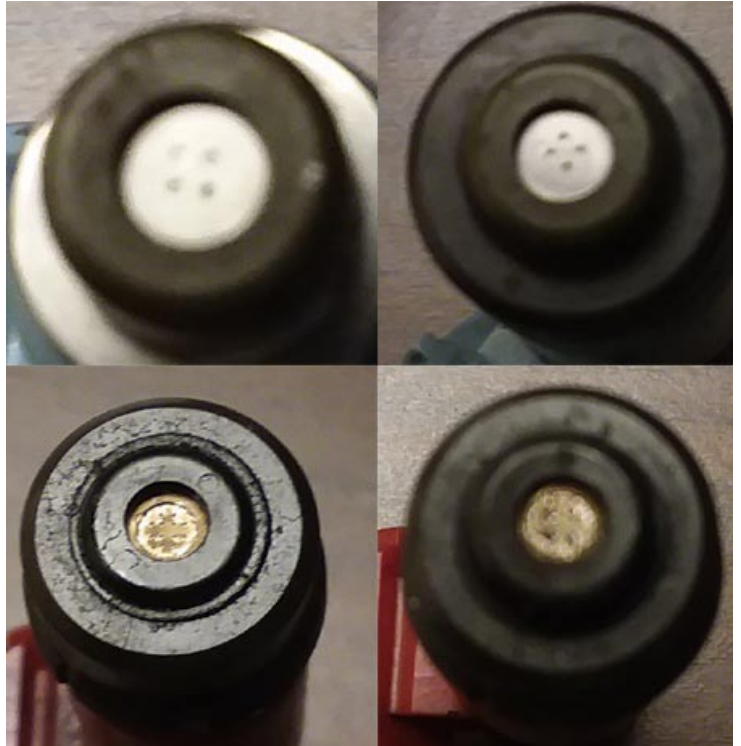
### Condition of Removed Fuel Injectors

Secondary Fuel Injectors (Top Blue)	Very Clean	Very Clean
Primary Fuel Injectors (Bottom Red)	Clogged	Carbon Dirt

The primary fuel injectors are on from idle through high revs. The secondary injectors come on at >~3000 rpm, don't affect idle.

Front Primary Injector is completely clogged with white oil-grease. Rear Primary Injector 4-Port Engine holes filled with carbon grime.

**Injector Install:** Inspected injector ports, found one rubber boot end fallen off, embedded and stuck, removed. Cleaned connectors with contact spray. Prepped injector seals with a thin coat of Permatex dielectric grease (email verified) being very careful not to get grease on the tips. Installed harnesses on injectors before placing into rails. Primary injector cups are deep, be sure to push the primary injectors in all the way down. Secondary tops need a push. Rails bolted back in. Made sure rail to rail fuel quick connects were tight.
