M-TIPS

2004 RX-8

Audio Unit Removal

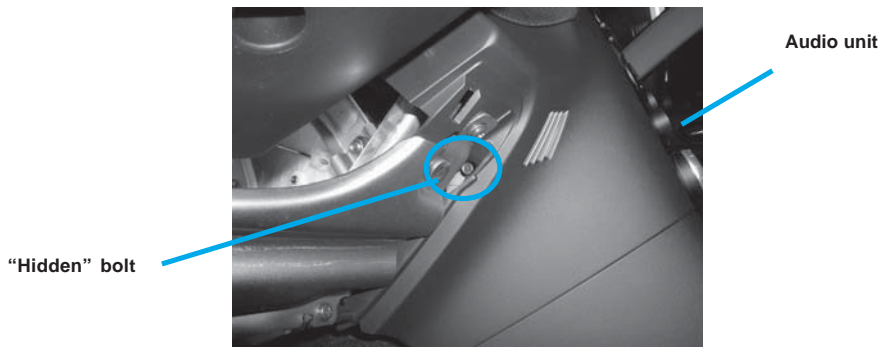
1. Remove plastic lower dash panel piece under steering column.

2. Locate 10mm gold anodized “hidden” bolt.

3. Remove bolt. **Caution: Watch sharp edges on dash frame!**

4. Continue removal of audio unit according to Workshop Manual.
