MULTIPLE MODELS PREVENT DAMAGE TO CENTER PANEL FINISH

Technician Submitted M-Tip Norm Ostrowski

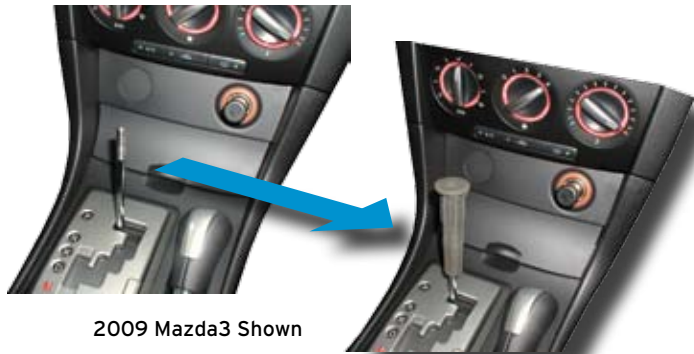
2009 Mazda3 Shown

When removing and installing the center panel during diagnostics and repair procedures on Mazda vehicles (with center console mounted AT or MT shifter) to gain additional access during removal the gear shift knob may be removed. When the gear shift knob is removed, the gear shift lever threads are left exposed and have a sharp edge that may damage the finish of the center panel during removal or installation (especially when unplugging the audio unit connectors).

To prevent damage to the center panel finish, after removing the shift knob, place a straight spark plug boot (such as used for a Tribute or B-Series truck) over the threads of the shift lever. The spark plug boot will prevent damage as a result of contact between the center panel and the shift lever threads.
