M-TIPS

Mazda M-TIPS • May/June • 2006

All Models W/Sirius Satellite Radio Installed RI4922

Satellite Radio Displays 'ANTENNA+FAIL'

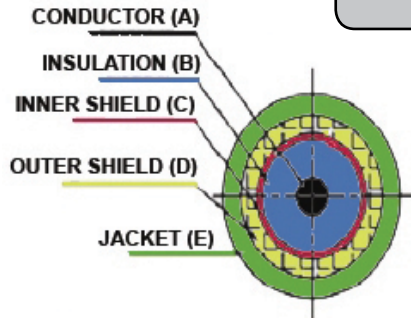
Inspect This Connector

1. Remove antenna from plastic bag.
2. Inspect cable assembly connector for proper length of conductor. The conductor (A) must be flush with surface of insulation (B).
3. If conductor is not flush with white plastic insulation surface, antenna is not good. A new antenna is necessary before installation.
4. If conductor is flush with white plastic insulation surface, antenna is good. Continue with install.

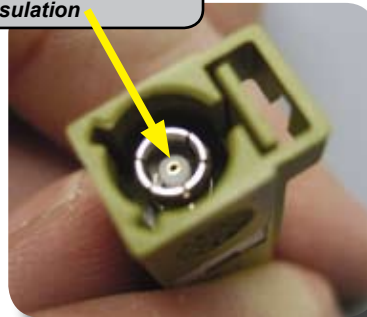
GOOD - Conductor Flush With Insulation

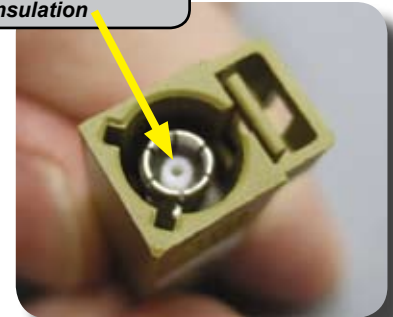
BAD - Conductor NOT Flush With Insulation
