Subject: CHIPS AND SCRATCHES ON FRONT SEATBACK COVER - LEATHER SEATS	Bulletin No: 09-034/04
	Last Issued: 11/22/2004

2004 RX-8 with VINs lower than JM1FE****40128213

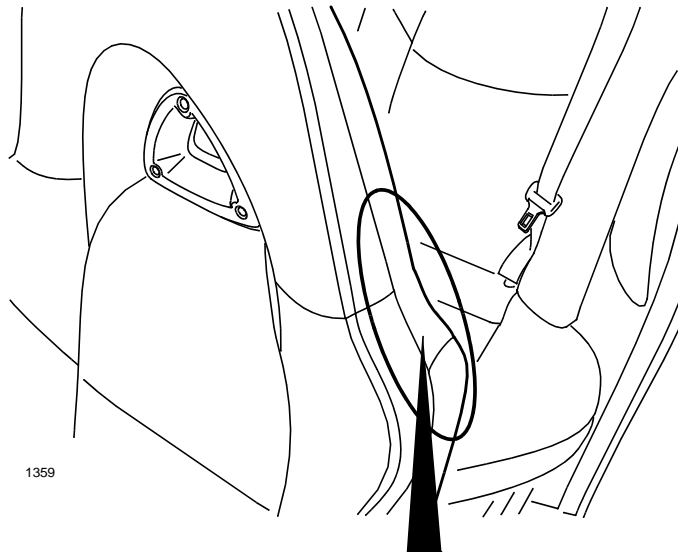
On 2004 RX-8 vehicles with leather seats, some customers may complain of noticeable chips and scratches that appear on the front seatback cover, near the headrest where the seatbelt comes in contact with the seatback cover. These chips and scratches may be caused by the seat belt coming into contact with the seatback when using the seat belt or when the rear door is closed.

**LOOK HERE FOR
CHIPS/SCRATCHES**

2. For vehicles with leather seats built prior to November 12, 2003, replace the front seatback cover and front seat belt assembly with modified ones. See appropriate Workshop Manual section 08 - FRONT SEAT BELT REMOVAL / INSTALLATION for replacement of the seat belt assembly and section 09 - FRONT SEAT DISASSEMBLY / ASSEMBLY for replacement of the seatback cover.
3. For vehicles with leather seats built between November 12, 2003 and December 15, 2003, replace only the front seatback cover with a modified one. See appropriate Workshop Manual Section 09 - FRONT SEAT DISSASSEMBLY / ASSEMBLY for replacement of the seatback cover.
4. Verify repair.
