Service Bulletin Mazda North American Operations

SEAT SHAKES BACK AND FORTH / MAKES NOISE WHEN BRAKING

Bulletin No: 09-061/09

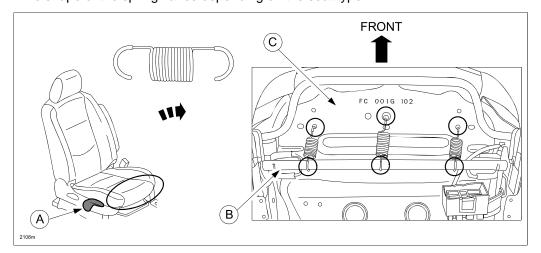
RX-8, Mazda5 & Mazda6 [with pantograph type seat lifter (A)]:

Some vehicles may exhibit a seat that shakes back and forth and is noisy during braking.

NOTE: The shape of the spring varies depending on the seat type.

- 1. Verify customer complaint.
- 2. Install three (3) springs to the back of the seat cushion seat pan (C) and pipe frame (B).

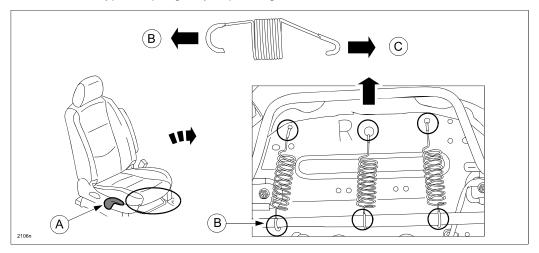
CX-7, CX-9 & Mazda3:

NOTE: The hooks of this type of spring vary depending on which side the hooks fit to.

Models	Part Number	Description	Qty.
RX-8, Mazda5 and Mazda6	C2Y1-88-601	Spring	3
CX-7, CX-9 and Mazda3	L2Y1-88-601	Spring	3
