Service Information

Category S	Technical	Ref. No. E031/09	Page 1 of 1
Coverage <input type="checkbox"/> Distributor only <input checked="" type="checkbox"/> Please inform your dealers		Date Issued May 27, 2009	
Please convey this information to your <input type="checkbox"/> Director <input checked="" type="checkbox"/> General Manager <input checked="" type="checkbox"/> Warranty Dept. <input checked="" type="checkbox"/> Parts Dept. <input checked="" type="checkbox"/> Training Dept. <input checked="" type="checkbox"/> Field Rep.		Date Revised	
Applicable Model All models		Applicable Countries or Specifications Worldwide

Subject: Concerns in Dashboard Upper Surface Appearance

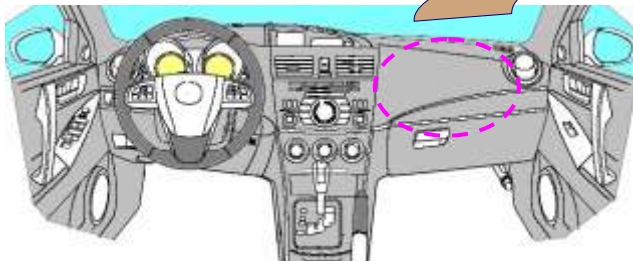
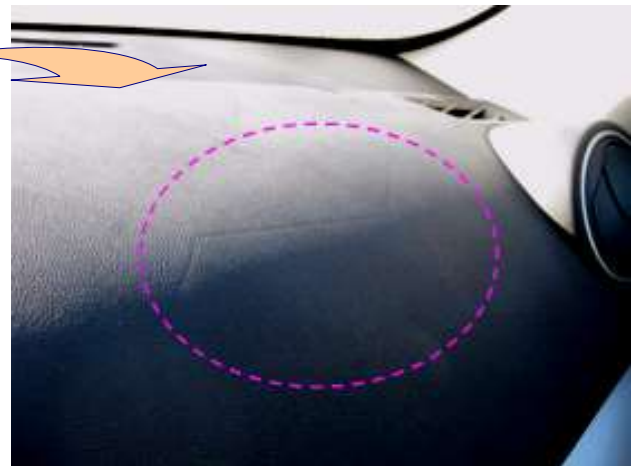
Example: Mazda3 (BL)

Some customers may complain that the dashboard looks bad with a visually recognizable line appears on the upper surface of the dashboard on the passenger side.

If any customers come to us with the complaints above, please explain that the line is intentionally made to deploy the air bag, which is sometimes visually recognizable under a certain lighting conditions, but it is not a problem.

The airbag cover is usually made of a thin plastic material in most of the models with a tear line to open up for air-bag deployment on the flip side.

As the plastic molding technology advances, it becomes harder to recognize the tear line recently. However, a subtle luster difference appears sometimes.
