# Service Information

Category <b>S</b>	<b>Technical</b>	Ref. No. E001/09	Page 1 of 2
Coverage <input type="checkbox"/> Distributor only <input checked="" type="checkbox"/> Please inform your dealers		Date Issued January 6, 2009	
Please convey this information to your <input type="checkbox"/> Director <input checked="" type="checkbox"/> General Manager <input checked="" type="checkbox"/> Warranty Dept. <input checked="" type="checkbox"/> Parts Dept. <input checked="" type="checkbox"/> Training Dept. <input checked="" type="checkbox"/> Field Rep.		Date Revised	
Applicable Model  Multiple Models		Applicable Countries or Specifications  Worldwide

## Subject: Repair Procedure for Unusual Noise from Front Seat

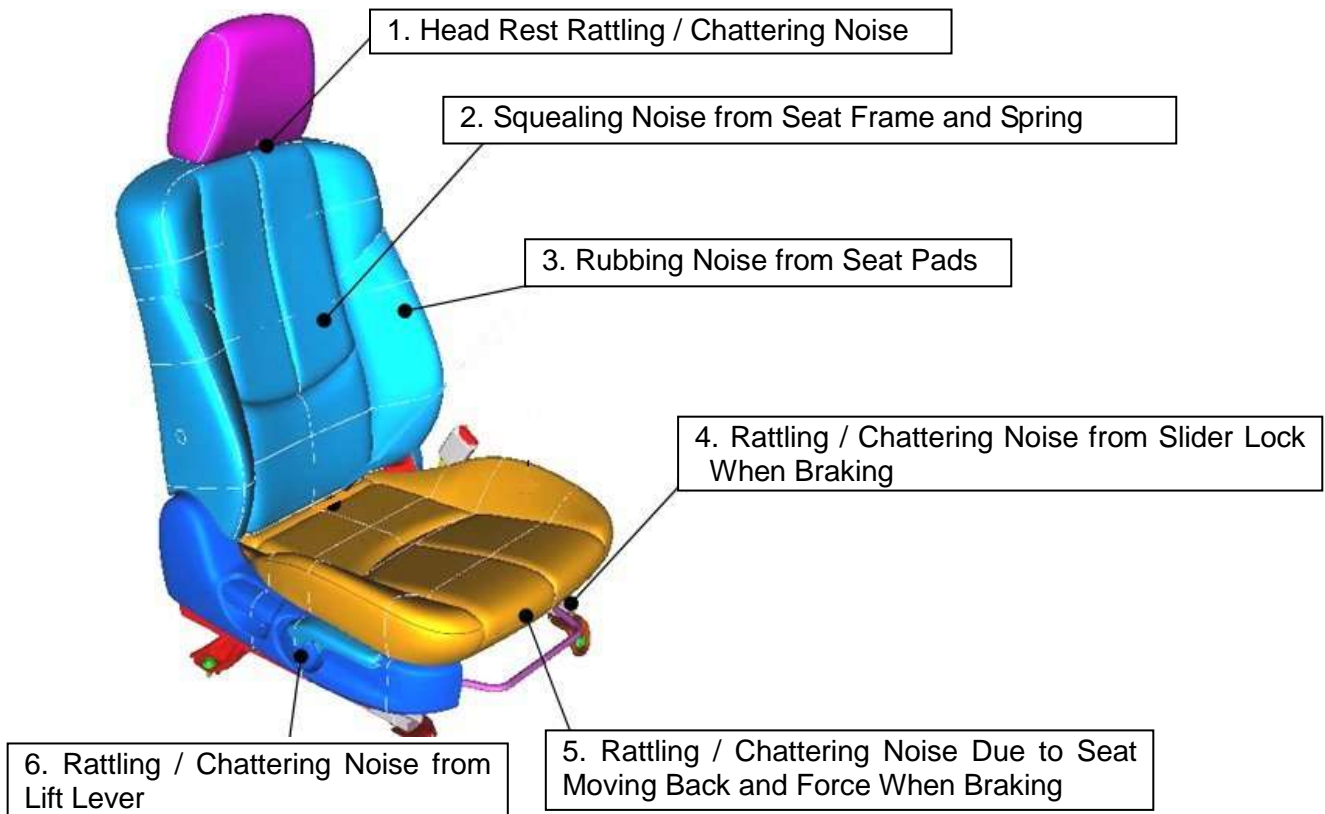
This is to advise you on general repair procedures for various kinds of unusual noise from a front seat. When you encounter a customer complaint, verify the symptom and determine the noise location, then select an appropriate procedure.

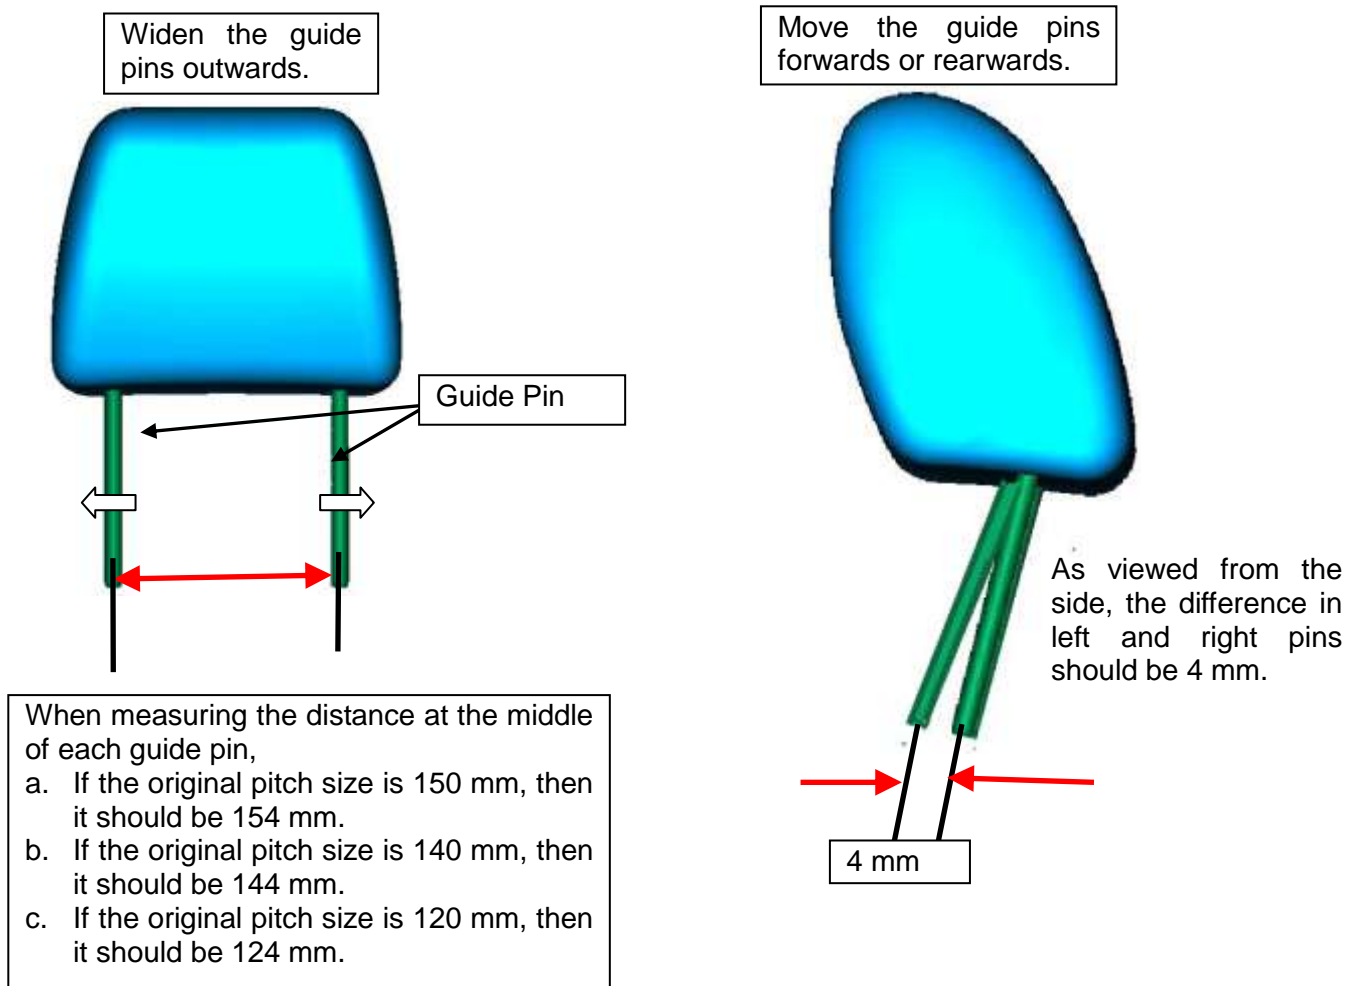
Symptom: There is looseness in the head rest, making a rattling or chattering noise.

Cause: The looseness exists between the guide pin and pole guide or between the pole guide and pole guide base.

1. Remove the head rest and widen the guide pins by 4 mm outwards. Then, move one forward and the other one rearward until the difference of the left and right guide pins is 4 mm.
2. Fit the head rest back, and confirm if the noise is still occurring.

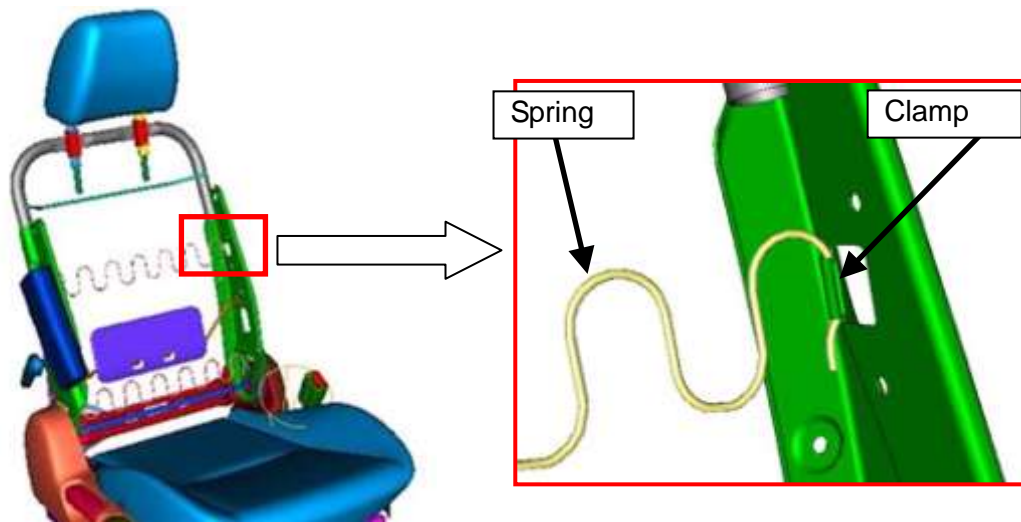
Symptom: When sitting in the seat and moving the body left and right, a squeaking noise is heard from the seat back.

Cause: The frame (clamp) makes contact with the spring.

1. Widen the clamp and remove the spring.

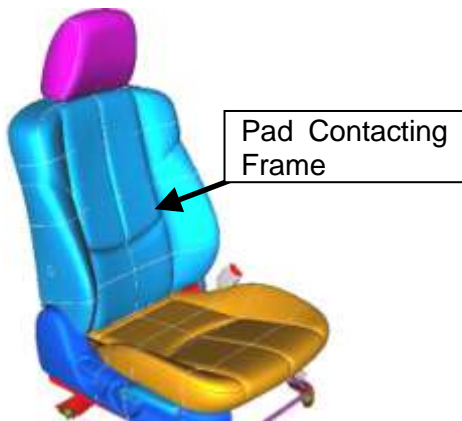
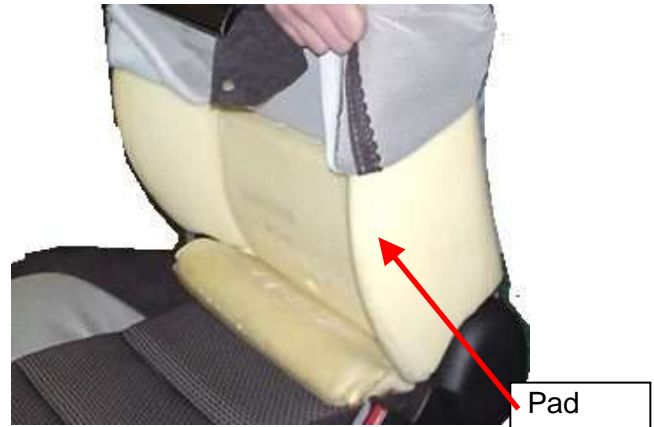
Symptom: When getting in or out of the car or moving the body on the seat, a squeaking noise is heard from the seat.

Cause: The frame and urethane pad make contact with each other when the body is moving on the seat.

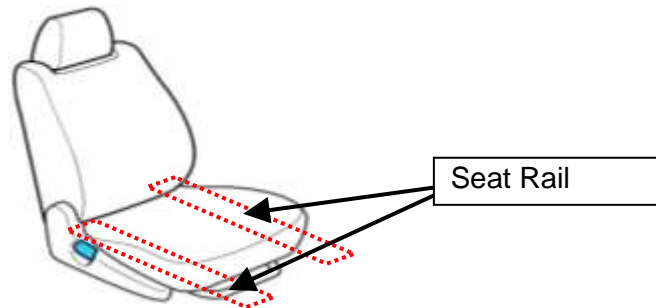
Symptom: Clunking noise is heard from the slider lock when braking.

Cause: The locations of the seat rails (both sides) go out of position.

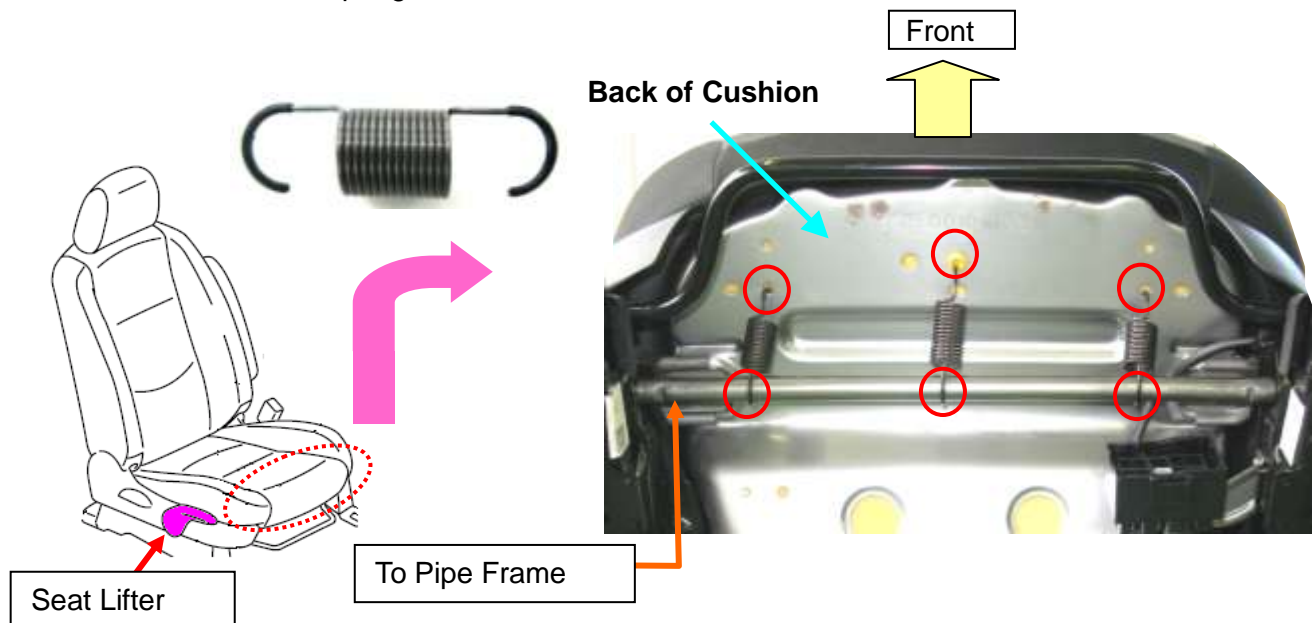
Symptom: When positioning the seat cushion to the highest position, the seat gets shaky back and forth and makes an unusual noise.

Cause: Pantograph type seat lifter is employed. As the lifter is raised and getting upright, the seat gets shaky.

Install 3 pieces of springs to the back of the seat cushion (seat pan and pipe frame).

Type A: Mazda2 (DY / MC Production Only), Mazda5 (CR), Mazda6 (GG/GY), RX-8 (FE/SE)  
For these models, use Spring C2Y1-88-601.

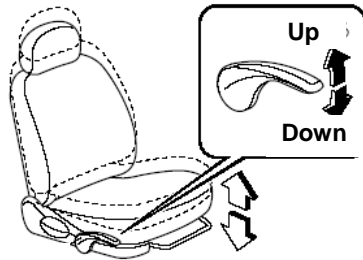
Symptom: Chattering noise is heard from the driver-side seat lift lever. In some cases the driver-side seat lift cannot be adjusted.

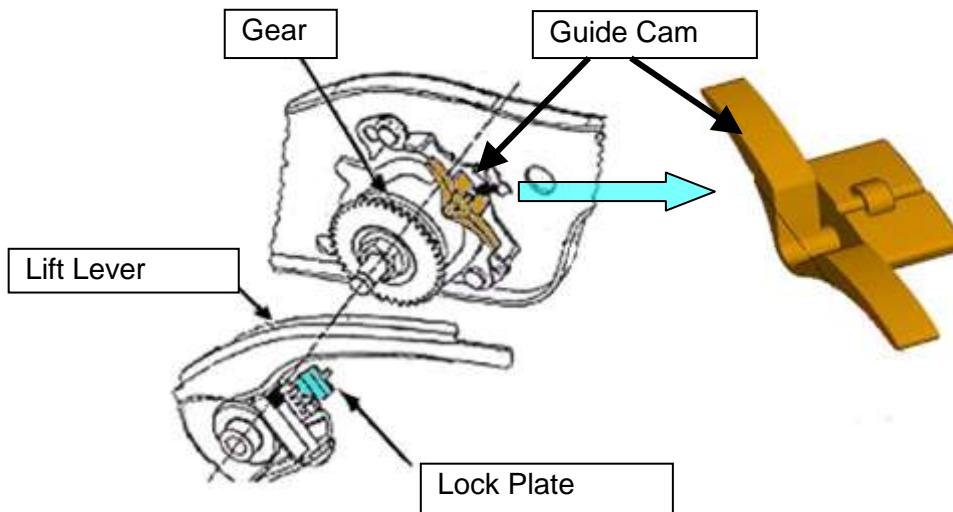
Cause: The lock plate comes off from the guide cam. This occurs because the seat lift lever is operated forcibly.

Replace the guide cam and spring with the following service parts. (Please refer to R048/07 for the detailed procedure.)

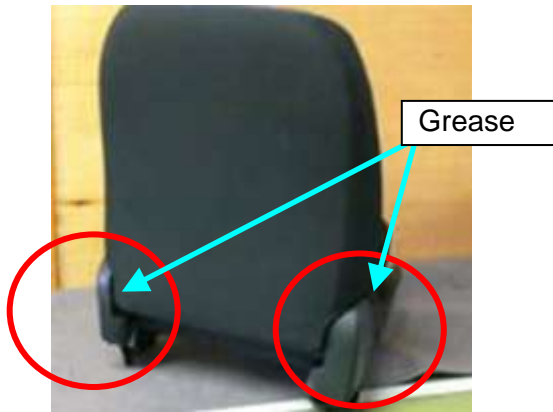
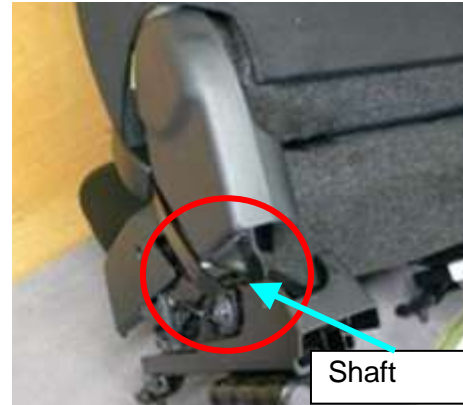
Symptom: Squeaking noise is coming from under the driver-side seat when getting in or out of the vehicle or turning a corner.

1. Position the seat lifter to the highest position, then remove the seat ass'y from the vehicle.

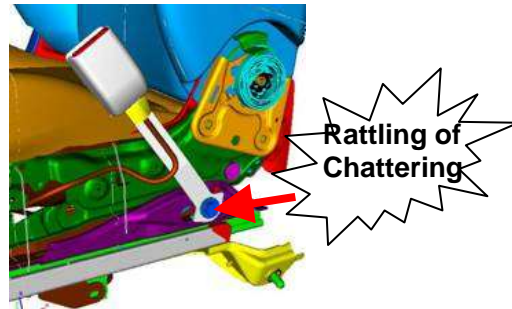
Symptom: Rattling or chattering noise is heard from the seat belt buckle when driving.

Cause: The bolt and wave washer come into contact with each other.

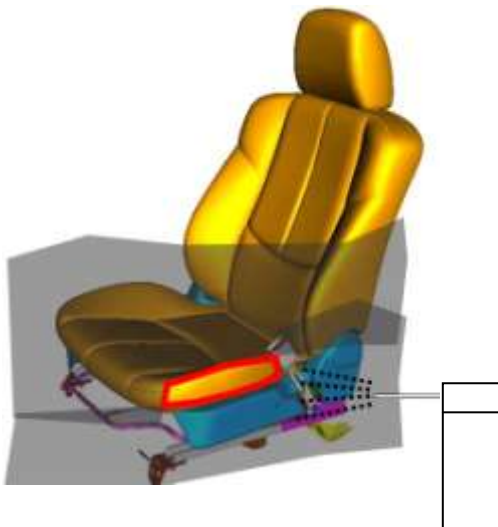
e.g. Console and cushion contact each other.

Repair Procedure: Apply silicone grease to the leather surfaces where are contacting each other as per the following procedure.

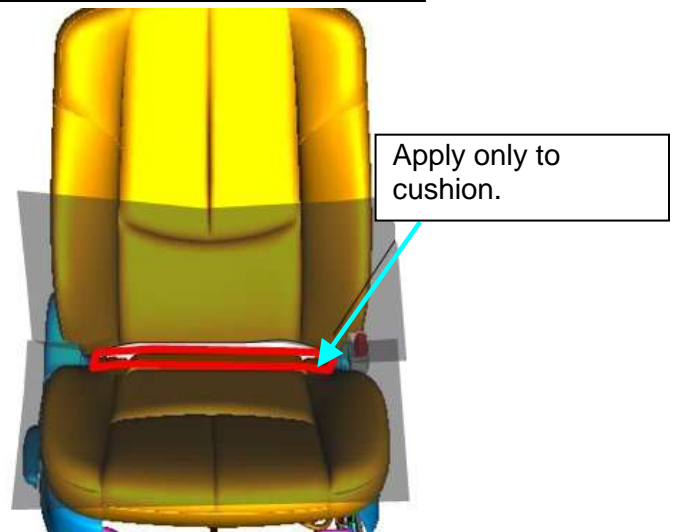
e.g. Cushion and back contact each other.

Apply only to cushion.

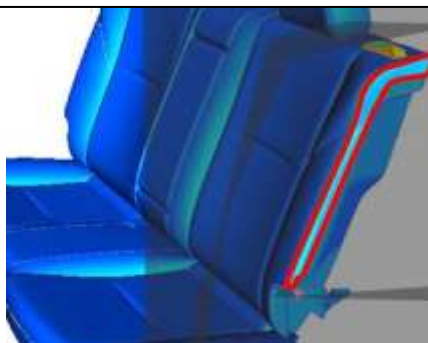
e.g. Back and trunk side contact each other.

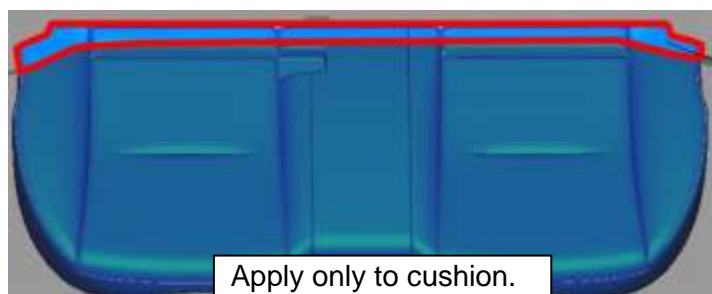
e.g. Cushion and back contact each other.

Apply only to cushion.
