Service Information

Mazda Motor Corporation

Category S	Technical	Ref. No. E023/09	Page 1 of 5
Coverage <input type="checkbox"/> Distributor only <input checked="" type="checkbox"/> Please inform your dealers		Date Issued May 21, 2009	
Please convey this information to your <input type="checkbox"/> Director <input checked="" type="checkbox"/> General Manager <input checked="" type="checkbox"/> Warranty Dept. <input checked="" type="checkbox"/> Parts Dept. <input checked="" type="checkbox"/> Training Dept. <input checked="" type="checkbox"/> Field Rep.		Date Revised	
Applicable Model All Models		Applicable Countries or Specifications Worldwide

Subject: Sealer Peeling from Rear Fender

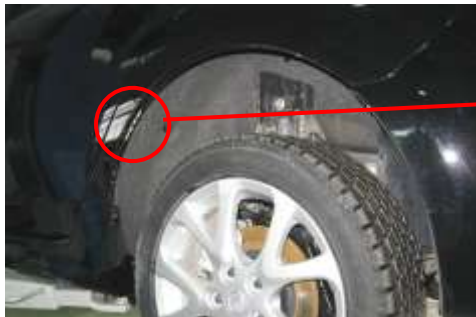
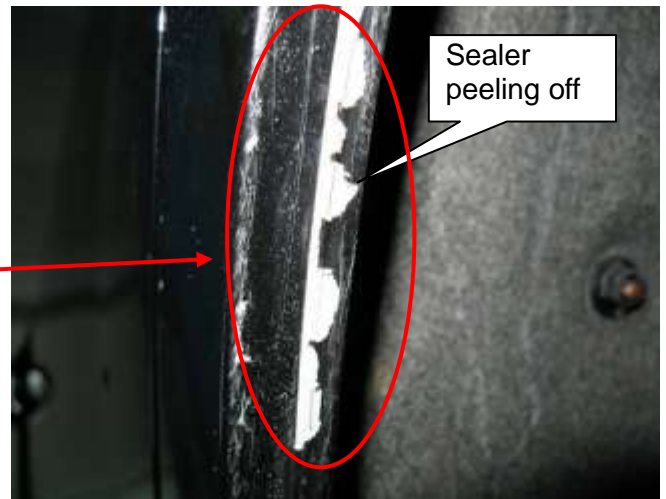
Some vehicles may experience sealer peeling from rear fender arch area.

Due to positioning the nozzle of high-pressure cleaner too close to the rear fender arch (closer than approx. 200mm), the sealer gets damaged during car wash.

When you encounter a customer complaint on this concern, please inform the customer to use high-pressure cleaner with positioning the nozzle always more than 300mm away from the rear fender arch, otherwise the sealer gets peeled off and may result to cause corrosion. Please refer to the following procedure for repair.

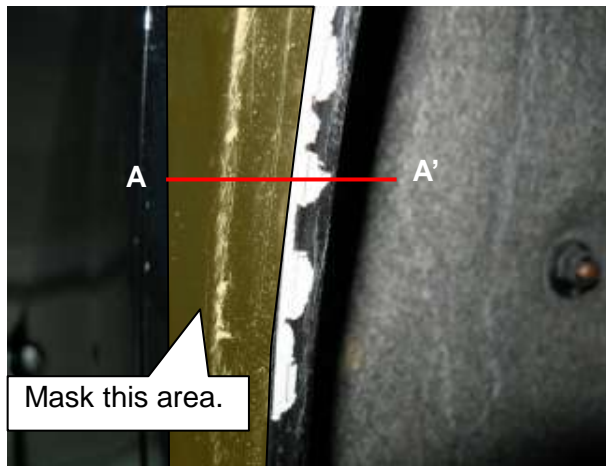
Rear Fender Arch

1. Clean the rear fender area.
2. Remove the tire.
3. Apply masking tape along the rear fender arch as shown below.

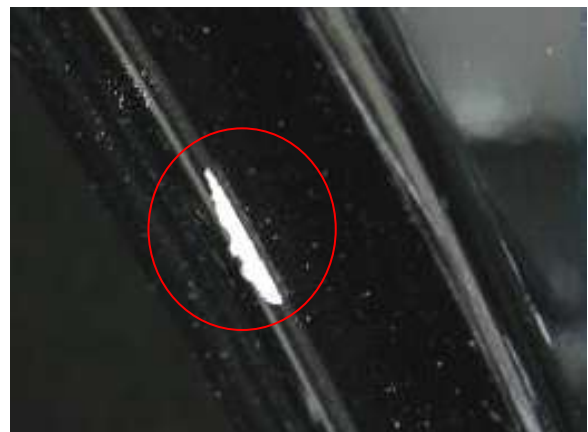
Paint damage only

A) If only the paint is damaged
(No damage on sealer)

- (1) Sandpaper the surface of damaged area (#320 is recommended).
- (2) Mask the area not to be painted.
- (3) Repaint over the damaged area.

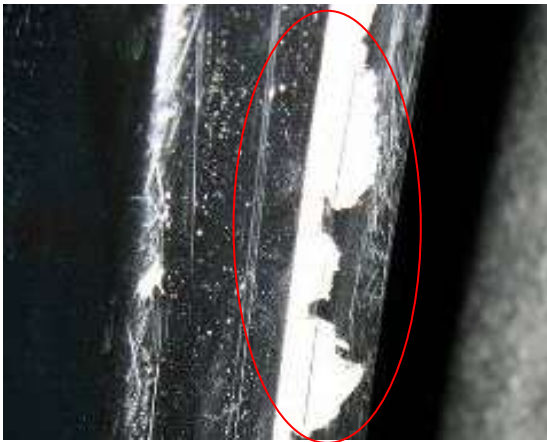
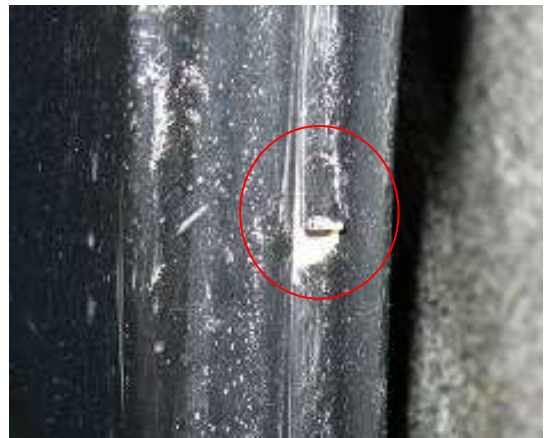
Peeled Sealer

B) If the sealer is damaged/peeled

- (1) Remove the damaged sealer from the body panel, and then cut both ends at an angle as per the image below. If primer layer is damaged, apply touch-up primer to ensure proper anti-corrosion treatment.

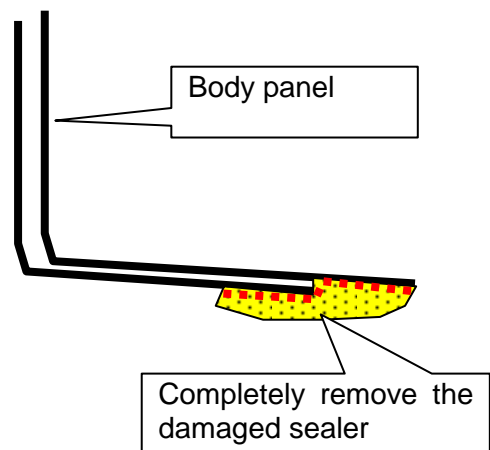
- (2) Ensure to remove all damaged, loosen or flaking sealer residues from body panel completely.

Note: Residuals of loosen or flaking paint sealer will cause improper adherence of new paint sealer.

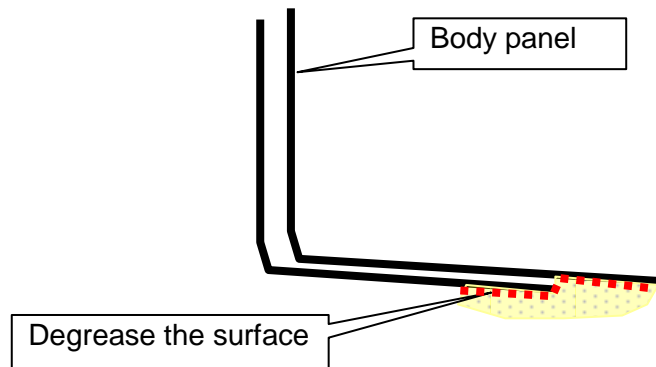
(3) Degrease the surface with conventional degreaser.

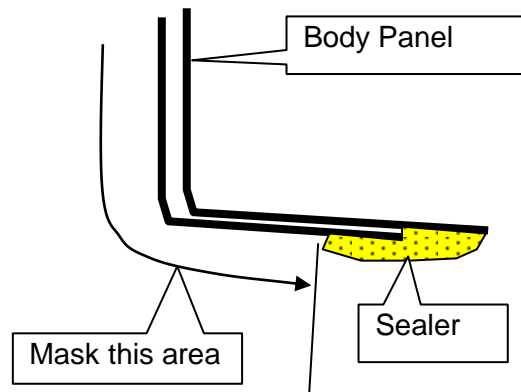
(4) Check the masking applied in step 3, for damage.
If it is damaged, remove old masking and mask the area again.

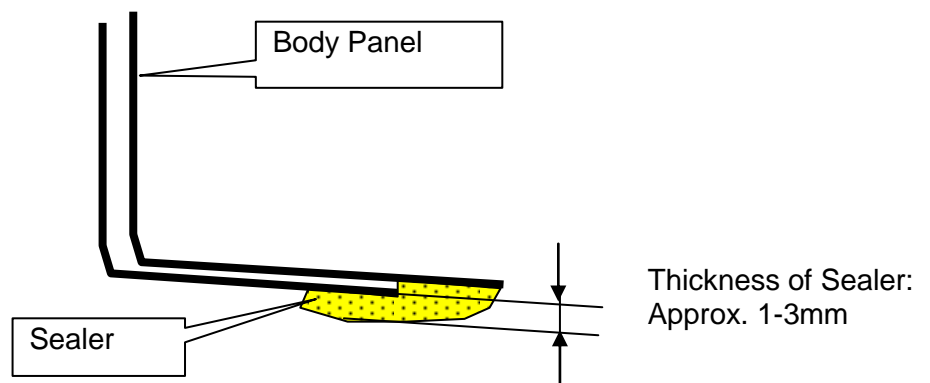
(5) Apply new paint sealer on body panel.

Recommended sealer:

- Henkel Terson Terostadt 9120, WUERTH saBesto BOND + SEAL ALL-IN-ONE

(6) Even the sealer to achieve appropriate thickness of approx. 1-3mm.
