Category S	Technical	Ref. No. E035/07B	Page 1 of 32 41
Coverage <input type="checkbox"/> Distributor only <input checked="" type="checkbox"/> Please inform your dealers		Date Issued July 30, 2007	
Please convey this information to your <input type="checkbox"/> Director <input checked="" type="checkbox"/> General Manager <input checked="" type="checkbox"/> Warranty Dept. <input checked="" type="checkbox"/> Parts Dept. <input checked="" type="checkbox"/> Training Dept. <input checked="" type="checkbox"/> Field Rep.		Date Revised July 28, 2010	
Applicable Models All model vehicles		Applicable Countries or Specifications Europe

**Subject: Blister & Rust Repair Procedure for Hem
(Liftgate, Door, Bonnet, Trunk Lid)**

This service information provides you with the repair criteria and the repair procedure against the blister & rust / perforation on the hem of the liftgate, door, bonnet and/or trunk lid, in order to promote the proper repair.

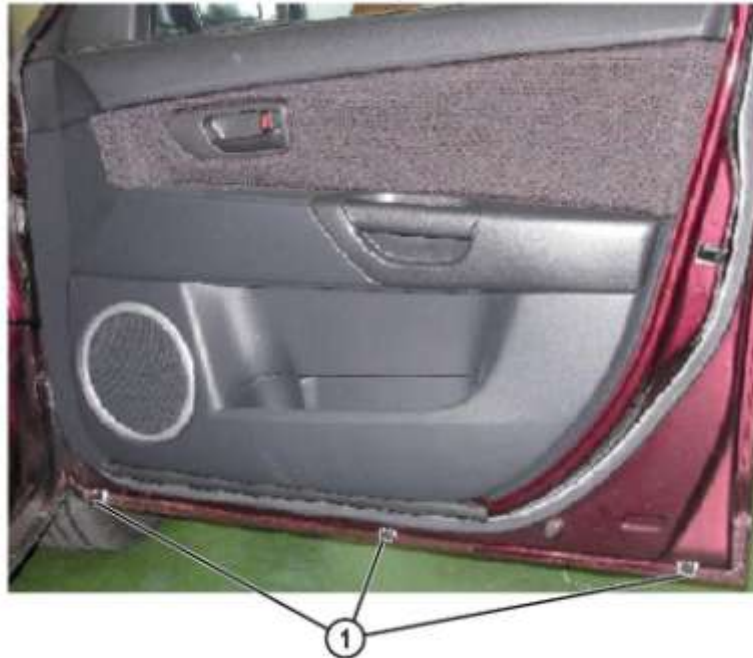
MSP1_026

1. Remove the one-way valves at the lower area of the door.

- 1 One-way valve

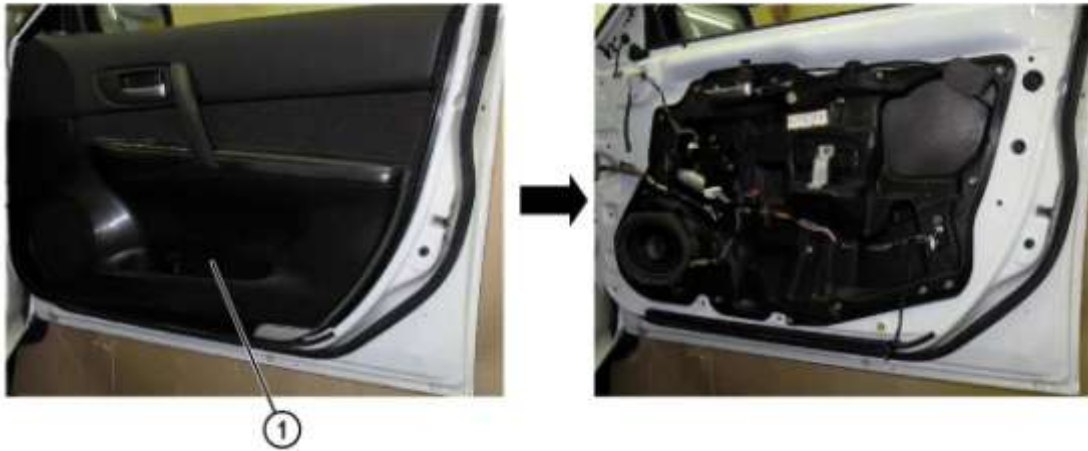
MSP1_028

2. Remove the door trim according to the Workshop Manual.

- 1 Door trim

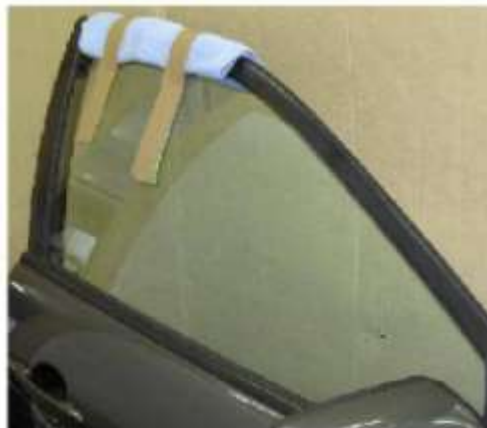
MSP1_033

5. Remove the securing bolts of the window glass according to Workshop Manual. Slide the glass upward, and then secure it on the upper door sash as shown in the picture by using masking tape and cloth.

NOTE: The cloth should be used to avoid residues of the masking tape from sticking on the black colored door sash.

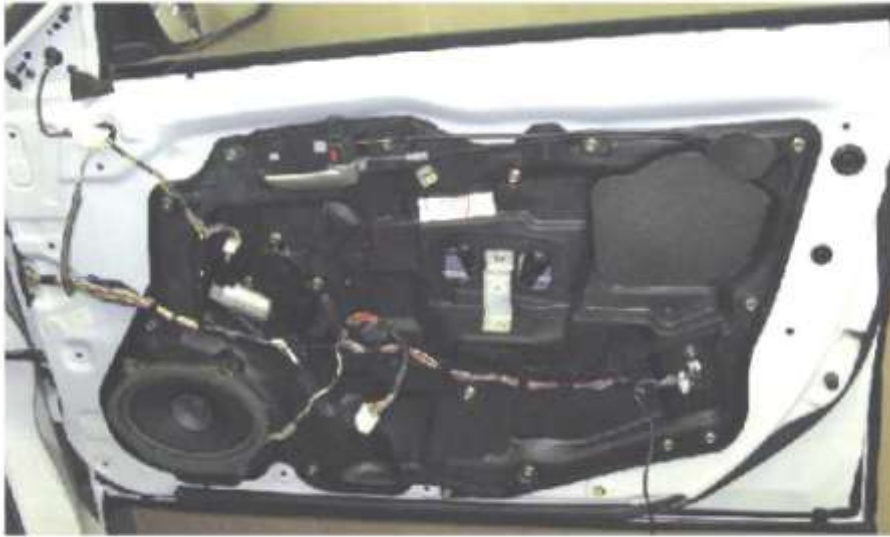
MSP1_034

8. Remove the speaker and all harness and bolts from the door module.

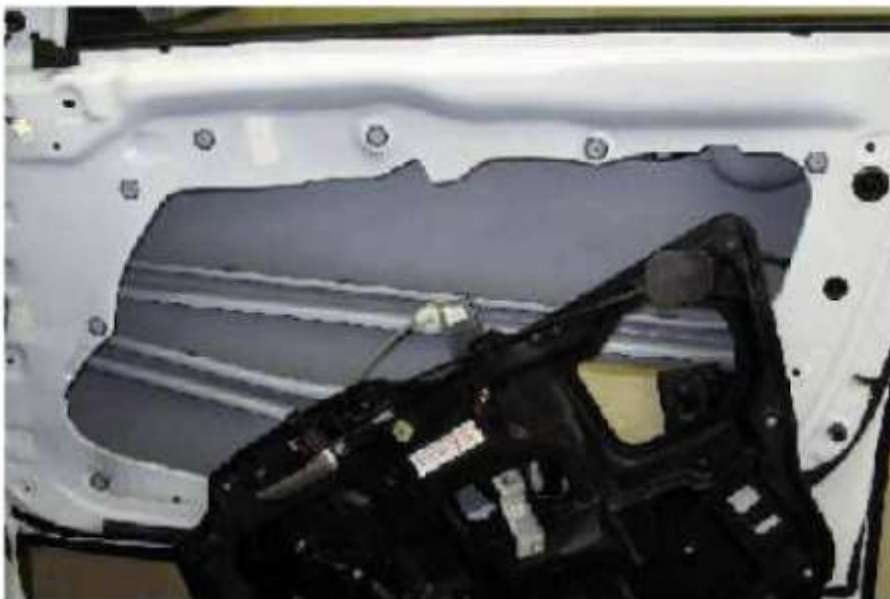
MSP1_035

9. Move the door module downward to ensure the workspace.

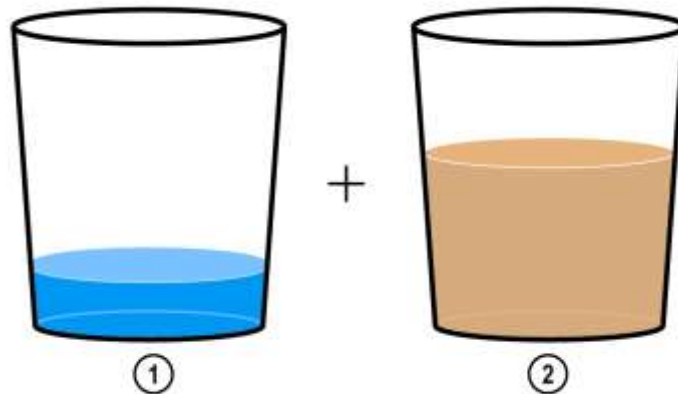
MSP1_060

15. Mix hardener (VI) (3 ml) and clear coat (VII) (9 ml), and stir well. (Mixture ratio is 1:3)

1 Hardener (VI) (3 ml)

2 Clear coat (VII) (9 ml)

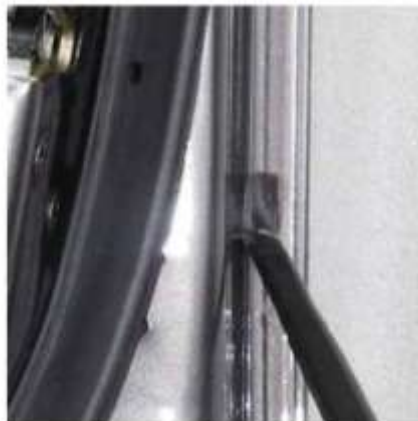
MSP1_061

16. Using a brush, apply mixed fluid "B" to the door flange.

Area to be applied: Approx. 15 mm from the center of the sealant. (See the picture below.)

NOTE: Use a 10 mm-length tip of brush. Use soft one. If the tip of brush is soaked with too much liquid, there is a possibility that the liquid drips while applying. Place the tip of the brush on the edge, then paint along with the sealant. It will make the finish appearance good.

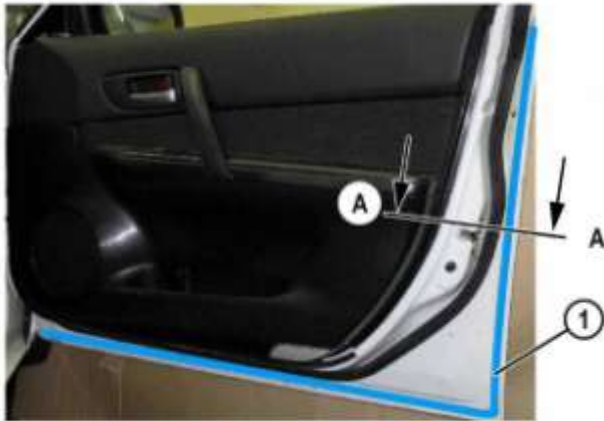
MSP1_061

1 Mixed fluid B

2 Center of sealant

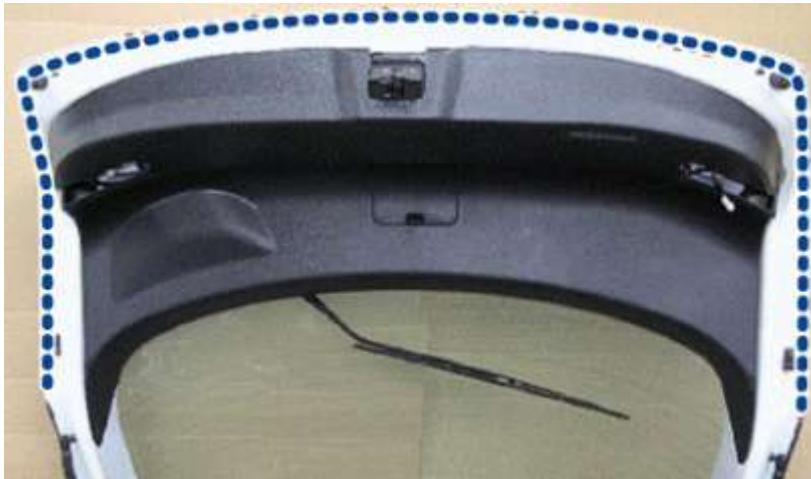
MSP1_049

- Application of mixed fluid "A" (hardener (VI) and clear coat (VII))
 - Apply the mixed fluid "A" to the inner cleavage of lift gate/tail gate/trunk lid via the opening of the removed rear combination lamps.

NOTE: Even if the inside of the lift gate is waxed, apply the mixed fluid on top of the wax.

NOTE: The main purpose of this procedure is to cover those areas of the factory applied adhesive sealer where water can enter the clinched flange from the inside of the lift gate/tail gate/trunk lid. The mixed fluid "A" will rinse along the inner cleavage and cover the factory applied adhesive sealer. In a consequence, water cannot enter the clinched flange from inner side of the lift gate/tailgate and already existing corrosion inside the clinched flange will be sealed-off from the atmospheric oxygen and humidity.

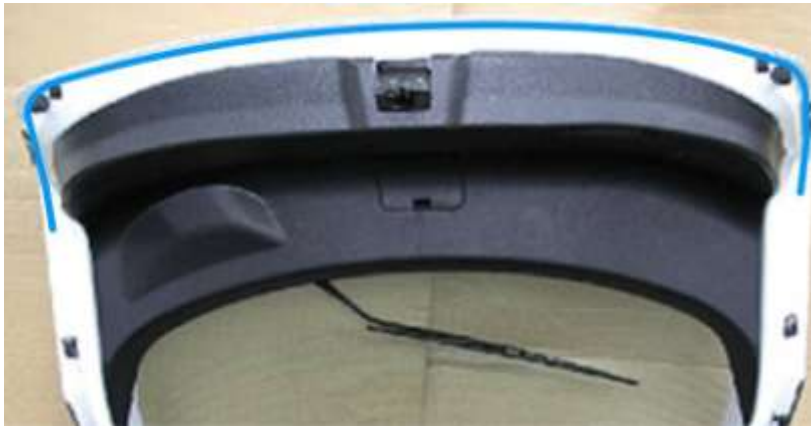
MSP1_050

- Application of Mixed fluid “B” (hardener (VI) and clear coat (VII))
 - Apply the Mixed fluid “B” along the visible area of the clinched flange of the lift gate/tailgate/trunk lid

NOTE: Clean and degrease the location where the Mixed fluid “B” will be applied.

View from under the rear combination lamp location

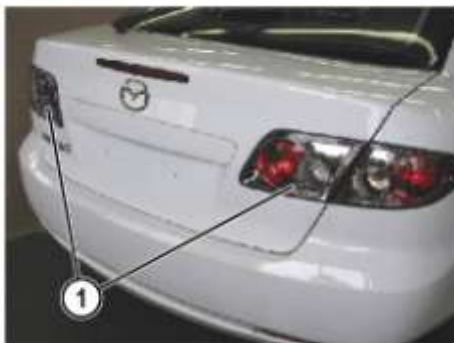
MSP1_051

22. Remove both of the rear combination lamps from the lift gate according to the Workshop Manual.

- 1 Rear combination lamp

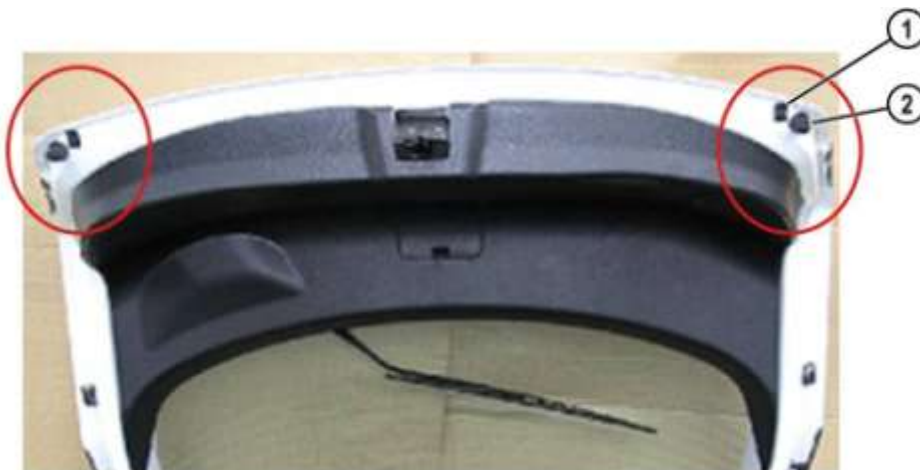
MSP1_052

23. Remove the water drain hole valves and stoppers.

- 1 Drain Hole Valve

- 2 Stopper

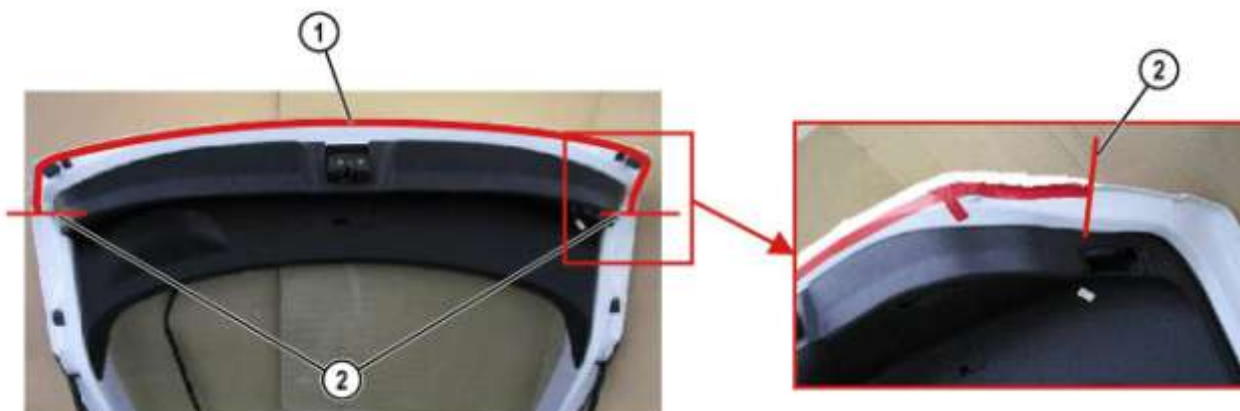
MSP1_063

NOTE: Apply vinyl tape (VIII) by approx. 15 mm from the center of the factory applied paint sealer.

- 1 Apply vinyl tape to this area
- 2 Vinyl tape (VIII)

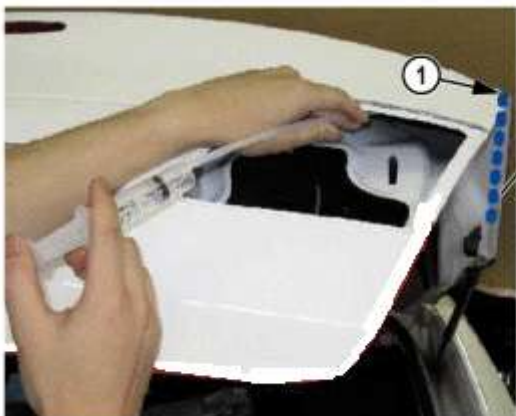
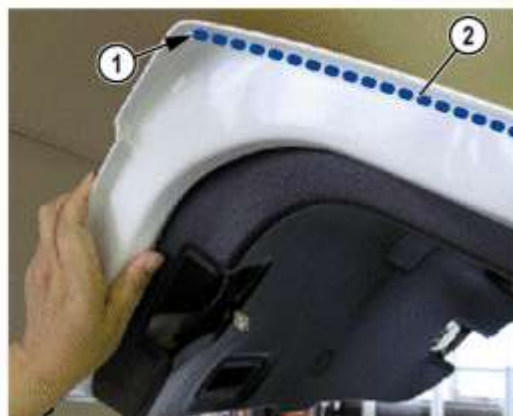
MSP1_058

29. Bring in a portion of 2 ml of mixed fluid "A" to each side of the lift gate by aiming a little to the forward area of the corner inside the lift gate.

1 Pour from here

NOTE: Even if the inside of the liftgate is waxed, apply the mixed fluid "A" on top of the wax. (There is a possibility that the wax is not applied completely. Be sure to apply the mixed fluid "A" in all cases.)

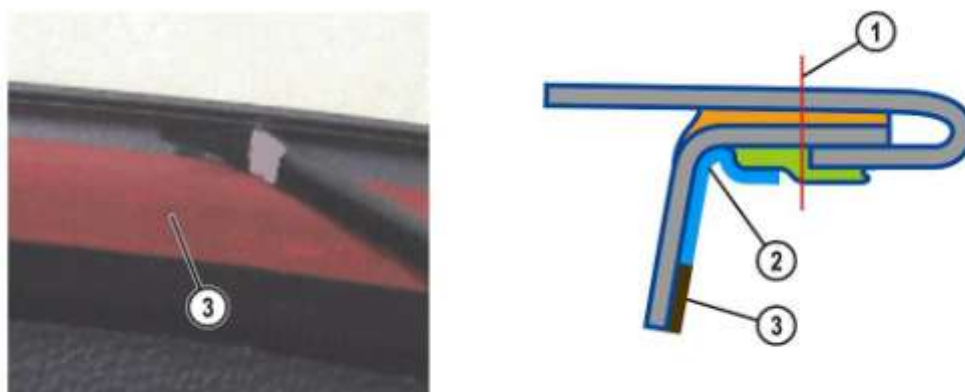
MSP1_067

NOTE: Area to be applied: From the center of sealant to vinyl tape (VIII). (See the picture below.)

1 Center of Paint Sealer

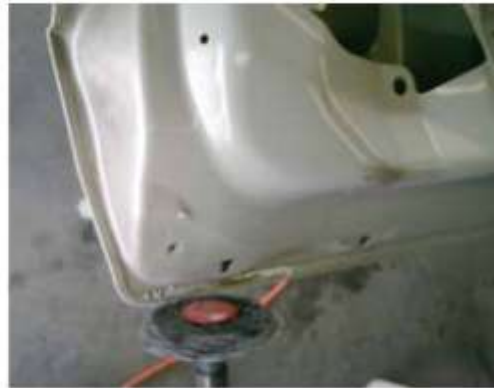
BL-1010_02045

5. If paint sealer residue still remains on the connecting area, use a sharp-edged tool and completely remove.

- 1 Clean this area thoroughly

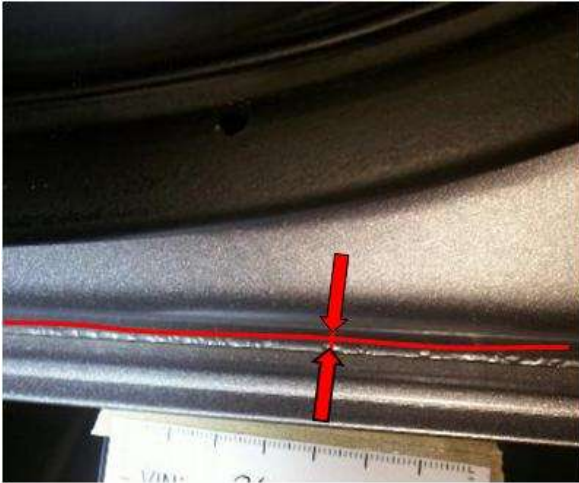
Photo #3

Maximum width of blisters is less than or equal to 5mm from inner edge of paint sealer.

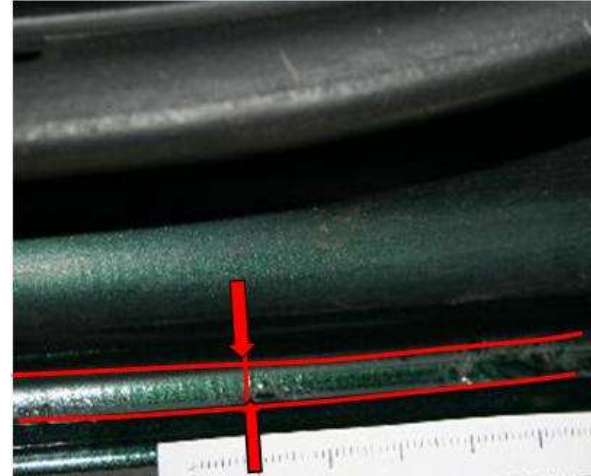
Photo #6

Maximum width of blisters is less than or equal to 5mm from inner edge of paint sealer.

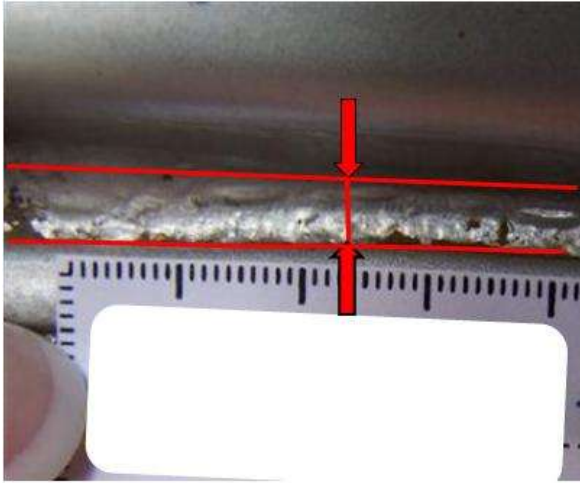
Photo #3

Visible blisters have spread more than 5mm from inner edge of paint sealer

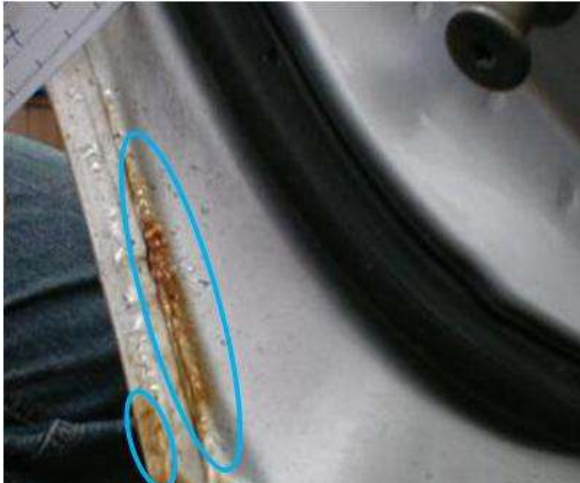
Photo #5

Blisters burst open without external influence and red rust becomes visible. In this case, width of blisters is not longer main criteria.

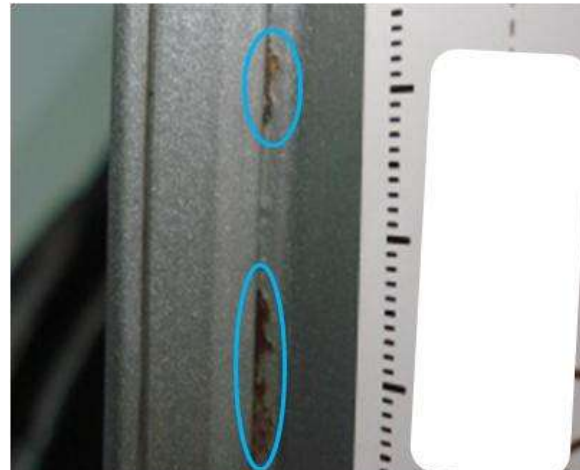
Photo #7

Blisters burst open without external influence and red rust becomes visible. In this case, width of blisters is not longer main criteria.

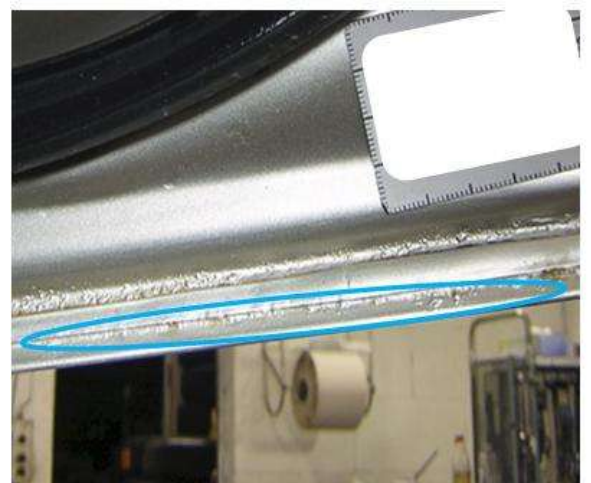
Photo #6

Visible blisters appearing between outer edge of sealer and lower outer edge of door.

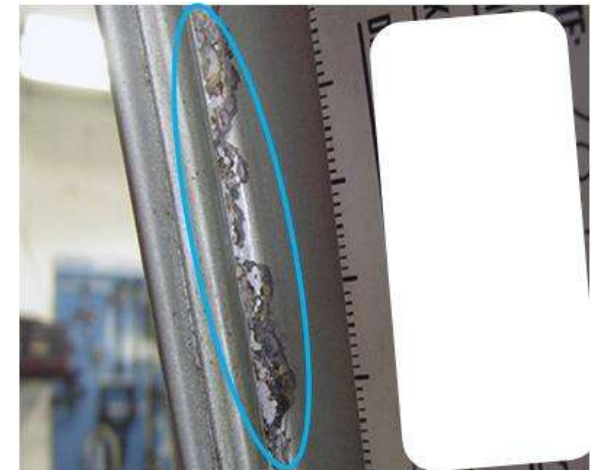
Photo #8

Blisters burst open without external influence and red rust becomes visible. In this case, width of blisters is not longer main criteria.

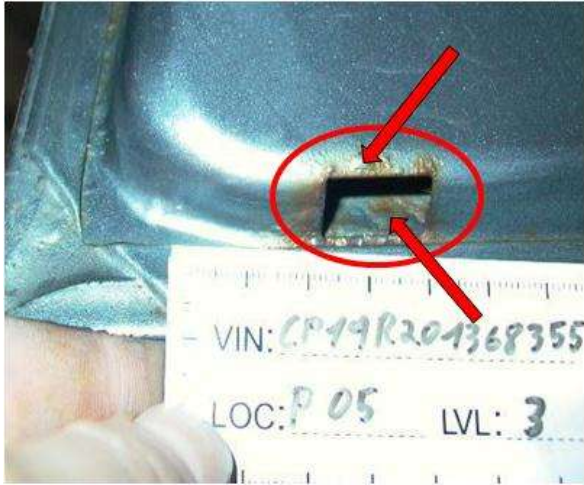
Photo #9

If you find visible corrosion or blister inside door and/or edge of drain hole, please ask NSC how to handle this case.

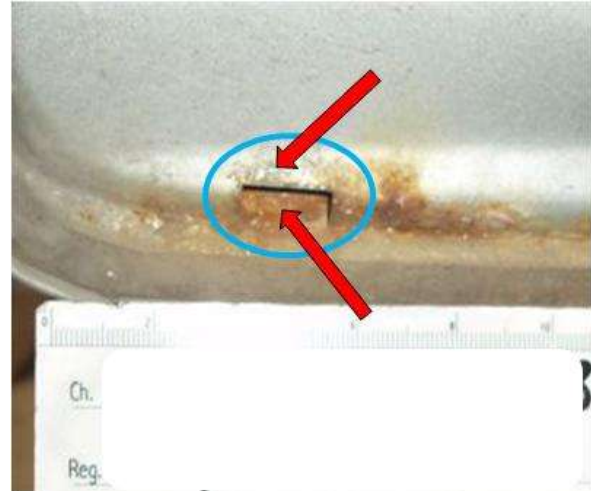
Photo #10

If you find visible corrosion or blister inside door and/or edge of drain hole, please ask NSC how to handle this case.

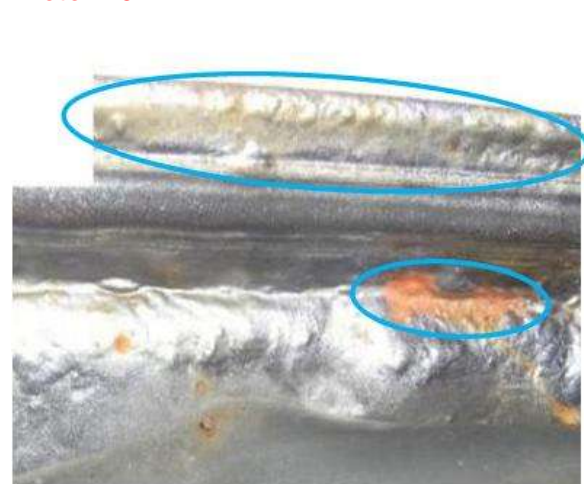
Photo #13

Blisters burst open without external influence and red rust becomes visible. In this case, width of blisters is not longer main criteria.

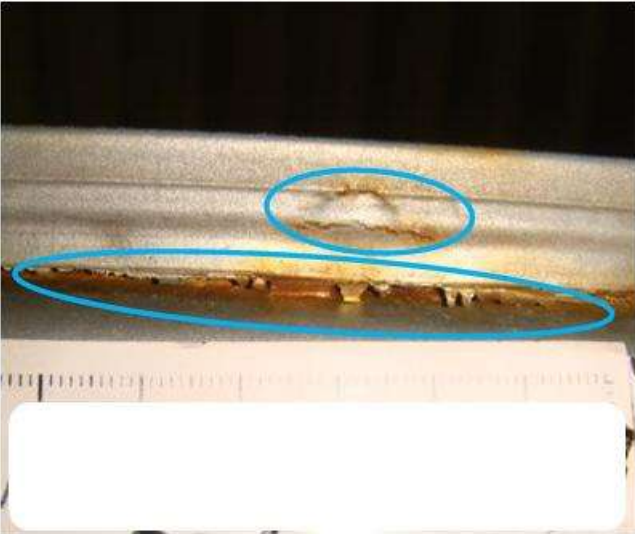
Photo #15

Blisters burst open without external influence and red rust becomes visible. In this case, width of blisters is not longer main criteria.

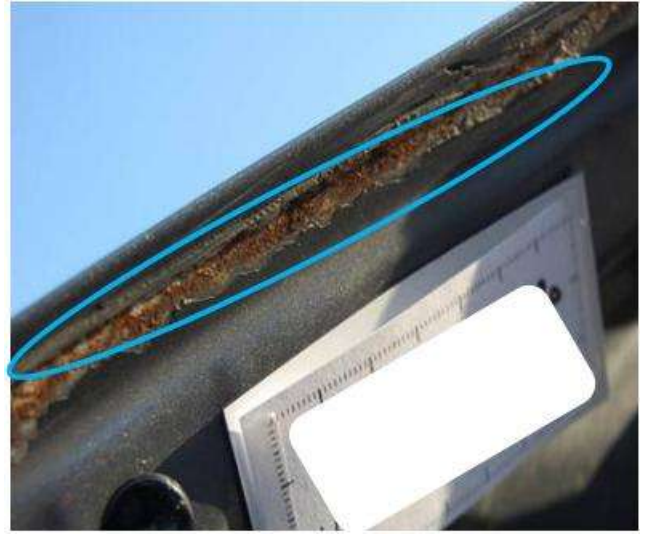
Photo #16

Blisters burst open without external influence and red rust becomes visible. In this case, width of blisters is not longer main criteria.

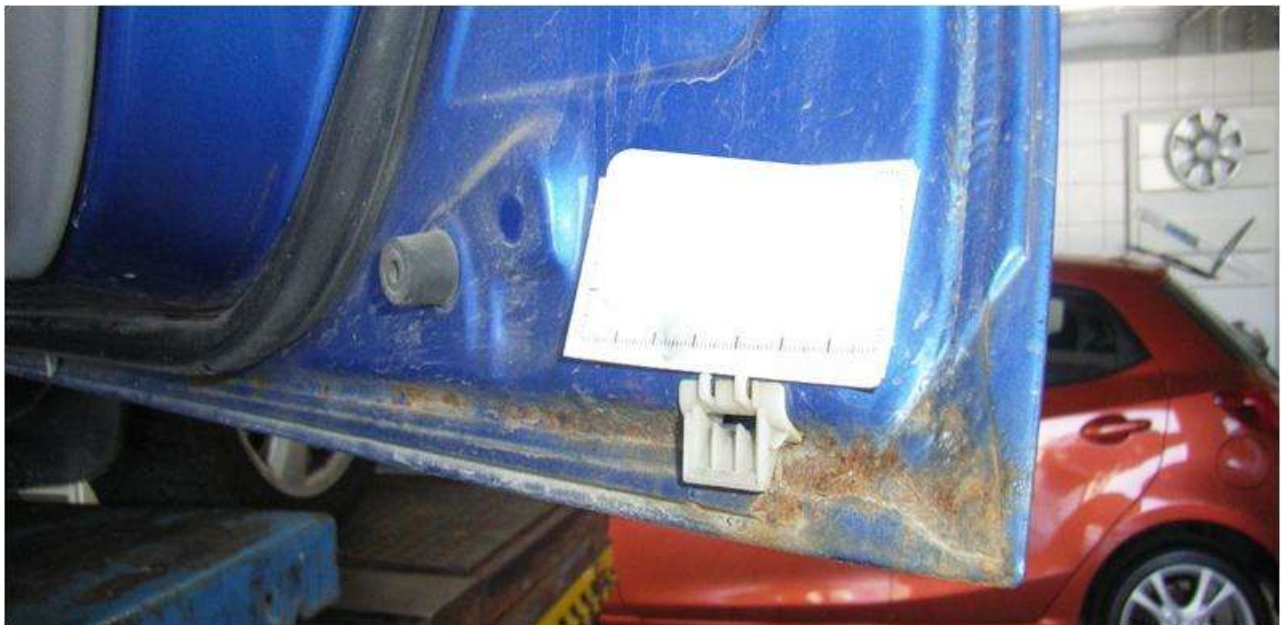
Photo #1

<Before removing paint and corrosion>

No visible perforation corrosion can be detected with the initial inspection, which leads to a level-2 assessment in the first step.

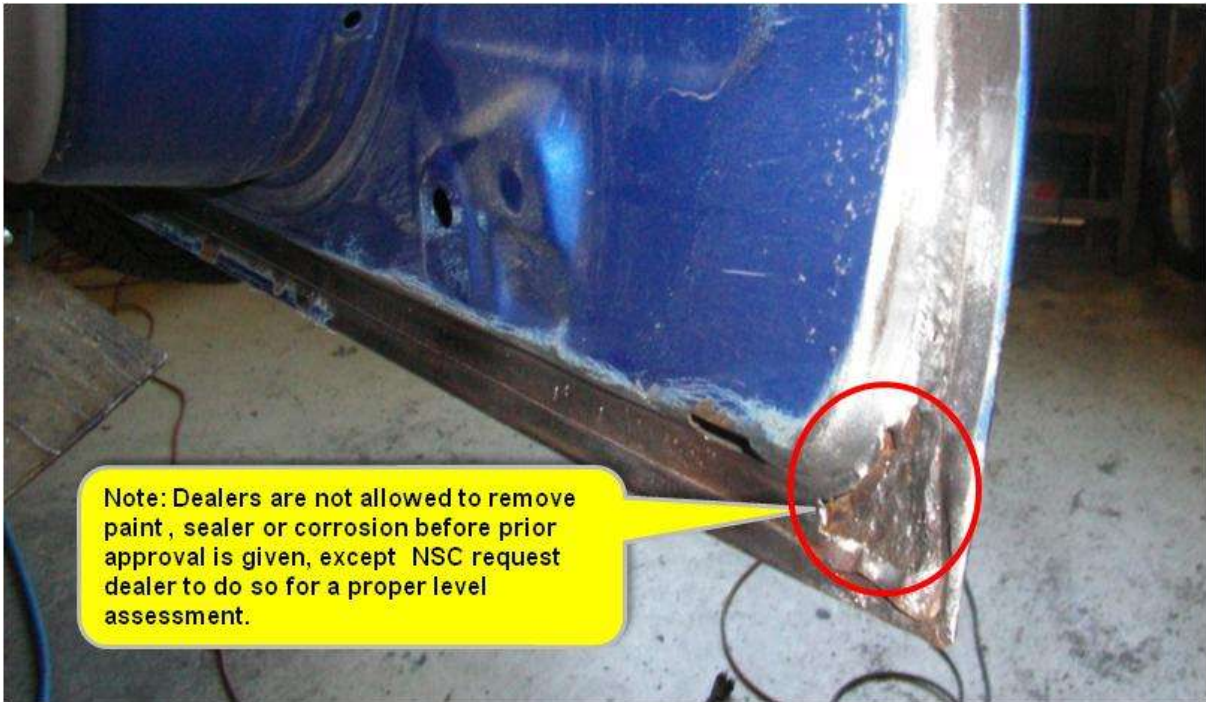
Photo #2

<After removing paint and corrosion>

Perforation becomes visible under the severe corrosion shown on photo #1. Those perforations are justifying an assessment for level-3 because it starts from the inside of the clinched flange.

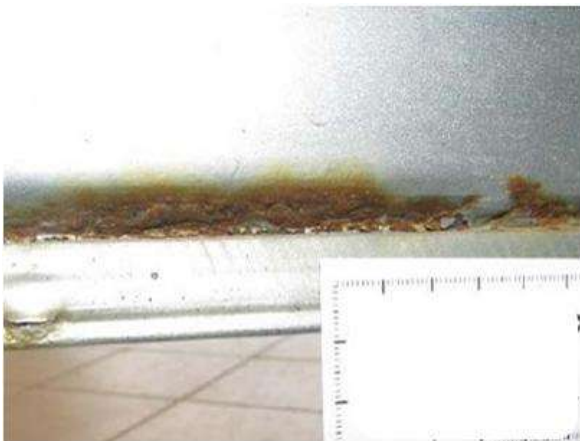
Photo #3

<Before removing paint and corrosion>

No visible perforation can be detected with the initial inspection, which leads to a level-2 assessment in the first step.

Perforation becomes visible under the severe corrosion shown on photo #3. This perforation justifies an assessment for level-3 because it starts from the inside of the door.

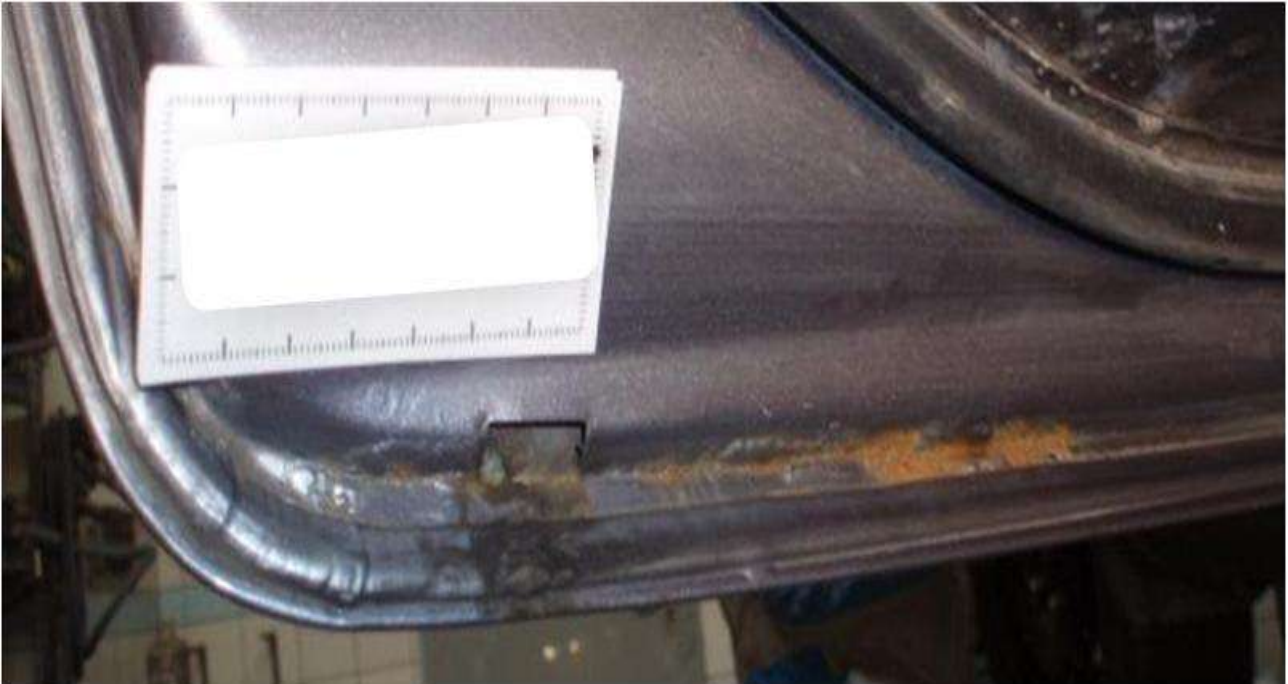
Photo #4

<Before removing paint and corrosion>

No visible perforation can be detected with the initial inspection, which leads to a level-2 assessment in the first step.

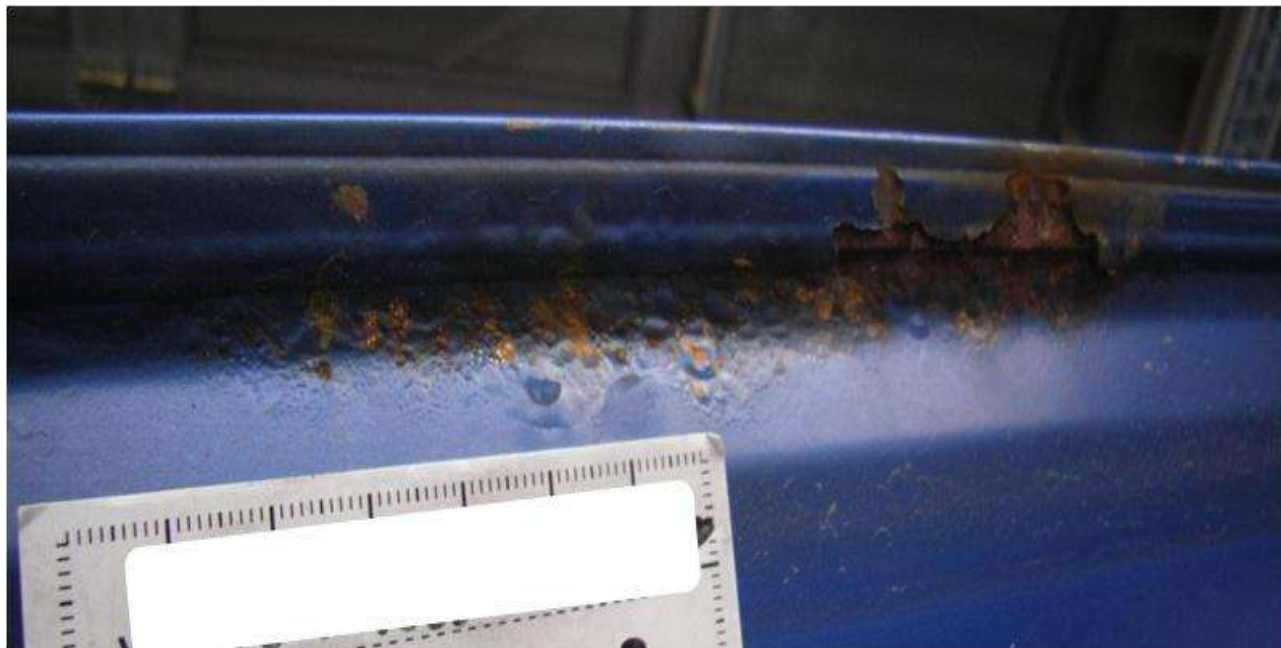
Photo #6

<Before removing paint and corrosion>

No visible perforation can be detected with the initial inspection, which leads to a level-2 assessment in the first step.

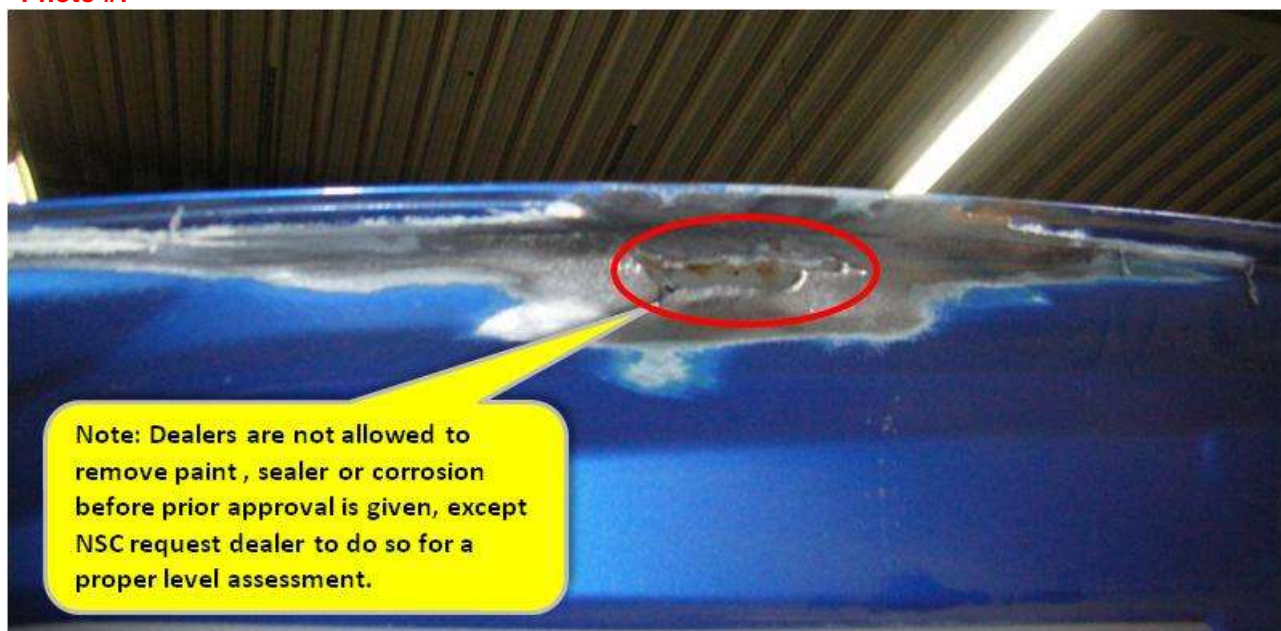
Photo #7

<After removing paint and corrosion>

Perforation becomes visible under the severe corrosion shown on photo #7. This perforation justifies an assessment for level-3 because it starts from the inside of the clinched flange.
