Service Information

Category U	Repair Guidance	Ref. No. R108/15A	Page 1 of 6
Coverage <input type="checkbox"/> Distributor only <input checked="" type="checkbox"/> Please inform your dealers		Date Issued November 11, 2015	
Please convey this information to your <input type="checkbox"/> Director <input checked="" type="checkbox"/> General Manager <input checked="" type="checkbox"/> Warranty Dept. <input checked="" type="checkbox"/> Parts Dept. <input checked="" type="checkbox"/> Training Dept. <input checked="" type="checkbox"/> Field Rep.		Date Revised November 19, 2015	
Applicable Model CX-5 (KE) with SKYACTIV-G 2.0		Applicable Countries or Specifications Europe

Subject: Insufficient Heater Performance

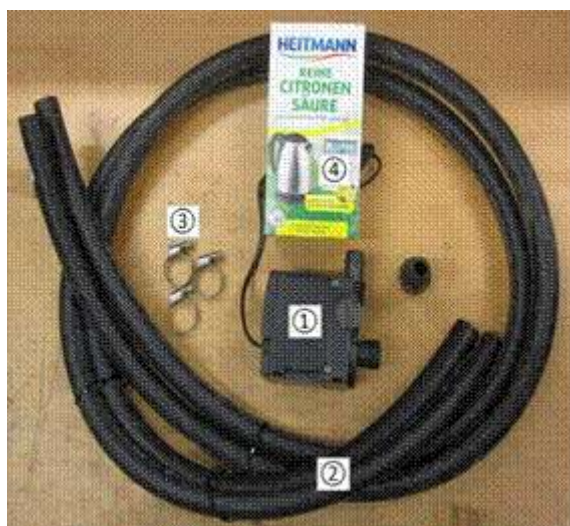
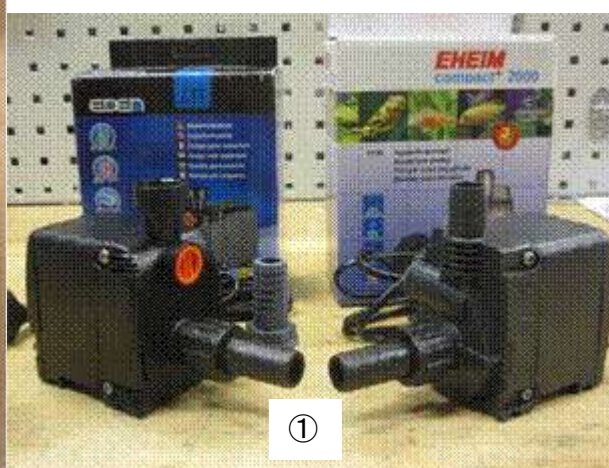
No.	Name	Note
①	Circulation Pump (1)	Power Output: min. 720l/hr./Pump Head approx. 2m (e.g. Eheim compact+ 2000 or Eden 135)
②	Water Hose (2)	Length: 2.5m - 3m Inner diameter: 18mm
③	Hose Band (1)	Used to secure water hose (②) to the circulation pump (①).
④	Citric Acid (2 x 15 grams)	Pure citric acid as powder is available in grocery or drug stores. Note: Usage of acetic acid or other acids may cause damage to the heater core.
⑤	Bucket (2)	Capacity: 10 liters

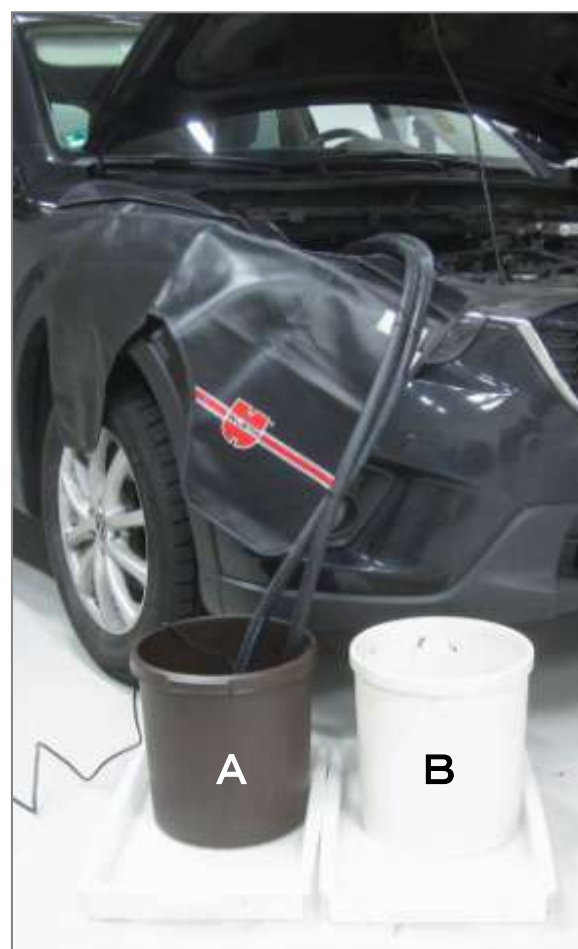
WASH HEATER CORE BY CIRCULATING DETERGENT (TWO TIMES).

9. Fill bucket (A) with 4 liters of warm water (max. 40°C), add 15 grams of citric acid powder and stir it well.
10. Place the PUMP and the open end of the other hose into bucket (A).
11. Turn on the PUMP and allow the mixture to circulate through the heater core for about 1 hr.
12. Dispose the used mixture.
13. Repeat step 9 to 12 for another cycle of 1 hr. using a fresh mixture of water and citric acid.
