Subject: CONDENSATION / FOG IN FRONT AND REAR COMBINATION LIGHTS	Bulletin No: 09-016/09
	Last Issued: 11/19/2009

2003-2010 Mazda6
2004-2010 Mazda3
2006-2010 Mazda5
2006-2010 Mazda MX-5
2007-2010 Mazda CX-7
2007-2010 Mazda CX-9
2004-2010 Mazda RX-8

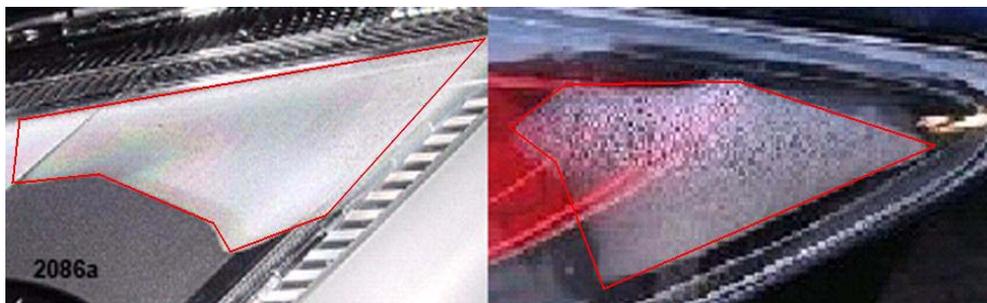
Some customers may complain of condensation/fog inside the front or rear combination lights. The recent new models have been fitted with a clear lens which can cause the symptom to be more noticeable, however, it does not affect the performance of the light. This condensation/fog is a natural phenomenon that occurs when there is a fairly large temperature difference between the inside and the outside of the light housing. **It is normal for very small water drops to appear in certain locations on the light units where the air is stagnant (condensation), making the lens look whitish (fog). This happens mostly in the corners and narrow spaces, and will typically clear during warmer ambient temperatures, or when the lights have been on for some time.**

Explain to the customer that this is a natural phenomenon and not a quality defect. **DO NOT** attempt repairs as this is considered normal, **and is NOT covered under Warranty. Replacing the light unit will not correct this symptom.**
