Subject: HOOD VIBRATION WHILE DRIVING AT HIGHWAY SPEED	Bulletin No: 09-029/12
	Last Issued: 07/27/2012

2013 CX-5 vehicles with VINs lower than JM3KE*****120257 (produced before April 18, 2012)

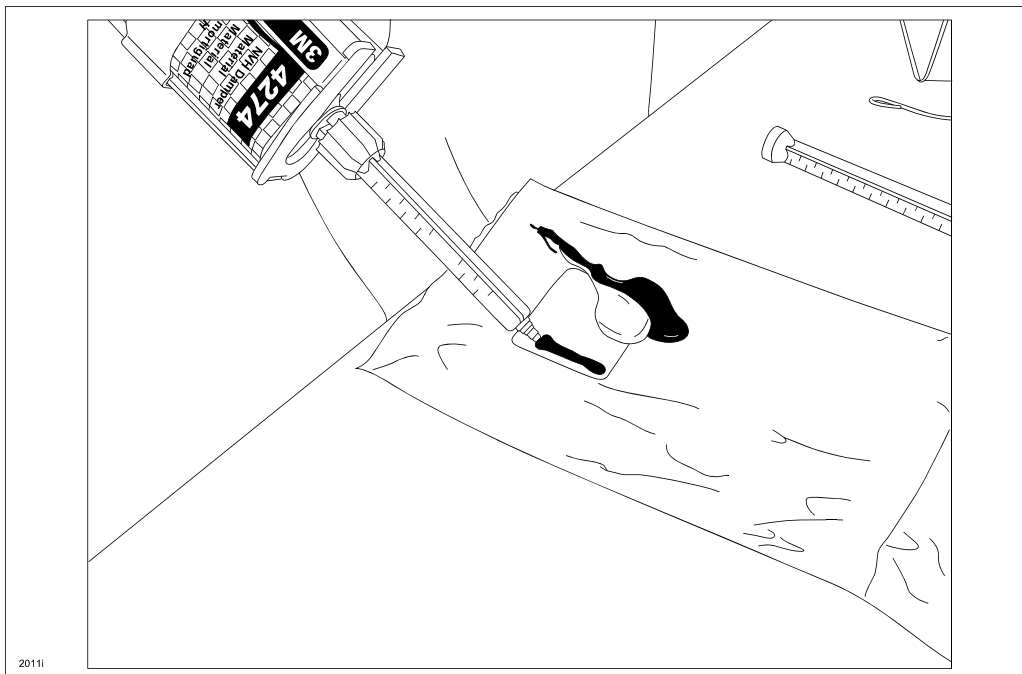
The amount of sealant used to fill in the space between the inner frame and outer panel at the bottom area of the hood is insufficient. If the sealant detaches (as shown below on the left), it may cause the hood to vibrate. The amount of sealant has been increased during vehicle production to eliminate the concern.

12. Apply a 5 mm wide bead of dampening material by pushing and filling it into the space between the inner frame (A) and outer panel (B) between the original sealant spots (C).

NOTE: It is recommended that a pair of protective rubber gloves be put on before applying the dampening material.
