Service Information

Category S	Repair Guidance		Ref. No. R020/13	Page 1 of 7
Coverage ☐ Distributor only ■ Please inform your dealers			Date Issued March 13, 2013	
Please convey this information to your ☐ Director ☐ General Manager ☐ Warranty Dept. ☐ Parts Dept. ☐ Training Dept. ☐ Field Rep.		o .	Date Revised	
Applicable Model		Applicable Countries or Specifications		
CX-5(KE)		Worldwide

Subject: Outer mirror base cover discolors to white

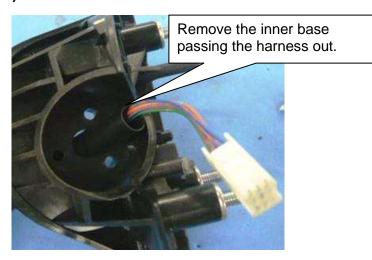
- 6. Remove the screws, and remove the upper base cover and inner base together.
 - * Some model use the TORX screw (T25)
