Service Information

Category S	Repair Guidance	Ref. No. R001/14A	Page 1 of 3
Coverage <input type="checkbox"/> Distributor only <input checked="" type="checkbox"/> Please inform your dealers		Date Issued January 6, 2014	
Please convey this information to your <input type="checkbox"/> Director <input checked="" type="checkbox"/> General Manager <input checked="" type="checkbox"/> Warranty Dept. <input checked="" type="checkbox"/> Parts Dept. <input checked="" type="checkbox"/> Training Dept. <input checked="" type="checkbox"/> Field Rep.		Date Revised March 27, 2014	
Applicable Model Mazda3(BM)		Applicable Countries or Specifications Worldwide

Subject: Rattle noise from the bottom of A-pillar

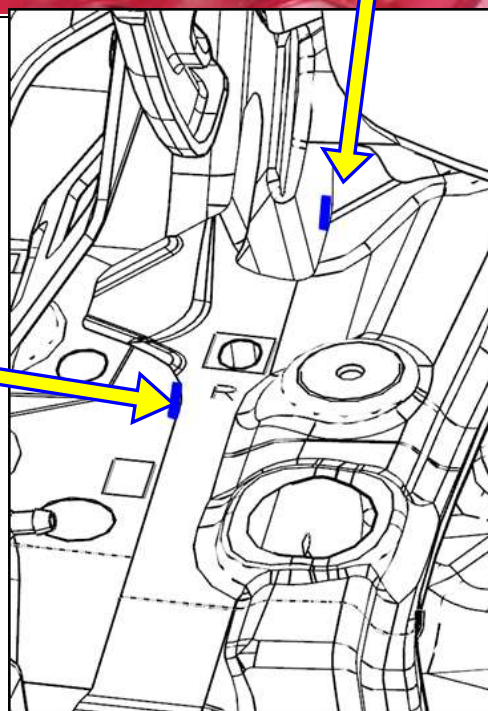
Wiper bracket – Dash upper panel

The cowl upper plate and/or dash upper panel interferes with the wiper bracket causing a noise.

***Note:** To avoid damaging the paint, wrap protection tape around the tip of the screwdriver. If there are scratches on the panels, apply appropriate corrosion protection primer.
