Service Information

Category T	Repair Guidance	Ref. No. R082/13	Page 1 of 7
Coverage <input type="checkbox"/> Distributor only <input checked="" type="checkbox"/> Please inform your dealers		Date Issued October 15, 2013	
Please convey this information to your <input type="checkbox"/> Director <input checked="" type="checkbox"/> General Manager <input checked="" type="checkbox"/> Warranty Dept. <input checked="" type="checkbox"/> Parts Dept. <input checked="" type="checkbox"/> Training Dept. <input checked="" type="checkbox"/> Field Rep.		Date Revised	
Applicable Model CX-5(KE)		Applicable Countries or Specifications UK and Ireland

Subject: Electrical System Malfunction(s) in connection with failure of C-15 Connector

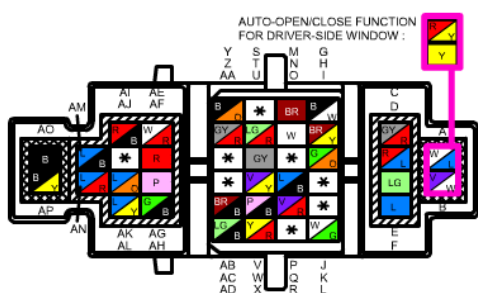
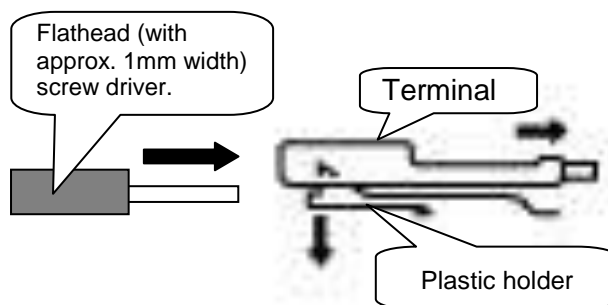
Note: The wire colors are different depending on the vehicle specification. Refer to appropriate Wiring Diagram.

7. Remove two terminals position marked A and B indicated by red circle in the figure from the C-15 connector using a flathead (with approx. 1mm width) screw driver.
