# Service Information

Category <b>T</b>	<b>Technical</b>	Ref. No. E010/14	Page 1 of 3
Coverage <input type="checkbox"/> Distributor only <input checked="" type="checkbox"/> Please inform your dealers		Date Issued May 12, 2014	
Please convey this information to your <input type="checkbox"/> Director <input checked="" type="checkbox"/> General Manager <input checked="" type="checkbox"/> Warranty Dept. <input checked="" type="checkbox"/> Parts Dept. <input checked="" type="checkbox"/> Training Dept. <input checked="" type="checkbox"/> Field Rep.		Date Revised	
Applicable Model  Mazda3(BM), Mazda6 (GJ) and CX-5(KE)		Applicable Countries or Specifications  Worldwide

## Subject: Multiple Electrical Malfunctions after replacing Front Fender Stay by body repair

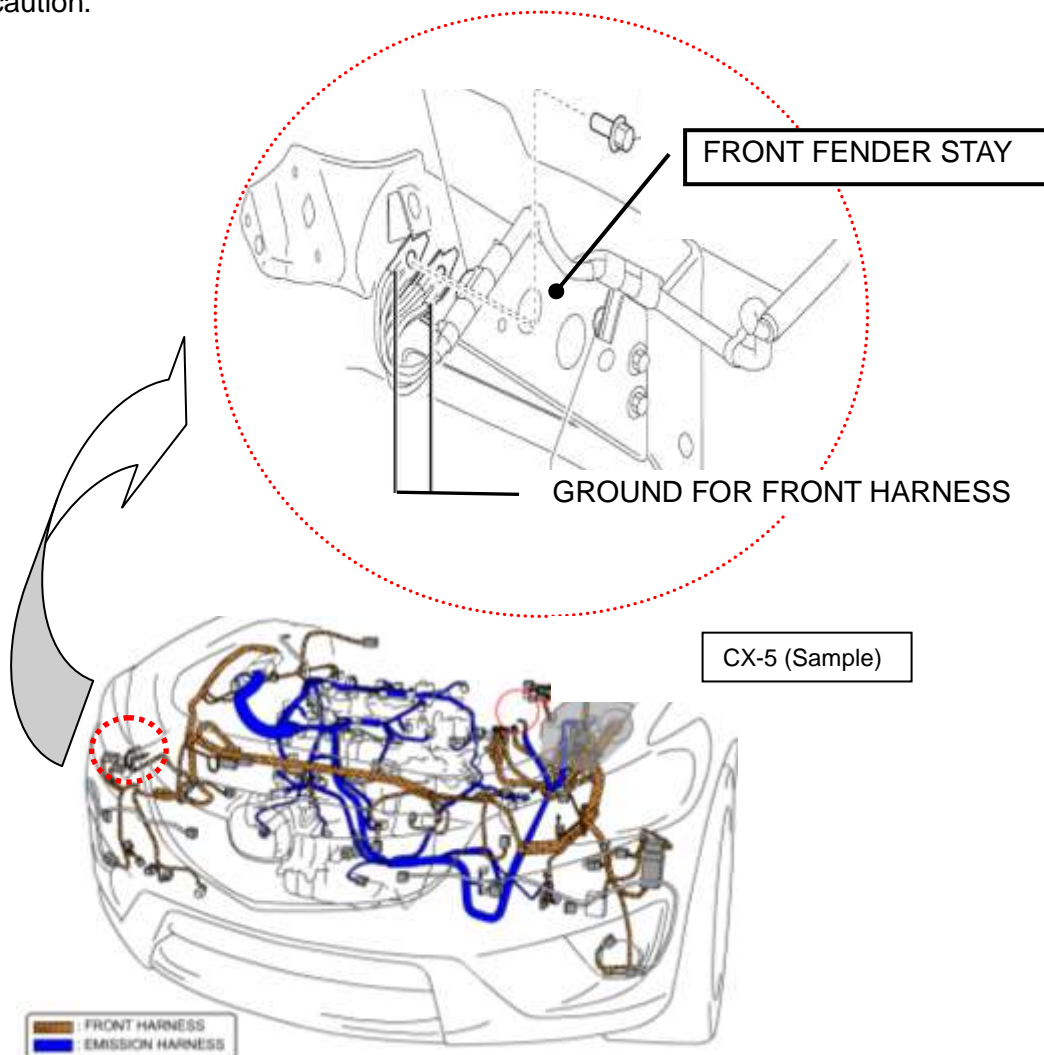
Several reports of multiple electrical malfunctions, that occurred after having replaced the front fender stay during body repair, were received. The cause is poor ground of the front harness, caused by improper replacement work of the front fender stay.

At all four vehicles the front fender stay was replaced by body repair previously, and inspection found that the newly installed fender stay was painted at the area where the bolt D is seated, causing poor ground of the front harness.

If the bolt D contact area is painted when the front fender stay is newly replaced, it could cause a malfunction in the PCM. Before painting a newly replaced part, protect the bolt D contact areas with masking tape as shown in the figure.
