# Service Information

Category <b>F</b>	<b>Repair Guidance</b>	Ref. No. R020/14	Page 1 of 3
Coverage <input type="checkbox"/> Distributor only <input checked="" type="checkbox"/> Please inform your dealers		Date Issued February 17, 2014	
Please convey this information to your <input type="checkbox"/> Director <input checked="" type="checkbox"/> General Manager <input checked="" type="checkbox"/> Warranty Dept. <input checked="" type="checkbox"/> Parts Dept. <input checked="" type="checkbox"/> Training Dept. <input checked="" type="checkbox"/> Field Rep.		Date Revised	
Applicable Model  CX-5 (KE) with SKYACTIV-D 2.2		Applicable Countries or Specifications  ADR, EC

## Subject: Engine Oil Warning Indication / Warning light ON with “Low engine oil pressure” message on LCD and DTC P253F:00 stored in memory

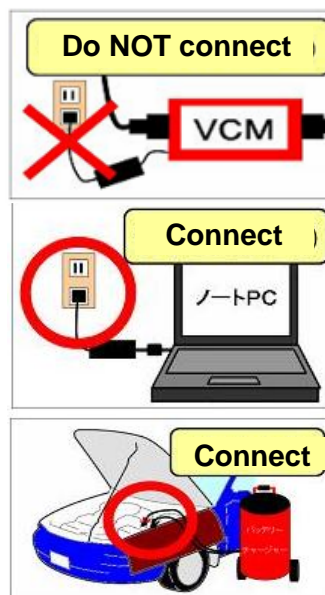
- Low voltage may result in abnormal termination and/or PCM (TCM) data corruption. Please check following items.

- Do NOT connect AC adapter to VCM when M-MDS is communicating with a vehicle.
- Connect AC adapter to the PC in order to stabilize voltage fluctuation during reprogramming (Do NOT use vehicle battery outlet as power source for the PC).
- Connect battery charger (charge current maintained within 10 to 15A) to the vehicle to stabilize voltage fluctuation.
- Make sure to turn off all the electrical loads. (Especially A/C (blower), audio, rear defogger and headlights).
- Disconnect all non-genuine aftermarket electrical parts and modifications.
