## MULTI-MODEL VEHICLE PULL / DRIFT AFTER TIRE REPLACEMENT

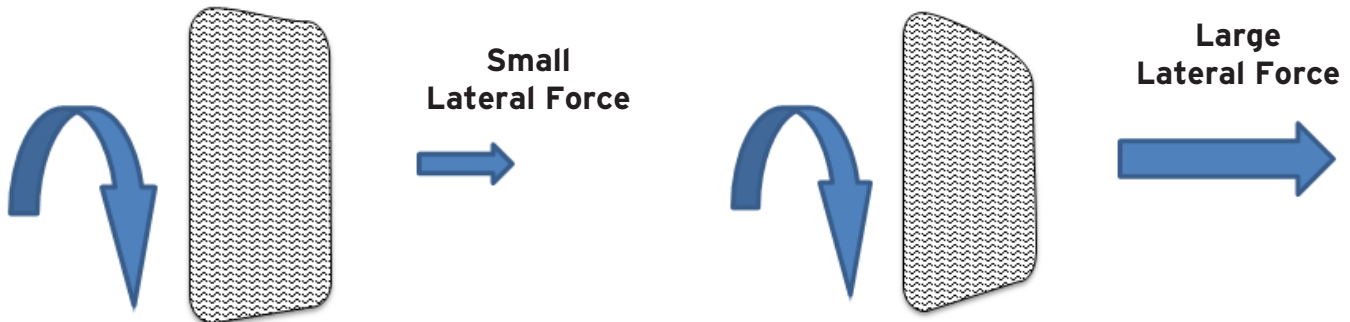
### Conicity

During the tire manufacturing process, there is some amount of conicity (lateral force). Tire conicity results when the tire belts are not perfectly aligned when the tire is built. Tire conicity should not be confused with a separated, worn, or damaged tire.

When a cone rolls, it rolls in a circle towards the point of the cone. This phenomena is known as conicity. The amount of lateral force varies from tire to tire.
