Service Information

Mazda Motor Corporation

Category S	Technical	Ref. No. E031/10	Page 1 of 12
Coverage <input type="checkbox"/> Distributor only <input checked="" type="checkbox"/> Please inform your dealers		Date Issued January 19, 2011	
Please convey this information to your <input type="checkbox"/> Director <input checked="" type="checkbox"/> General Manager <input checked="" type="checkbox"/> Warranty Dept. <input checked="" type="checkbox"/> Parts Dept. <input checked="" type="checkbox"/> Training Dept. <input checked="" type="checkbox"/> Field Rep.		Date Revised	
Applicable Model All models	Applicable Countries or Specifications Worldwide

Subject: Tips for Paint Damage Caused by External Factors

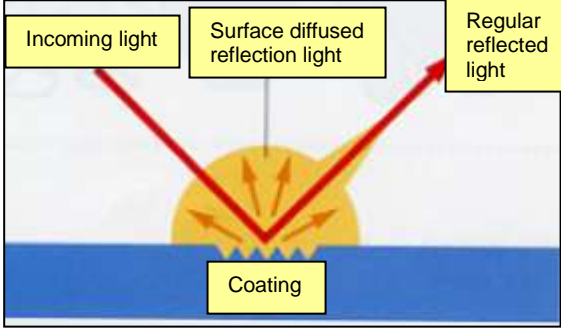
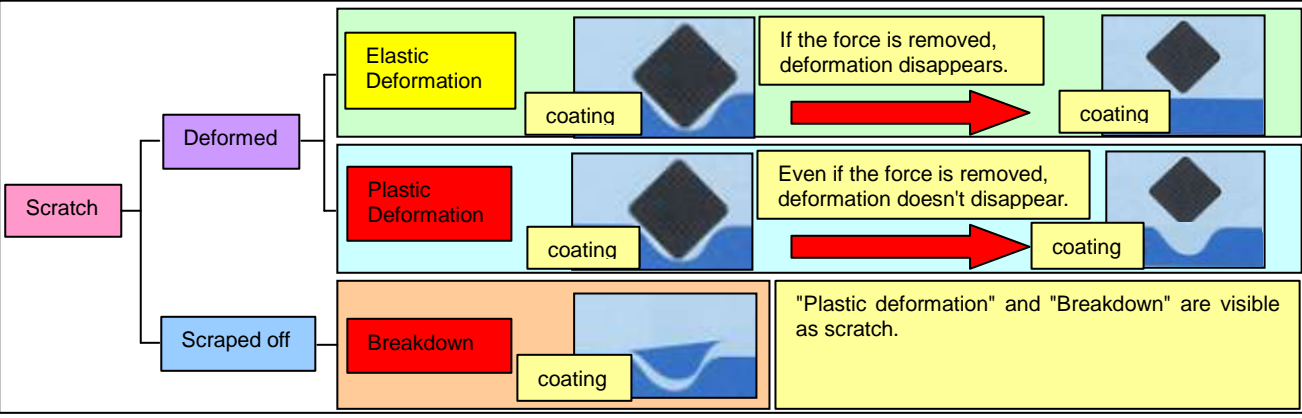
Scratch

- As shown in the right picture, scratch looks white because surface of the scratch reflects diffusely.
- As shown in the picture below, the scratch is created because paint coating is scraped or depressed due to foreign material under surface and hardness of material for wiping.

1. Very little flaw that disappears if the force is removed is elastic deformation.
2. If pushing force is strong, deformation doesn't disappear even though the force is removed. Deformation becomes large and plastic deformation exceeding elastic deformation.
3. If the deformation increases further, it causes coating breakdown.

- Deformed
 - Elastic Deformation: If the force is removed, deformation disappears.
 - Plastic Deformation: Even if the force is removed, deformation doesn't disappear.
- Scraped off: Breakdown. "Plastic deformation" and "Breakdown" are visible as scratch.

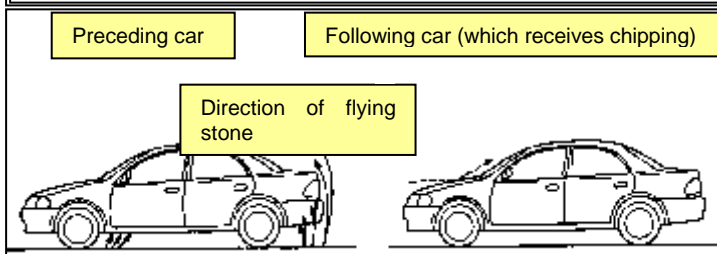
Right after the peeling, impact area is burned and whitened. Edge of peeled area is scraped off at a sharp angle.

1. The stone hits and breaks the coating, which triggers peeling.
