<b>Subject:</b> <b>MULTI-MODEL - CONDENSATION / FOG IN FRONT AND REAR COMBINATION LIGHTS</b>	<b>Bulletin No:</b> 09-057/10
	<b>Last Issued:</b> 12/23/2010

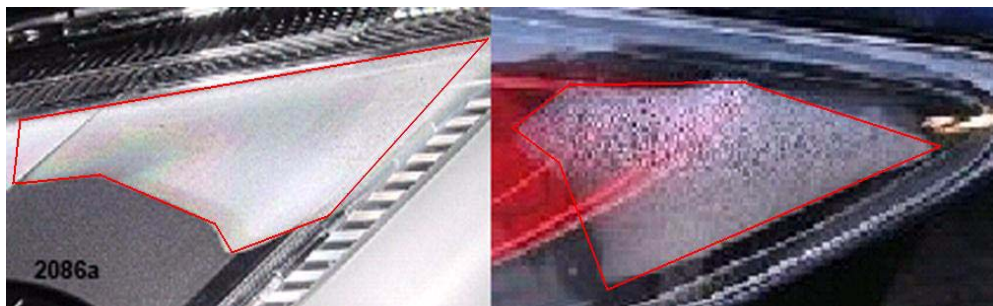
Some customers may complain of condensation/fog inside the front or rear combination lights. The recent new models have been fitted with a clear lens which can cause the symptom to be more noticeable, however, it does not affect the performance of the light. This condensation/fog is a natural phenomenon that occurs when there is a fairly large temperature difference between the inside and the outside of the light housing. It is normal for very small water drops to appear in certain locations on the light units where the air is stagnant (condensation), making the lens look whitish (fog). This happens mostly in the corners and narrow spaces, and will typically clear during warmer ambient temperatures, or when the lights have been on for some time.

Explain to the customer that this is a natural phenomenon and not a quality defect. DO NOT attempt repairs as this is considered normal, and is NOT covered under Warranty. Replacing the light unit will not correct this symptom.
