Service Information

Subject: Unusual long cranking and rough idling after cold start at low ambient temperatures

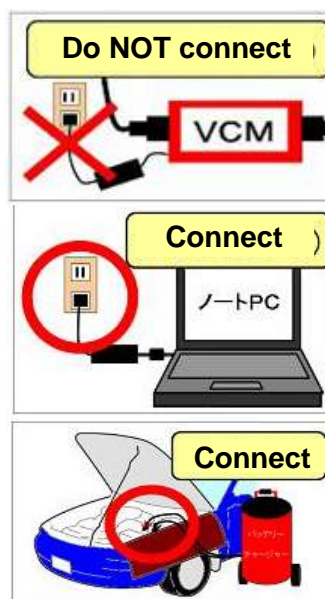
- Do NOT connect AC adapter to VCM when M-MDS is communicating with a vehicle.
- Connect AC adapter to the PC in order to stabilize voltage fluctuation during reprogramming (Do NOT use vehicle battery outlet as power source for the PC).
- Connect battery charger (charge current maintained within 10 to 15A) to the vehicle to stabilize voltage fluctuation.
- Make sure to turn off all the electrical loads. (Especially A/C (blower), audio, rear defogger and headlights).
- Disconnect all non-genuine aftermarket electrical parts and modifications.
