MUTIPLE MODELS W/NAVIGATION

### BEEPING NOISE FROM DASH AREA RI6327

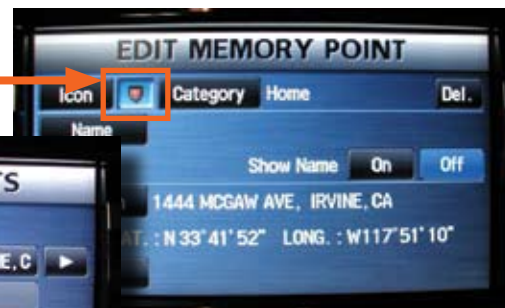
Some 2006 and later model year vehicles equipped with navigation may exhibit a mysterious "beep" sound in the dash while driving. This may be due to inadvertent or accidentally programmed sound icons in the navigation system.

NOTE:
Programmed addresses will display, with an icon beside each one. Non-programmed addresses will show a push-pin.

Sound icons are identified as follows:
- Exclamation
- Bell
- Single note
- Multiple notes
- Siren
- Stop

Check if sound icons are programmed and remove them as needed using the following procedure.

1. Select MENU.
2. Select ADDRESS BOOK.
3. Select MEMORY POINTS/HOME.
4. Select LIST.
5. Select memory point with an Icon.
6. Display shows EDIT MEMORY POINT.
7. Select ICON. 3 lists of icons are available.
8. Select a non-sound Icon from Page 1 or Page 2, or choose No Icon to remove the sound.
