Service Information

Mazda Motor Corporation

Category F	Repair Guidance	Ref. No. R018/14	Page 1 of 3
Coverage <input type="checkbox"/> Distributor only <input checked="" type="checkbox"/> Please inform your dealers		Date Issued February 11, 2014	
Please convey this information to your <input type="checkbox"/> Director <input checked="" type="checkbox"/> General Manager <input checked="" type="checkbox"/> Warranty Dept. <input checked="" type="checkbox"/> Parts Dept. <input checked="" type="checkbox"/> Training Dept. <input checked="" type="checkbox"/> Field Rep.		Date Revised	
Applicable Model CX-5 (KE)		Applicable Countries or Specifications Europe

Subject: i-stop warning light (Amber color) flashing with a message “Battery Management System Inspection Required” and DTC P0A8D:00 stored in memory

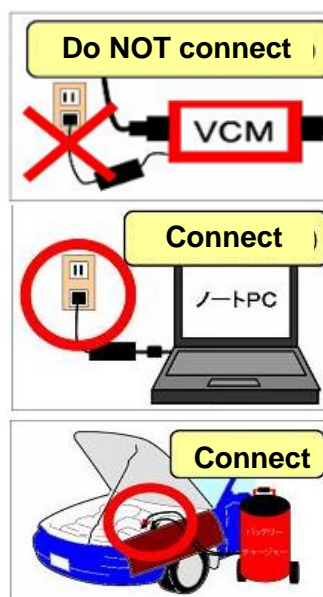
- Do NOT connect AC adapter to VCM when M-MDS is communicating with a vehicle.
- Connect AC adapter to the PC in order to stabilize voltage fluctuation during reprogramming (Do NOT use vehicle battery outlet as power source for the PC).
- Connect battery charger (charge current maintained within 10 to 15A) to the vehicle to stabilize voltage fluctuation.
- Make sure to turn off all the electrical loads. (Especially A/C (blower), audio, rear defogger and headlights).
- Disconnect all non-genuine aftermarket electrical parts and modifications.
