# Service Information

Category <b>F</b>	<b>Repair Guidance</b>	Ref. No. R083/12A	Page 1 of 2
Coverage <input type="checkbox"/> Distributor only <input checked="" type="checkbox"/> Please inform your dealers		Date Issued November 15, 2012	
Please convey this information to your <input type="checkbox"/> Director <input checked="" type="checkbox"/> General Manager <input checked="" type="checkbox"/> Warranty Dept. <input checked="" type="checkbox"/> Parts Dept. <input checked="" type="checkbox"/> Training Dept. <input checked="" type="checkbox"/> Field Rep.		Date Revised <b>July 11, 2013</b>	
Applicable Model CX-5 (KE) with SKYACTIV-D 2.2	Applicable Countries or Specifications Europe

**Subject: MIL Illumination with DTC P0421:00 <SKYACTIVE-D 2.2>**

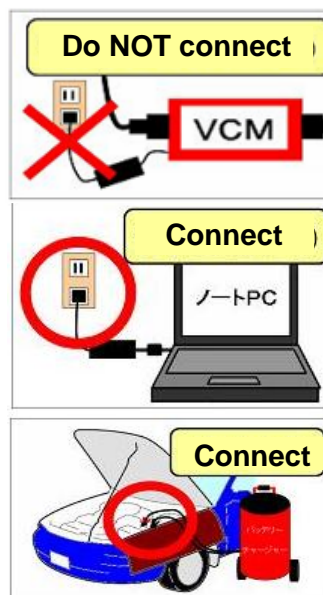
- Do NOT connect AC adapter to VCM when M-MDS is communicating with a vehicle.
- Connect AC adapter to the PC in order to stabilize voltage fluctuation during reprogramming (Do NOT use vehicle battery outlet as power source for the PC).
- Connect battery charger (charge current maintained within 10 to 15A) to the vehicle to stabilize voltage fluctuation.
- Make sure to turn off all the electrical loads. (Especially A/C (blower), audio, rear defogger and headlights).
- Disconnect all non-genuine aftermarket electrical parts and modifications.
