# Service Information

| Applicable Model<br>CX-5 (KE) Mazda6(GJ) with TomTom NB-1 Navigation | | Applicable Countries or Specifications<br>Europe | |

## Subject: TomTom NB-1 NAVIGATION Concerns Solved by Software update

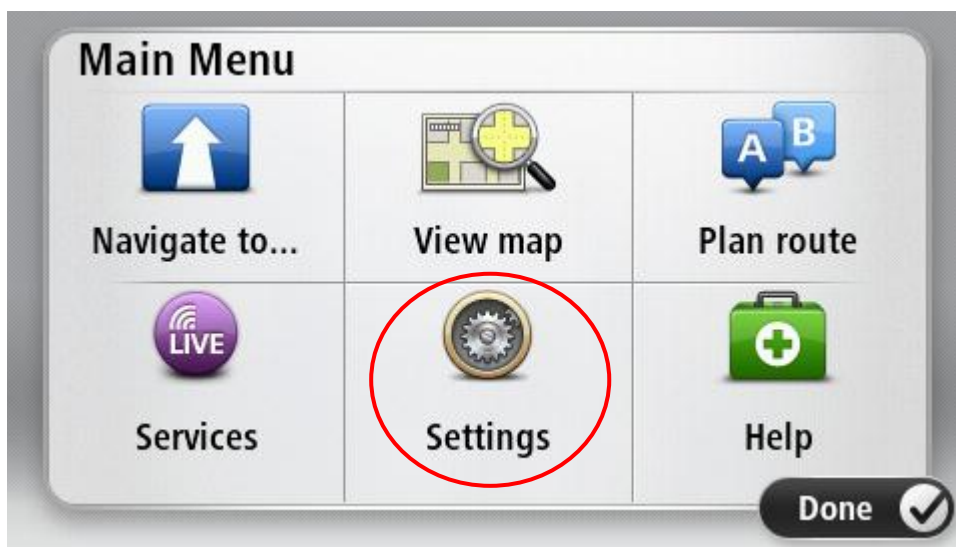
1. Tap screen (anywhere in map screen).
2. Push "Settings".

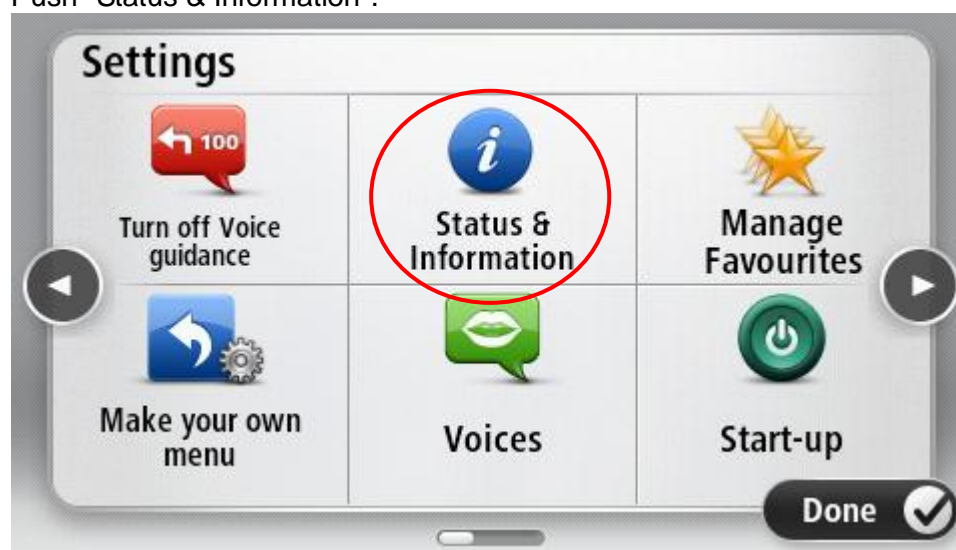
3. Push "Status & Information".

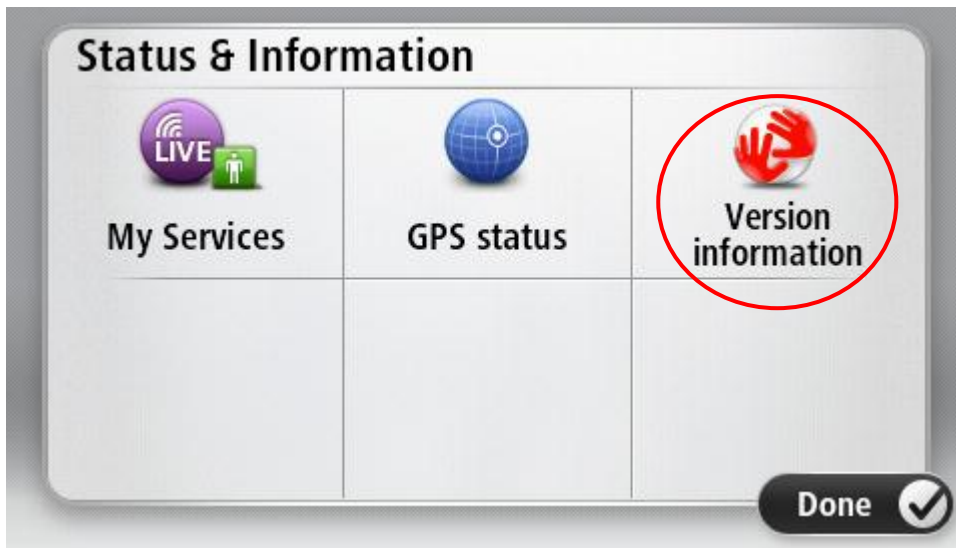
4. Push "Version Information"

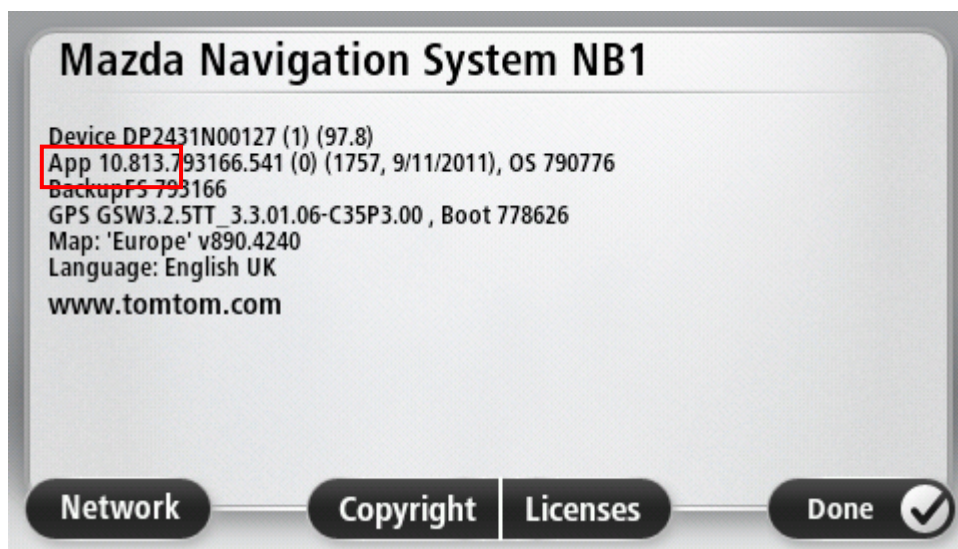
5. Confirm the Software version (If this version is **latest**, no update is needed)

Software Version begins straight after the word "App". It is only necessary to confirm the first 5 digits of Software Version.  
In the above example the Software Version is 10.813

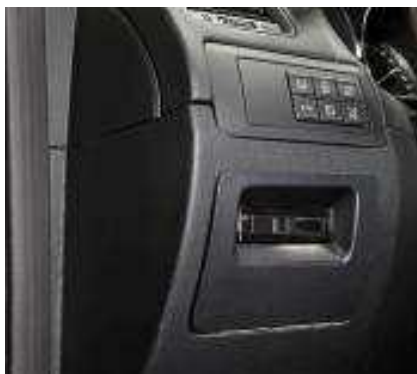
Figure 1: SD card location in Mazda Navigation System (example)

- 1) Insert an empty SD card to your computer, then download file named “ttsystem”, to your computer.
- 2) Copy downloaded “ttsystem” file to root folder of your SD card.  
**Note:** Please do not use customer’s MAP SD to update device.  
\* Root folder is highest level of folder configuration.
- 3) After step 2), safely remove your update SD card and bring it to the vehicle with target Navigation System NB-1.
- 4) Ensure that the car ignition is turned off and customer’s SD card is removed, then insert the update SD card to target Navigation System NB-1.

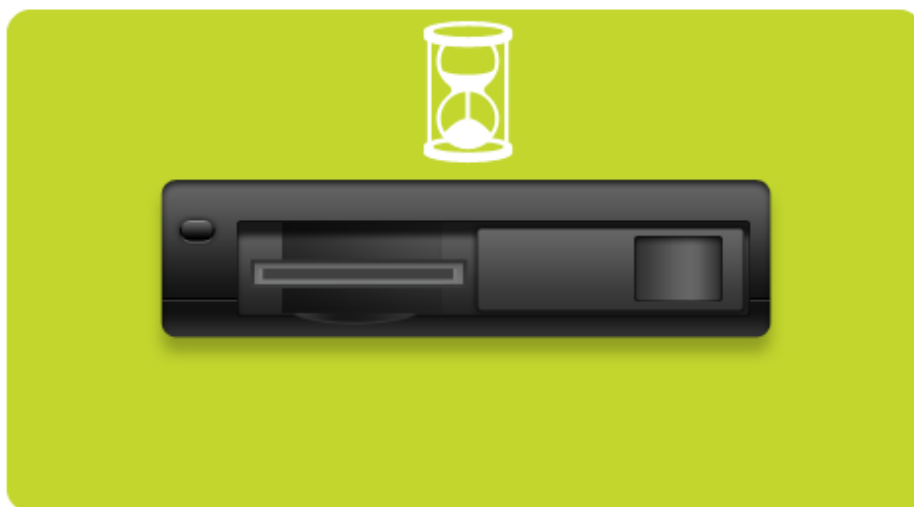
First, the software update screen appears:

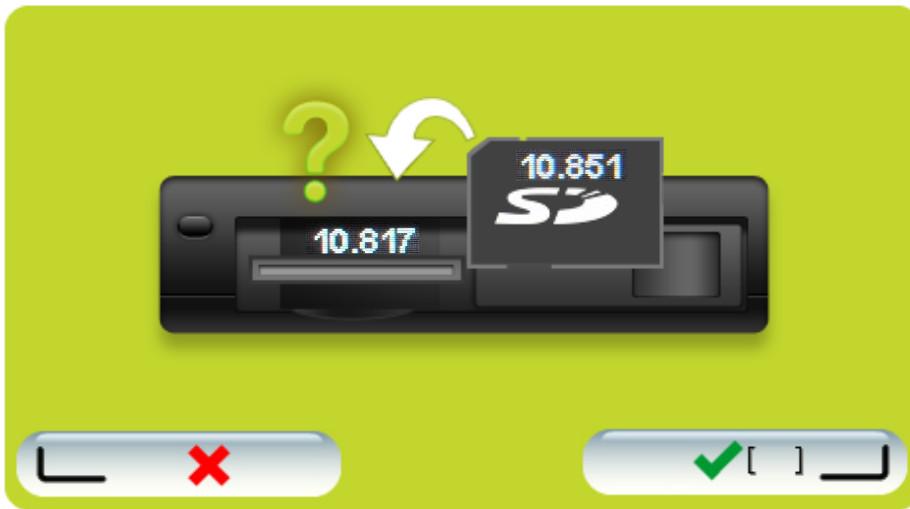
Next screen appears, below example details that 10.817 is present and can be updated with 10.852:

Press the green 'V' hook or wait 45 seconds. Then the software loading will start and the progress bar is filled from 0 - 100%.

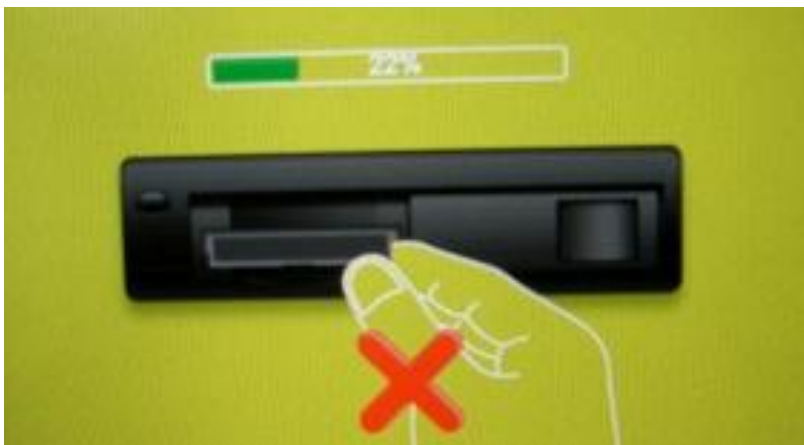
Screen during software loading with progress bar:

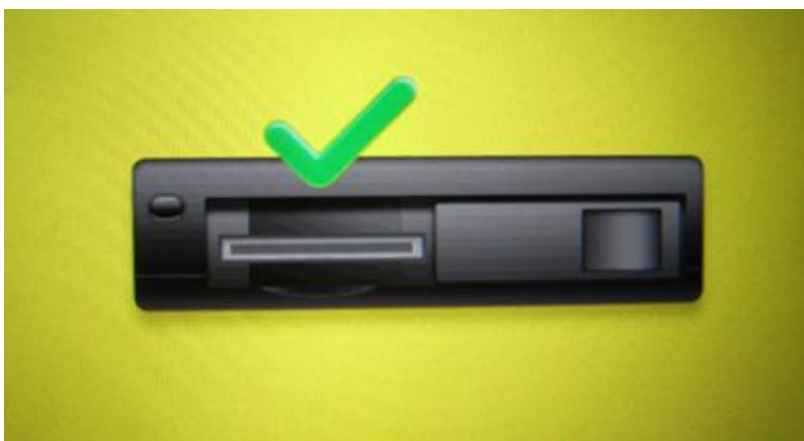
Screen of software loading completed:

After above the audio screen appears. Press the "NAV" button to switch to the navigation screen. To switch to the navigation screen takes less than 60 seconds.  
Depending on the previous software version on the NAVI unit it is possible that one or more additional software requires an installation:

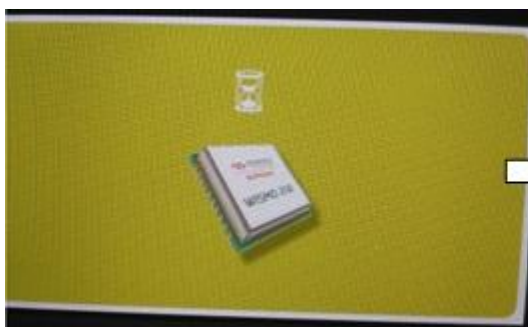
Screen "B" another additional installation ongoing:

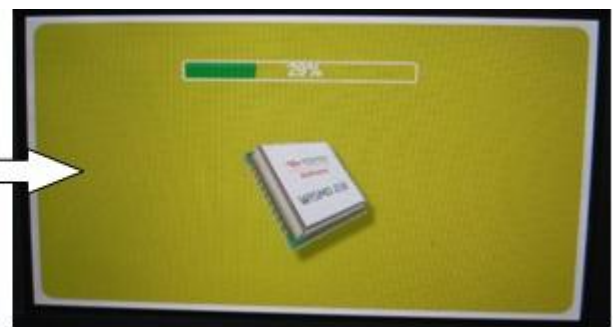
Screen "B" another additional installation in progress:

After each software installation the audio screen appears back. Press the "NAV" button again to switch back to the navigation screen. To switch to the navigation screen takes less than 60 seconds. Once the screens according to 4a) are present, go to step 5).
