<b>Subject:</b> *****MAZDA SERVICE PROGRAM (MSP41) - MAZDA CONNECT INFOTAINMENT GMGTEM UPDATE	<b>Bulletin No:</b> 09-034/13
	<b>Last Issued:</b> 11/25/2013

2014 Mazda3 vehicles (with MAZDA CONNECT Infotainment System) after June 11, 2013

An updated version of the software for the Connectivity Master Unit (CMU) has become available. Under this MSP41, the CMU of applicable Mazda3 vehicles will be reprogrammed to the updated version using a USB memory stick. This software update includes some fixes for the Infotainment System as described below as well as some additional minor fixes.

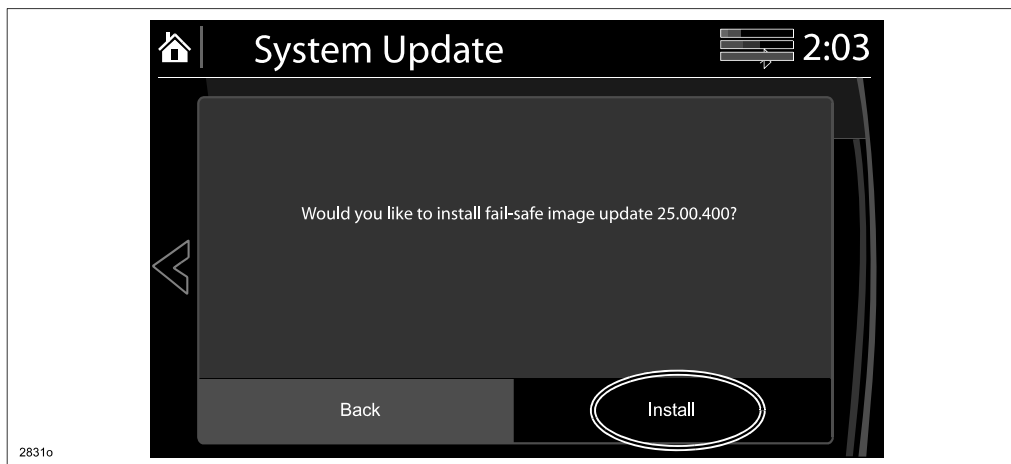
15. Select “Fail Safe Package” first using the touch screen.

**CAUTION:** Always do the “Fail Safe Package” first, followed by “Reinstallation Package”.

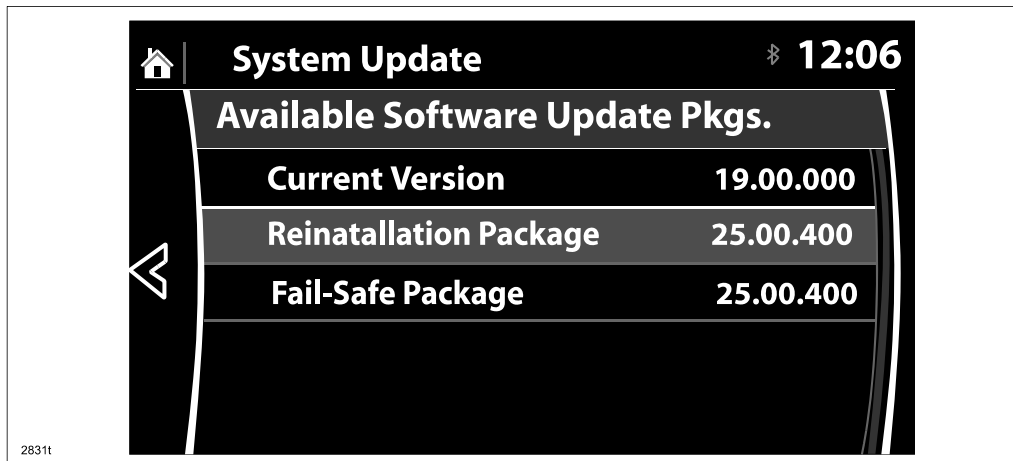
22. Select "Reinstallation Package" on the screen below.

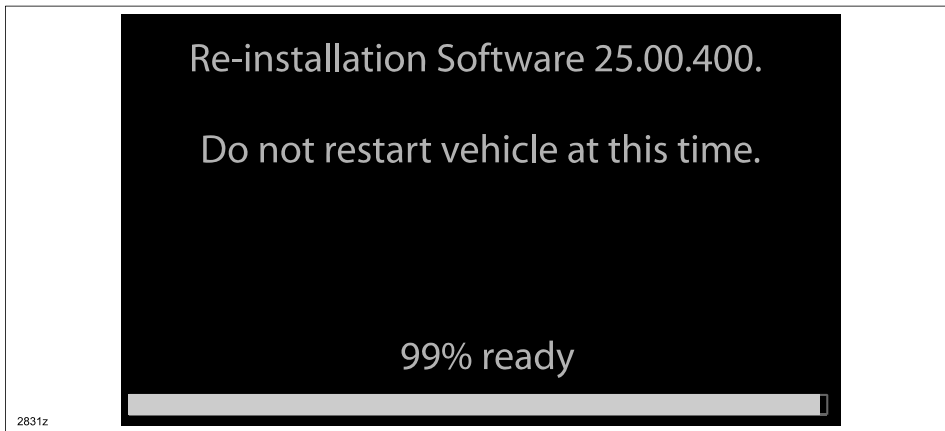
Type B: The ignition was turned “OFF” during the reflashing process. This screen will continue to be displayed until reflashing is completed. After the reflashing is completed, go to next step.
