MULTI-MODEL (EXCEPT MAZDA2)

AUTOMATIC TRANSMISSION ERRATIC SHIFTING OR HANGING IN GEAR

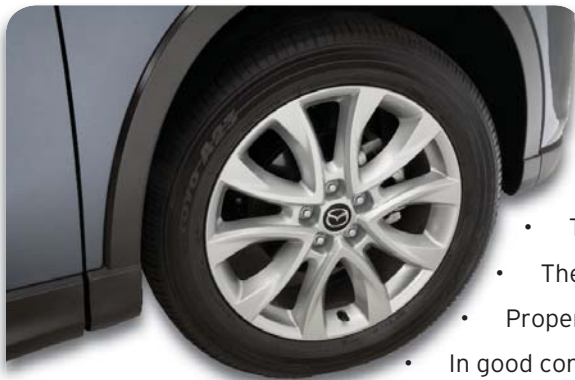
Because the A/T shift logic is partly dependent on ABS/TCS wheel sensors, some automatic transmission shifting concerns may be caused by different sized tires or tire brands on the same vehicle. Verify all four (4) tires on the vehicle are the same size and brand. Although the size of the tire may be the same between different manufacturers, the revolutions per mile may be different. Also, tires of the same brand may cause concerns if the set contains new and worn tires.
