Subject: HARD SHIFTING/SHIFT LEVER VIBRATION	Bulletin No: 05-001/15
	Last Issued: 11/11/2015

2012-2013 Mazda3 (SKYACTIV 6 M/T)

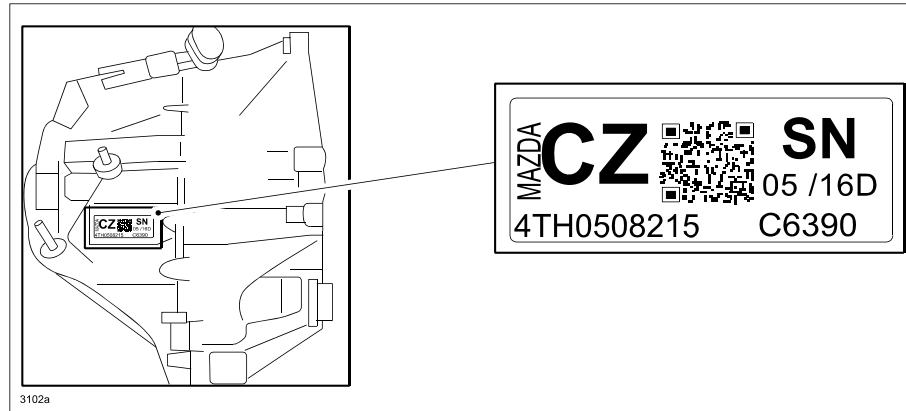
NOTE: The modification(s) applied to the transmission can also be found from the transmission number. The transmission number is printed on the label attached on the top side of the transaxle case. Refer to the below table for the beginning transmission numbers of each modification.

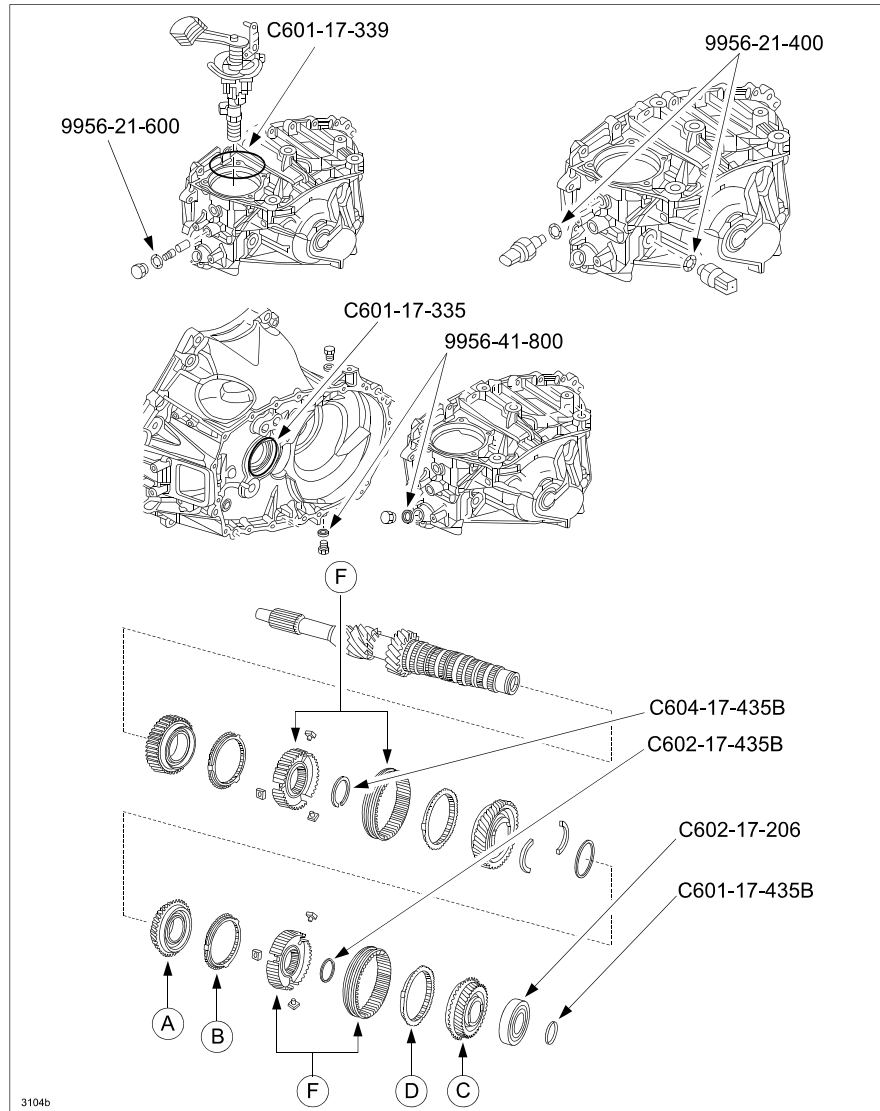
Location of Transmission Related Parts

- A: 3rd Gear
- B: 3rd Synchronizer Ring
- C: 3/4 Clutch Hub Assembly
- D: 4th Synchronizer Ring
- E: 4th Gear
- F: 5/6 Clutch Hub Assembly

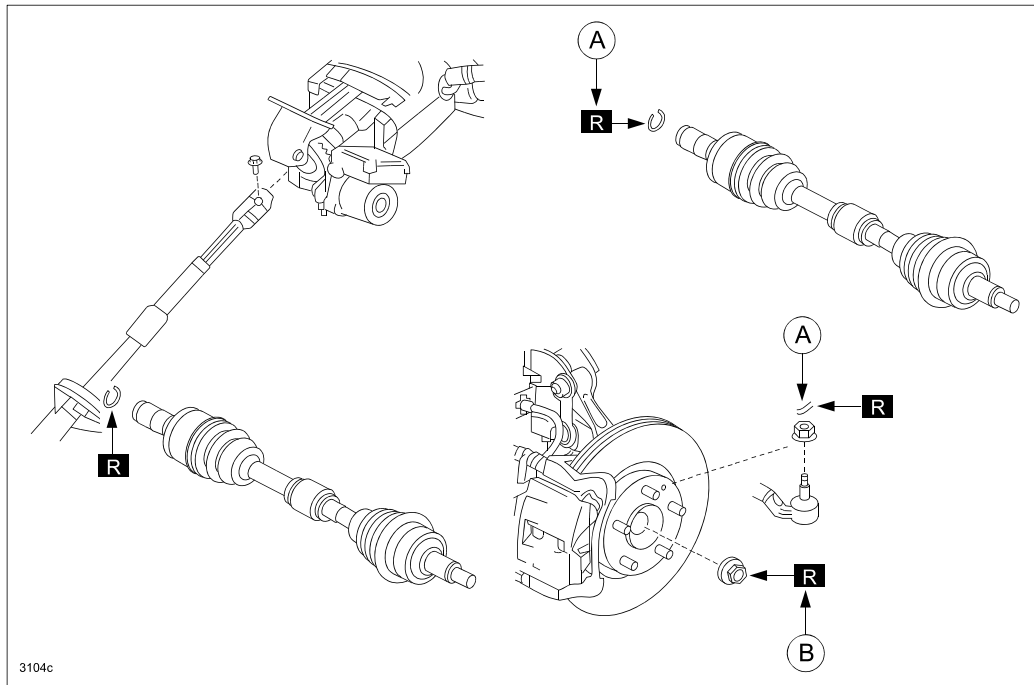
A: Clip

B: Nut

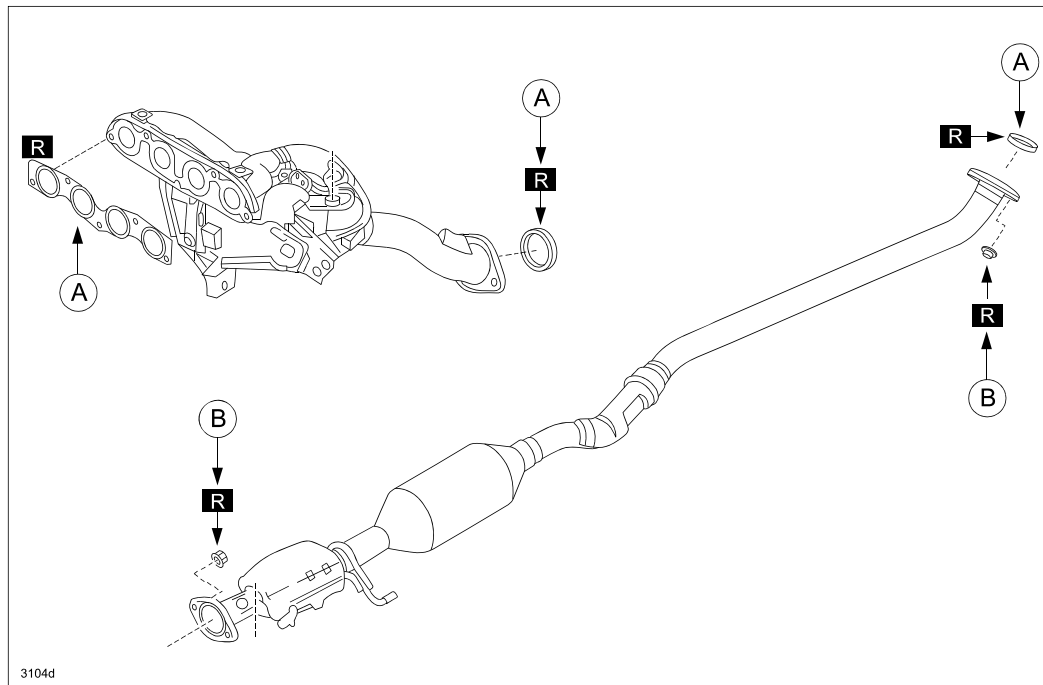
A: Gasket

B: Nut
