## 2014 Mazda6, CX-5 TIRE PRESSURE MAINTENANCE MONITOR

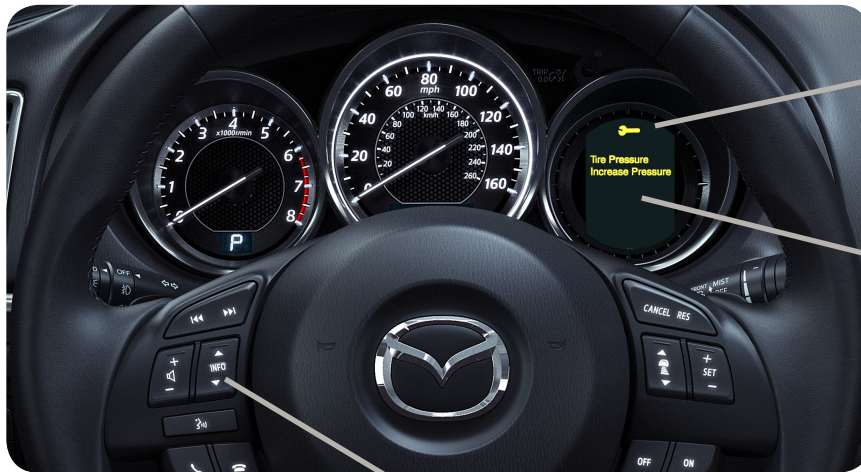
Multi-Information Display

INFO Switch

1. Use the steering wheel INFO switch to navigate to the "Maintenance" section of the Multi-Information Display.
2. Select "Tire Pressure"
3. Select "Set Time"
4. Set new values (if current values are being reused, skip to the next step)
5. Press the INFO button

1. Use the steering wheel INFO switch to navigate to the "Maintenance" section of the Multi-Information Display.
2. Select "Tire Pressure"
3. Select OFF

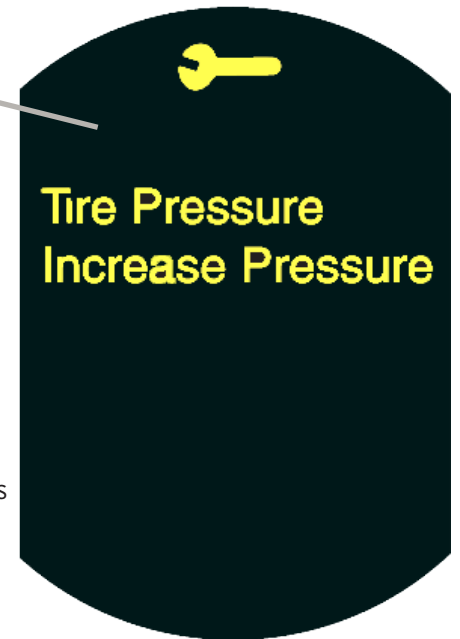
Some customers may complain about a TPMS malfunction when they see the "Tire Pressure Increase Pressure" message displayed in the Instrument Cluster Multi-Information Display. This message is a preset service reminder to check the tire air pressures. **It is not a low tire pressure warning or a TPMS malfunction.**

Tire Pressure Maintenance Display

The Tire Pressure Maintenance Monitor factory default setting is OFF. The customer can turn it ON and set the time.

The Maintenance Monitor may have been turned ON during PDI without the customer's knowledge; consequently, when the preset time period elapsed, the customer could misinterpret the message as a TPMS malfunction.
