Service Information

Category P	Technical	Ref. No. E049/12A	Page 1 of 1
Coverage <input type="checkbox"/> Distributor only <input checked="" type="checkbox"/> Please inform your dealers		Date Issued November 15, 2012	
Please convey this information to your <input type="checkbox"/> Director <input checked="" type="checkbox"/> General Manager <input checked="" type="checkbox"/> Warranty Dept. <input checked="" type="checkbox"/> Parts Dept. <input checked="" type="checkbox"/> Training Dept. <input checked="" type="checkbox"/> Field Rep.		Date Revised November 22, 2013	
Applicable Model All models with AT		Applicable Countries or Specifications Europe

Subject: Groan noise from Brake

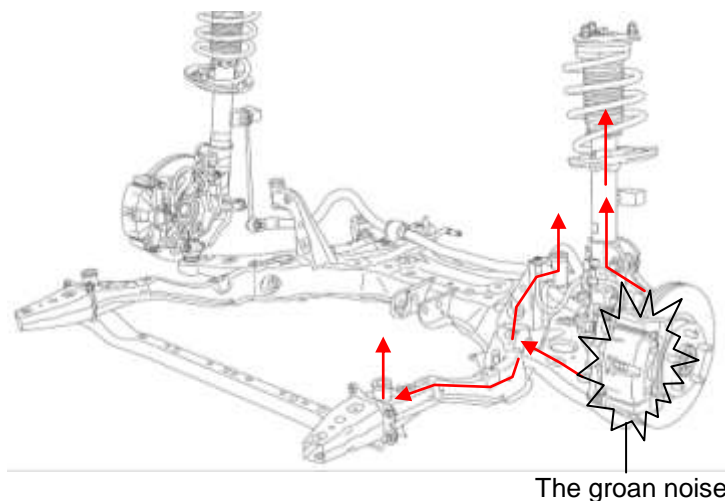
< The groan noise generating mechanism >

The groan noise may occur due to stick-slip between the disc plate and the brake pad when the braking force is reduced a little.

The noise is transported through the wheel hub, the suspension and/or the front crossmember.

If the friction coefficient is increased, this groan noise also increases.

Some customers, especially if they are not used to driving a vehicle with AT, may complain about a groan noise from brake at vehicle startup or just before vehicle standstill. The groan noise is not malfunction.
