Service Information

| Category R | Technical | Ref. No. E010/13A | Page 1 of 1 |

Subject: Stabilizer Bush of Front and Rear

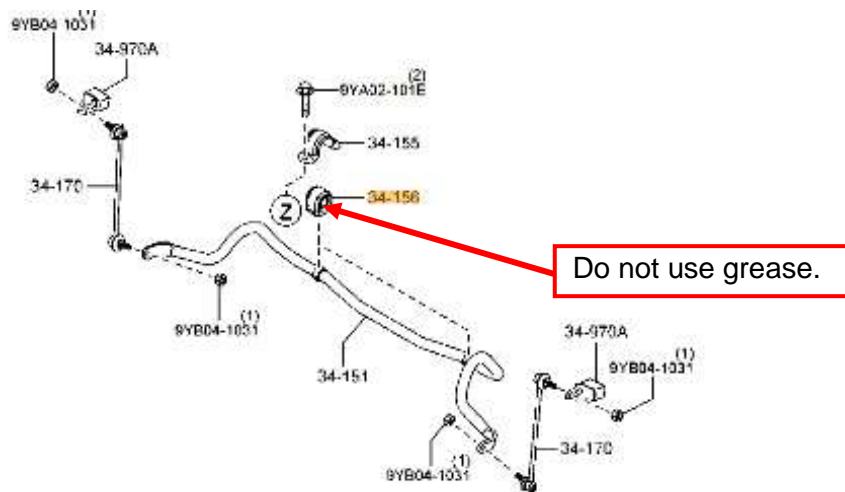
To prevent noise from stabilizer bush, do not apply grease on the bushes of front and rear stabilizer. (Example below shows CX-5 front stabilizer bush)

For the newly developed models from CX-5, grip type bushes are installed to prevent noise. If you apply grease mistakenly, a noise due to slipping may occur. Therefore, please do not apply any grease to the bushes of front and rear stabilizer.
