M-TIPS

2004 RX-8 (A/T)

Gear Range Indicator Change

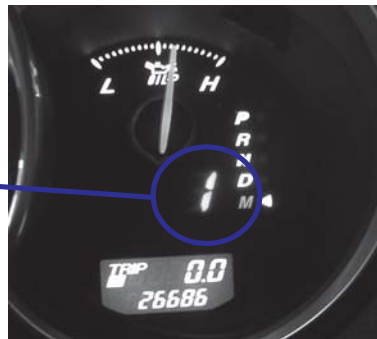
Beginning with Nov. 1, 2003 production, the gear range indicator on automatic transmission equipped vehicles displays in both “D” position and in the “manual” mode.

Gear range indicator displays in “D” position and in “Manual” mode since Nov. 1, 2003 prod.

Earlier production vehicles built before Nov. 1, 2003 display the gear range indicator in the “manual” mode only, not in “D” position. This is normal operation, do not attempt any repairs.

NOTE: It is not warrantable to replace the ICM on early production vehicles in an effort to add this change.
