Multiple Models

Side Mirror Glass Loose RI5910

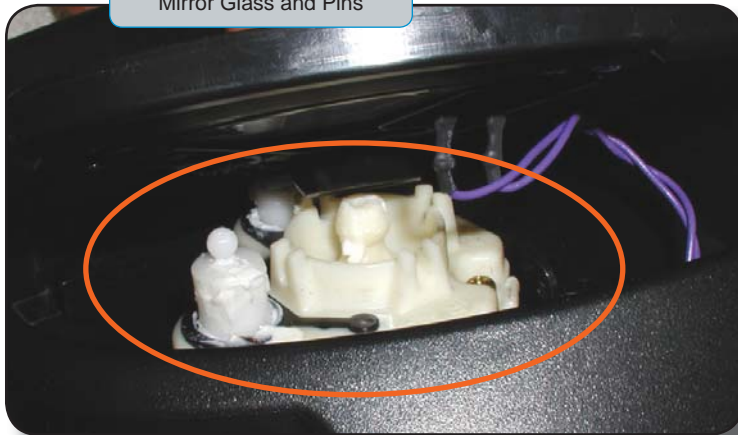
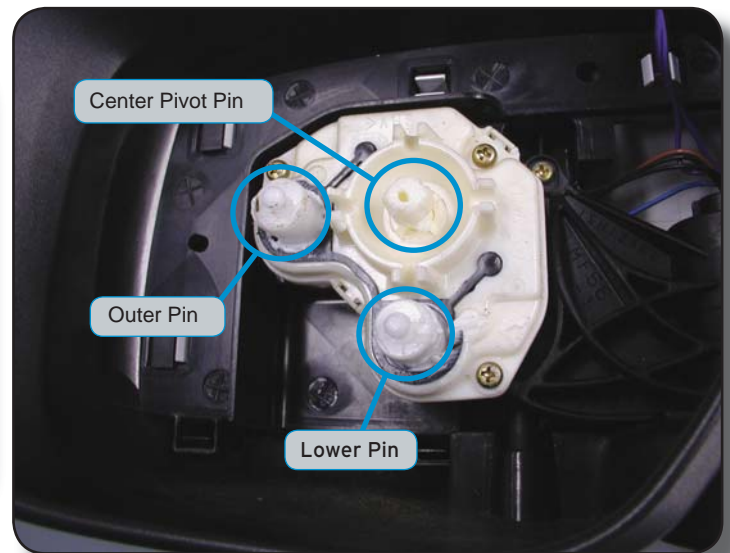
Visually Inspect The Rear Of Mirror Glass and Pins

Some vehicles may exhibit an outer mirror with mirror glass that moves back-and-forth freely. Many mirrors like this are being replaced unnecessarily when a simple inspection and repair will remedy the condition. Before diagnosing as a bad mirror assembly and ordering a replacement, inspect the back side of the mirror glass by carefully pulling outward to see the inside of the mirror. Verify if the rear of the mirror glass is broken or if one of the 3 pins attaching the mirror glass to the mirror assembly are broken.

CX-9 Mirror Shown Others Similar

If the rear of the mirror glass is OK and the 3 pins attaching the mirror glass to the mirror assembly are OK, using a rag, attempt to snap the mirror glass back onto the mirror assembly in the following order:

1. Center Pivot Pin - Firmly press the entire mirror glass inward to snap in the center pivot pin.
2. Lower Pin - Tilt the mirror glass toward the bottom of the mirror assembly. Firmly press the mirror glass inward at the bottom to snap-in the lower pin.
3. Outer Pin - Tilt the mirror glass toward the outside of the mirror assembly. Firmly press the mirror glass inward at the side to snap-in the side pin.

If all 3 pins snap in firmly and mirror no longer moves around freely, verify proper mirror operation. If the mirror glass continues to move around, attempt to snap the mirror glass in once more before proceeding with normal diagnostics.
