2010-2011 MODELS

STEERING LOCK DELETION

On certain vehicles, the steering lock mechanism was deleted.
RI 7423

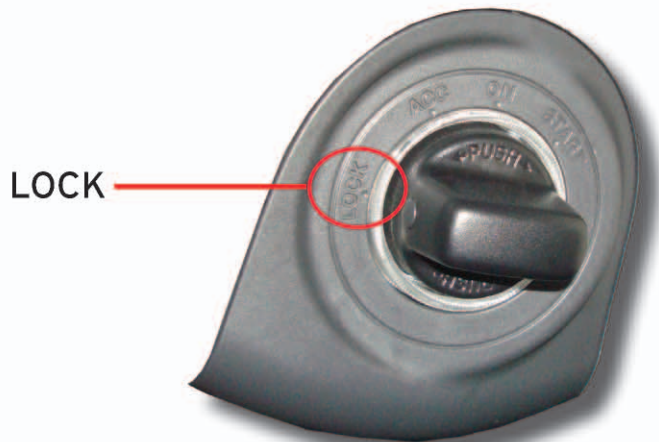
This can be verified by looking at the ignition cylinder ring bezel. For vehicles without the steering lock, the bezel will indicate "OFF" instead of "LOCK". If a vehicle does not have the steering lock mechanism, please proceed with warranty diagnosis and repairs accordingly. Do not attempt repairs, as this condition is normal and is not covered under warranty.

Equipped with Steering Lock

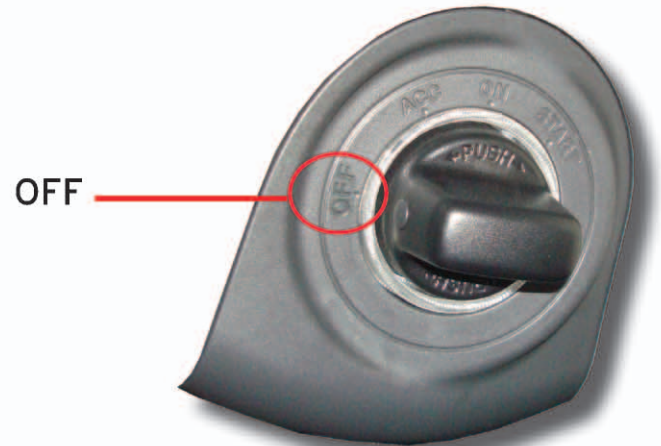
Not equipped with Steering Lock
