2004-2011 RX-8 M/T ***PILOT BEARING GREASE VERIFICATION ON*** ***REMANUFACTURED ENGINES***

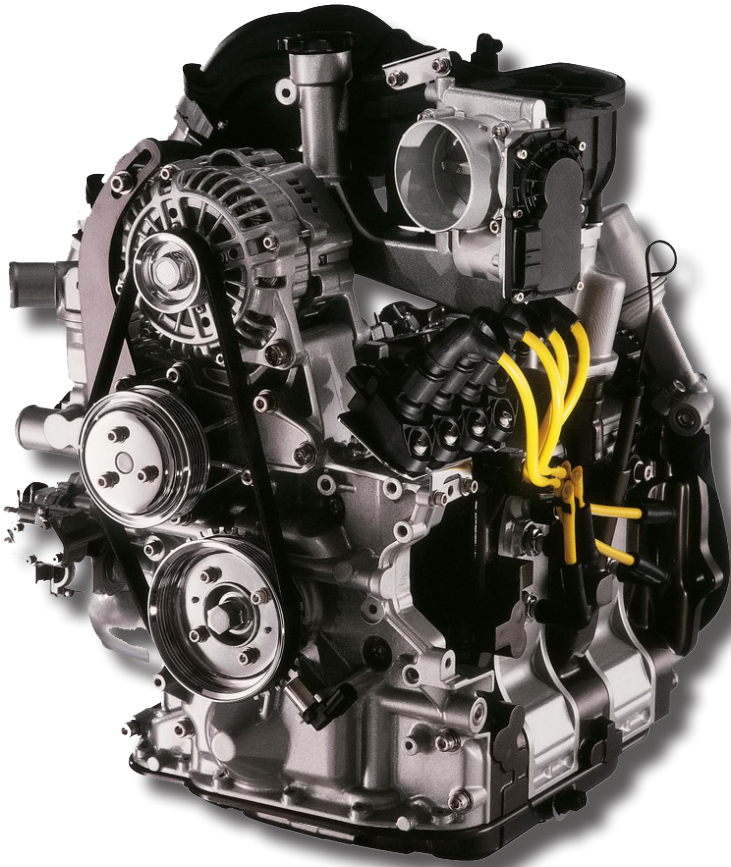
When installing a remanufactured engine in a 2004-2011 RX-8 M/T vehicle, verify grease is applied to the pilot bearing.

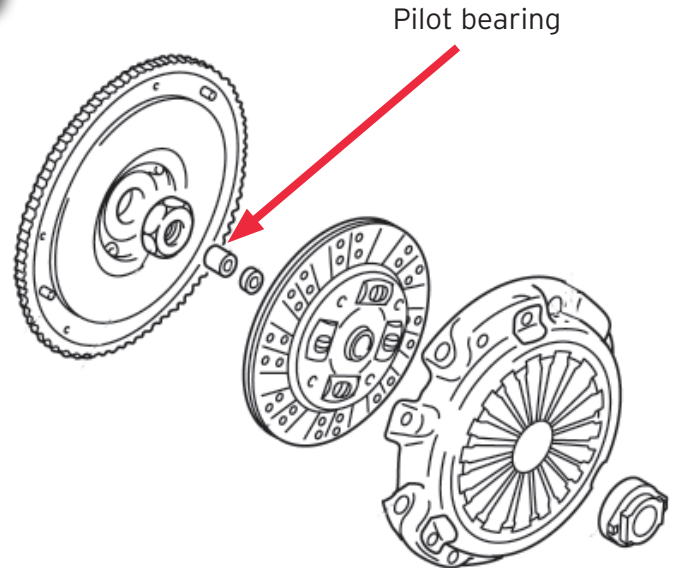
Pilot bearing

Roaring/whining type noise may occur if the pilot bearing is not properly lubricated.
