Service Bulletin

Subject:	Bulletin No:	01-047/04
NEW ENGINE OIL LEVEL GAUGE (DIPSTICK) - SERVICE TIP		
	Last Issued:	12/21/2004

2005 RX-8 - With VINs after JM1FE*****143676

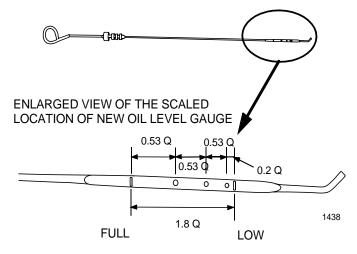
NEW OIL LEVEL GAUGE

- The material has been hardened.
- The diameter of the dipstick has been decreased from 0.12" (3.0 mm) to 0.08" (2.0 mm).
- · Dotted marks have been added to the oil level indicator.
- There is no longer a chamfer on the tip.

This service information is to inform you how to read the dotted marks on the new dipstick. These changes are also outlined in the Owner's Manual (Maintenance and Care section).
