Subject: SEAT SHAKES BACK AND FORTH / MAKES NOISE WHEN BRAKING	Bulletin No: 09-061/09
	Last Issued: 10/23/2009

APPLICABLE MODEL(S) / VINS

- 2004-2010 RX-8
- 2004-2010 MAZDA3
- 2006-2010 MAZDA5
- 2003-2010 MAZDA6
- 2007-2010 CX-7
- 2007-2010 CX-9

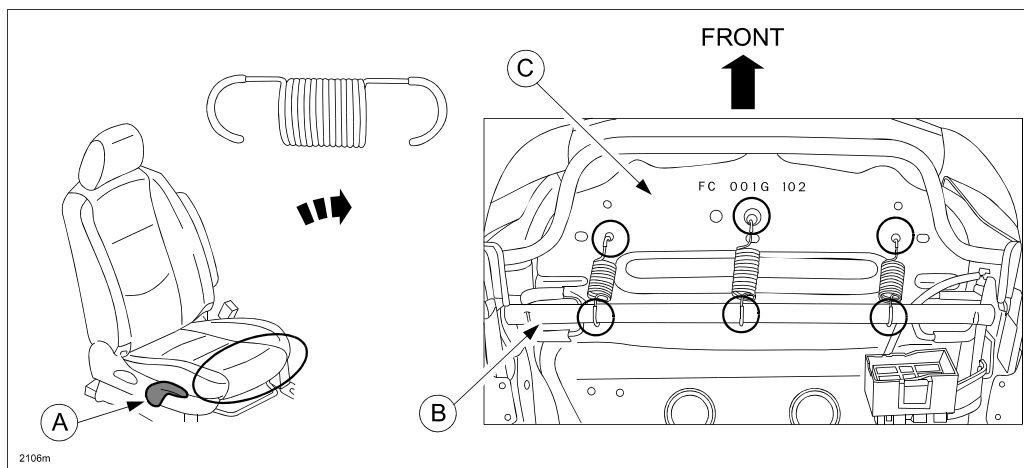
RX-8, Mazda5 & Mazda6 [with pantograph type seat lifter (A)]:

Some vehicles may exhibit a seat that shakes back and forth and is noisy during braking. Customers having these concerns should have their vehicle repaired using the following repair procedure.

NOTE: The shape of the spring varies depending on the seat type.

1. Verify customer complaint.
2. Install three (3) springs to the back of the seat cushion seat pan (C) and pipe frame (B).

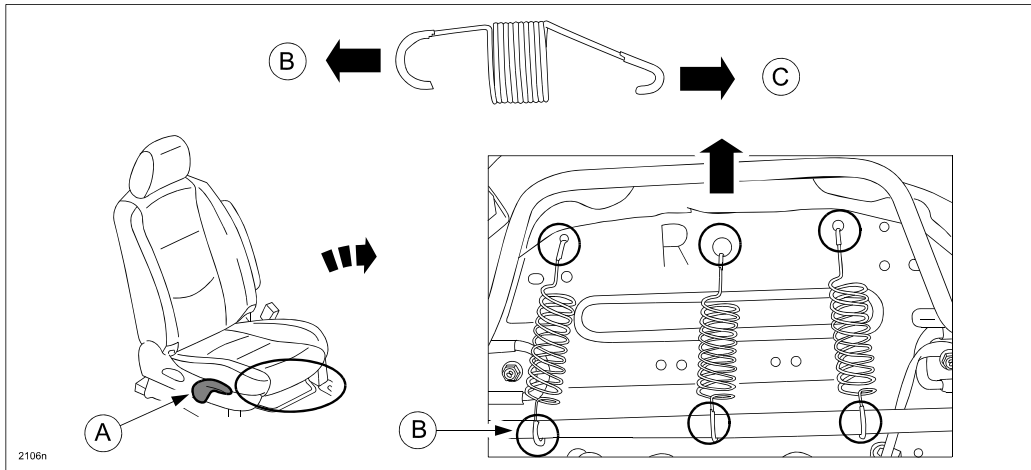
CX-7, CX-9 & Mazda3:

NOTE: The hooks of this type of spring vary depending on which side the hooks fit to.
