Service Information

Category S	Technical	Ref. No. E006/11	Page 1 of 2
Coverage <input type="checkbox"/> Distributor only <input checked="" type="checkbox"/> Please inform your dealers		Date Issued March 11, 2011	
Please convey this information to your <input type="checkbox"/> Director <input checked="" type="checkbox"/> General Manager <input checked="" type="checkbox"/> Warranty Dept. <input checked="" type="checkbox"/> Parts Dept. <input checked="" type="checkbox"/> Training Dept. <input checked="" type="checkbox"/> Field Rep.		Date Revised	
Applicable Model All models		Applicable Countries or Specifications Worldwide

Subject: Sunvisor Protector Removal Procedure

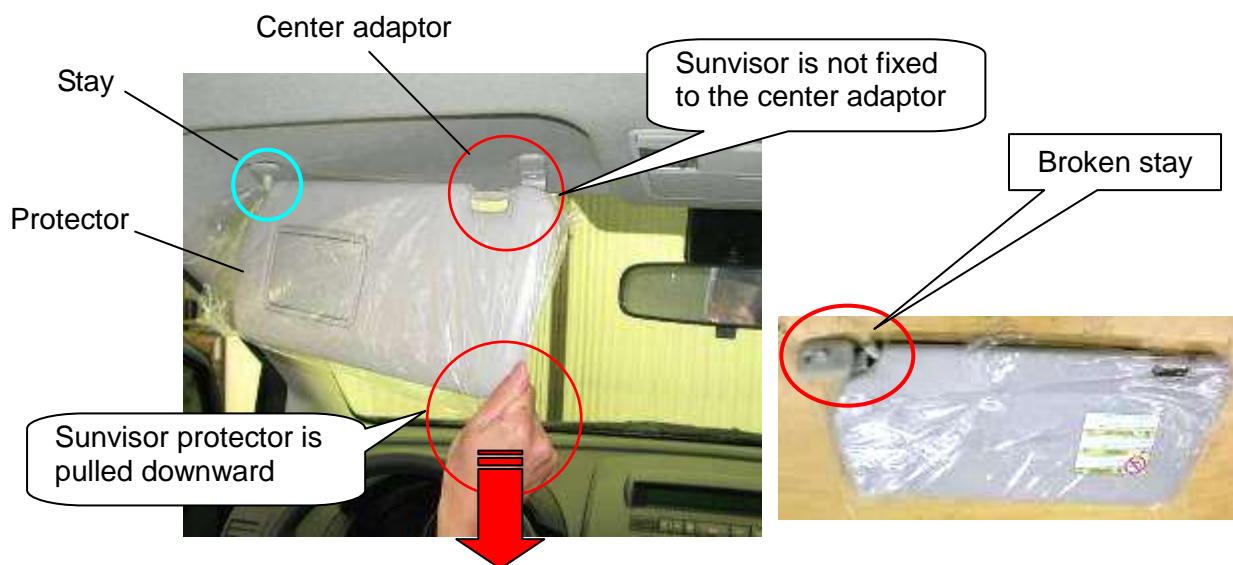
<Incorrect procedure>

If excessive downward force is applied and the sunvisor is detached from the center adaptor, the stay may be broken.
