# Service Information

Category <b>S</b>	<b>Technical</b>	Ref. No. E034/07B	Page 1 of <del>43</del> 49
Coverage <input type="checkbox"/> Distributor only <input checked="" type="checkbox"/> Please inform your dealers		Date Issued	July 30, 2007
Please convey this information to your <input type="checkbox"/> Director <input checked="" type="checkbox"/> General Manager <input checked="" type="checkbox"/> Warranty Dept. <input checked="" type="checkbox"/> Parts Dept. <input checked="" type="checkbox"/> Training Dept. <input checked="" type="checkbox"/> Field Rep.		Date Revised	July 28, 2010
Applicable Models  All model vehicles	Applicable Countries or Specifications  Europe

## Subject: Rust / Perforation Repair Procedure for Rear Fender Arch

This service information provides you with the repair criteria and the repair procedure against the rust / perforation on the rear fender arch, in order to promote the proper repair.

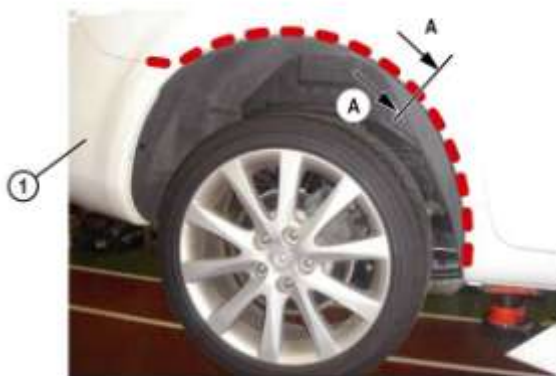
Apply the hardener from the top of the fender arch toward the lower part so that the hardener penetrates into all over the mating panels of arch flange.

Apply hardener and allow it to penetrate into the mating panels.

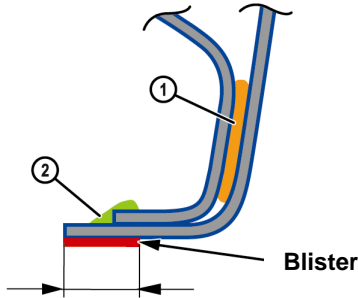
Corrosion Level	Evaluation Criteria for Rear Fender Arch Flange	Action Required	
Level - 0	<p>No damage on the paint sealer.(*) AND No visible blisters/peeling/corrosion on the rear fender arch.</p>	-	
Level - 1	<p>• No damage on the Paint Sealer.(*) AND • Visible blisters less than or equal to 10mm from the inner edge of the fender arch. (Even if corrosion appears in blisters.)</p>	<p>1 Adhesive Sealer 2 Paint Sealer</p>

<p>Less than or equal to 10mm</p>	Repair
Level-2	<p>• Paint Sealer damages.(*) OR • Visible blisters and corrosion in an area more than 10mm from the inner edge of the fender arch.</p>	<p>1 Adhesive Sealer 2 Paint Sealer</p>

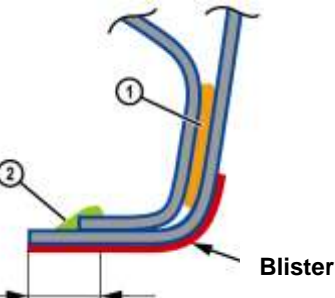
<p>More than 10mm</p>	Repair
Level-3	<p>Perforation in outer panel. OR Perforation in inner panel.</p>	<p>1 Adhesive Sealer 2 Paint Sealer</p>

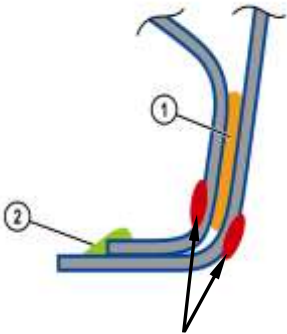
<p>Perforation</p>	Replace

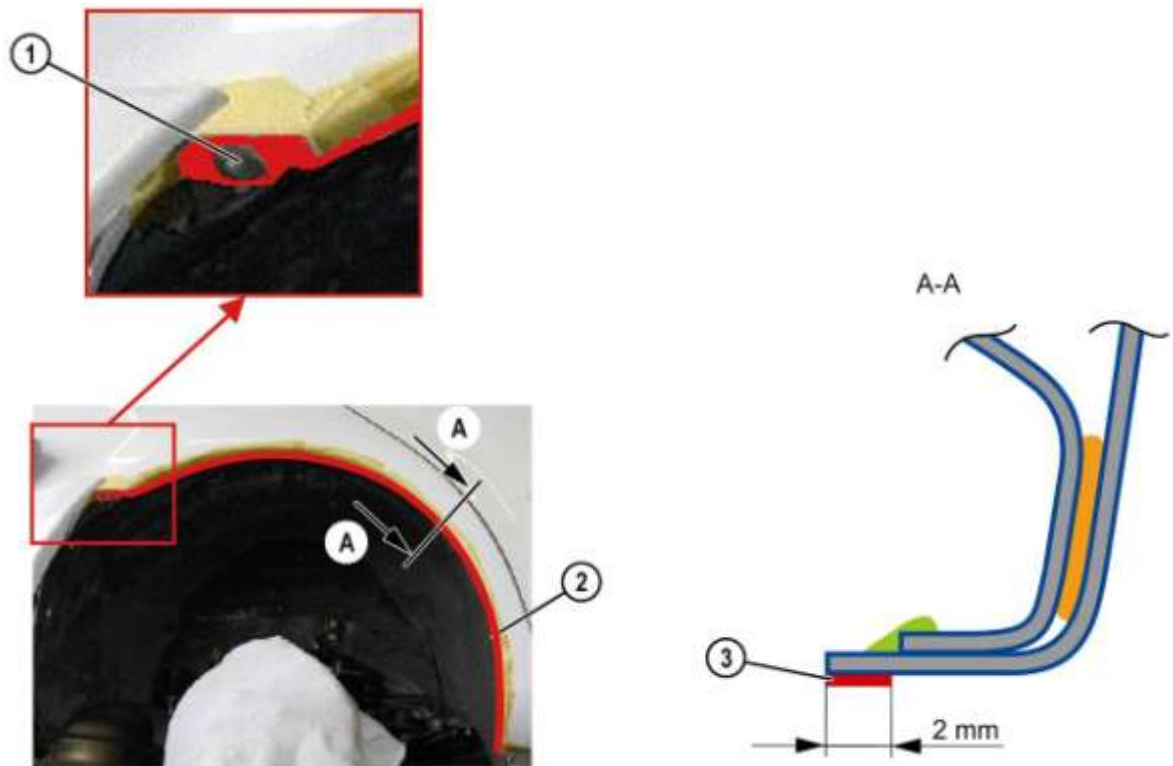
MSP1\_001

- Application of Chipping Primer (VII)
  - Apply chipping primer (VII) all along the fender. (Application width: 2 mm)
  - Apply chipping primer (VII) to the joint area of rear fender and bumper.

- 1 Grommet
- 3 Application area

- 2 Chipping primer (VII)

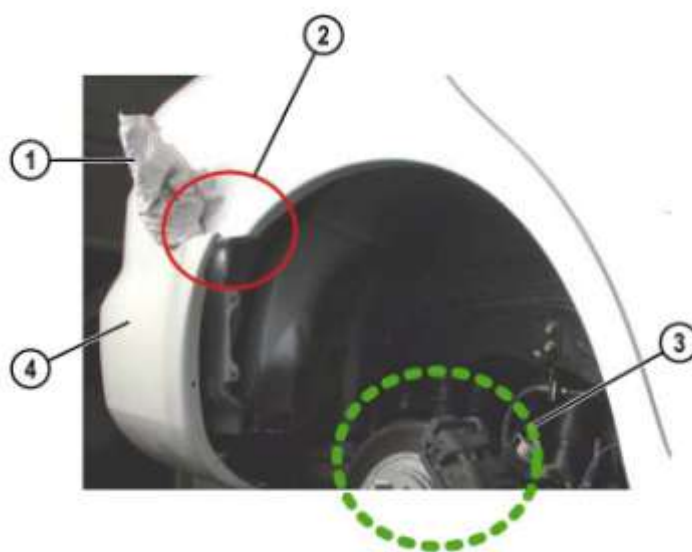
MSP1\_003

**NOTE:** To avoid any contamination of the brake system with chipping primer (VII) or silicone sealant , cover the area 3 shown in the picture below with a suitable protection sheet or foil.

| 1 | Cloth | 3 | Cover |
| 2 | Remove the screws | 4 | Rear bumper |

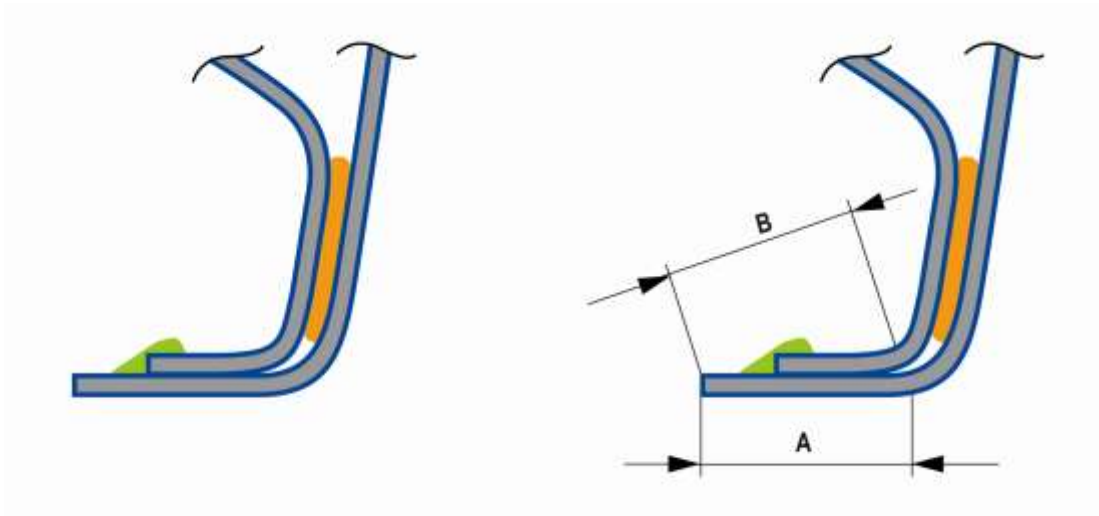
MSP1\_004

4. Clean and degrease the fender arch flange at locations “A” and “B” by using a waste cloth.

**NOTE:** Use suitable brush to clean the area B carefully from dust and sand. Take care not to damage the original paint sealer.

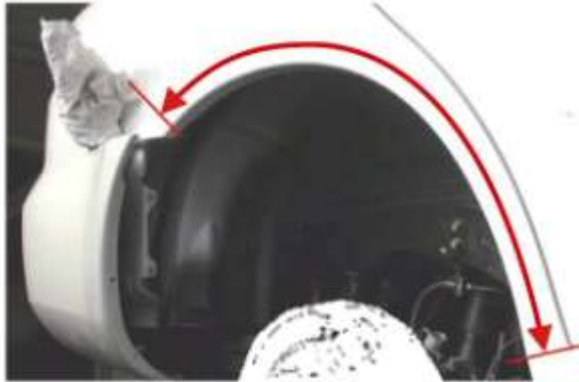
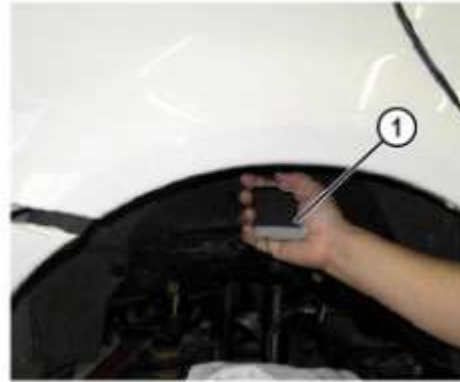
MSP1\_005

5. Make sure there is no break or damage on the sealer. If you will find any damage on the paint sealer, corrosion possibly has already appeared inside of the panel joint and corrosion prevention cannot be effective. In such cases remove the paint sealer and perform repair regarding to the level 2 repair procedure. .

- 1 Mirror

- 1 Break in paint sealer

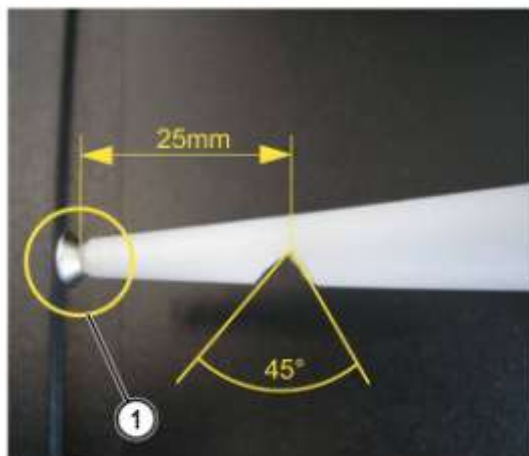
MSP1\_080

10. Prepare nozzle No. 1 for the application of the silicone sealant to the inner edge of the rear fender arch flange as shown on the following picture.

- 1 Close the whole by using a screw

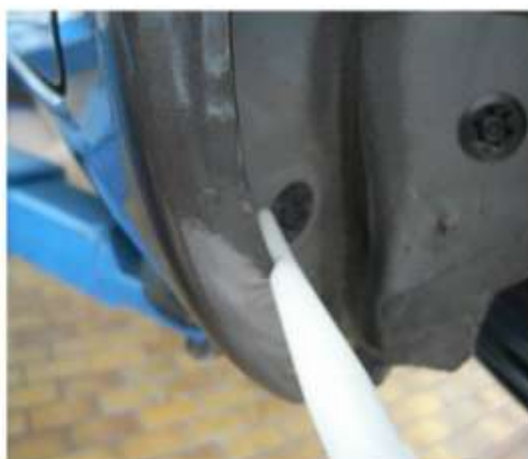
MSP1\_081

11. Position the nozzle to the inner edge of the flange and apply the silicone sealant all along the rear fender arch flange.

**NOTE:** Do not guide the nozzle by pressing the V-shape onto the edge because the chipping primer will get damaged. Guide the nozzle gently along the edge of the flange by ensuring the edge runs in between the V-shape.

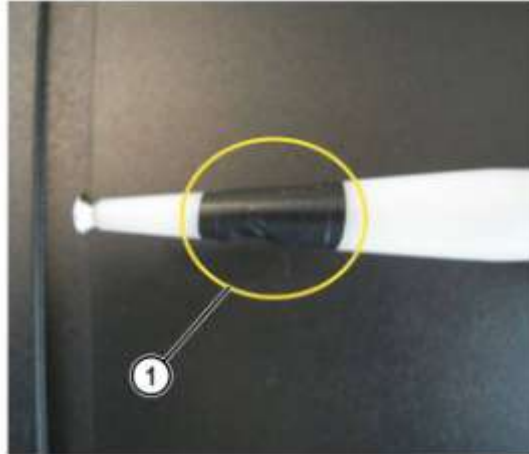
MSP1\_083

12. Close the V-shape of nozzle No. 1 by wrapping around vinyl tape. This will prevent the silicone sealer from drying.

- 1 Vinyl Tape

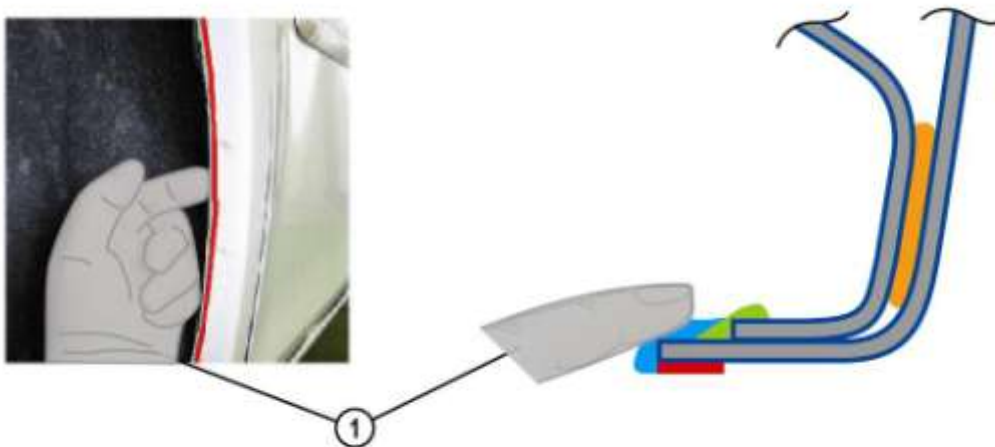
MSP1\_015

13. Arrange the applied silicone sealant onto the back of the flange by using your finger. Please ensure to wear protection gloves when spreading the material in this way.

- 1 Protection Glove

**NOTE:** Spread the material in a gentle way, otherwise you will wipe off the material from inner edge of the flange. Check the result by using a mirror.

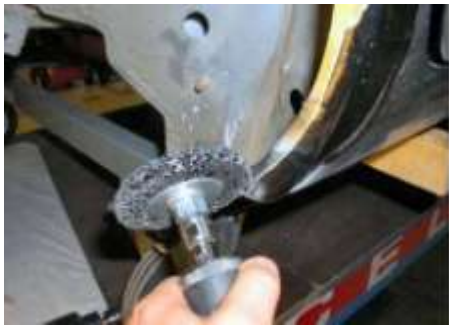
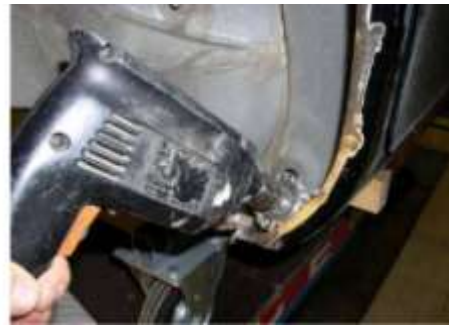
BL-1010\_02024

22. Detach the tires, the mud guards and any other vehicle parts necessary to obtain clear access. Protect the other surrounding vehicle parts with suitable material such as masking paper or other protective materials which are usually employed in the body workshop.
23. Use an air tool with a wire brush or equivalent, to completely remove the paint sealer from the rear and inner area of the wheel arch.

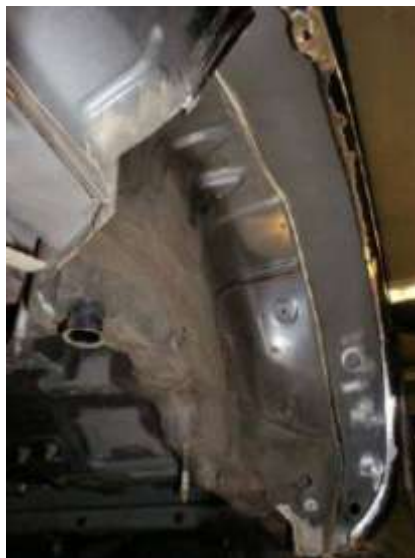
BL-1010\_02025

24. Use a wire brush or equivalent tool, to clean the inside and outside of the rear fender arch from old paint and underbody protection material. Clean the entire surface from existing corrosion patterns.

**NOTE:** Remove the sealer from all the visible corroded areas.  
If necessary, also remove it from the rear side of the fender arch.

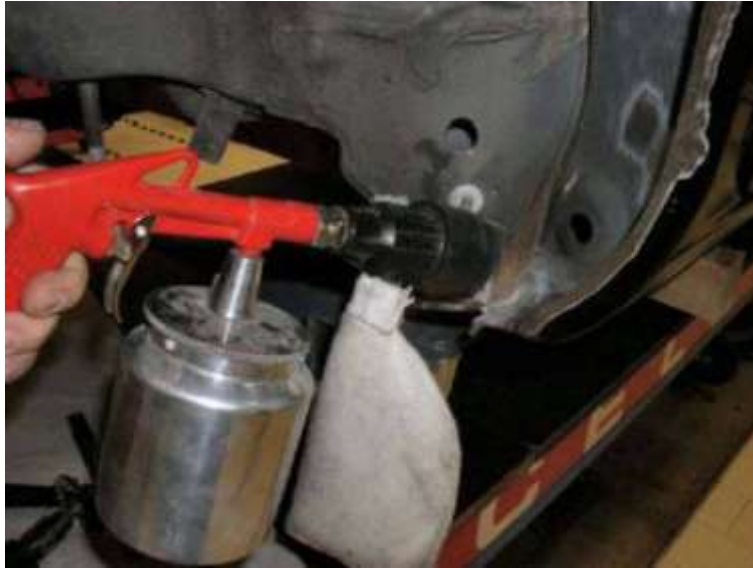
BL-1010\_02026

25. All areas which cannot be treated by the method described above must be sand blasted. This ensures that all traces of corrosion plus dirt and sealer or paint residues are removed completely.

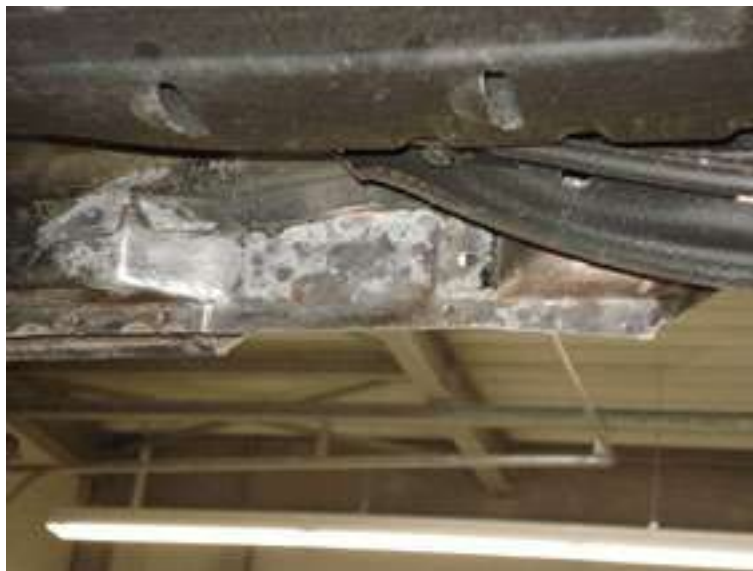
BL-1010\_02104

**NOTE:** If you will discover black or grey spots on the bare sheet metal as shown on the picture below, remove them by grinding them off to the blank metal. Such spots are caused by a damaged phosphate coating and need to be removed accurate. Otherwise the corrosion protection measures are not sufficient.

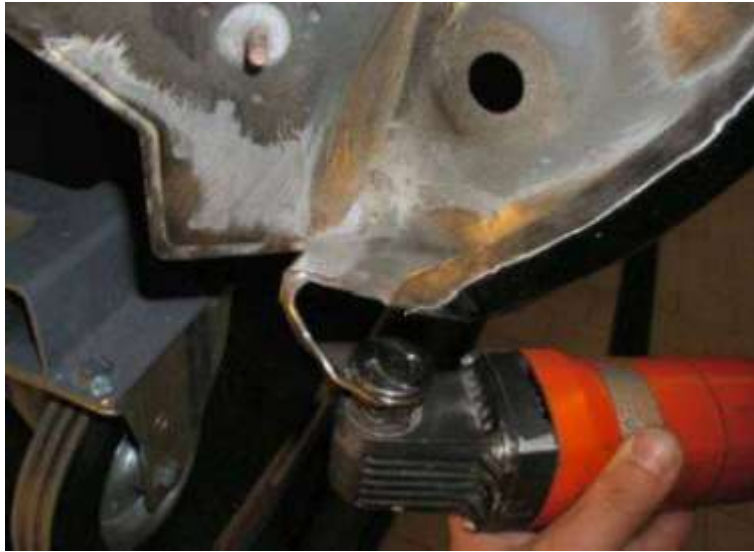
BL-1010\_02027

26. Remove any loose rust from the spaces between the panels using an oscillating tool.

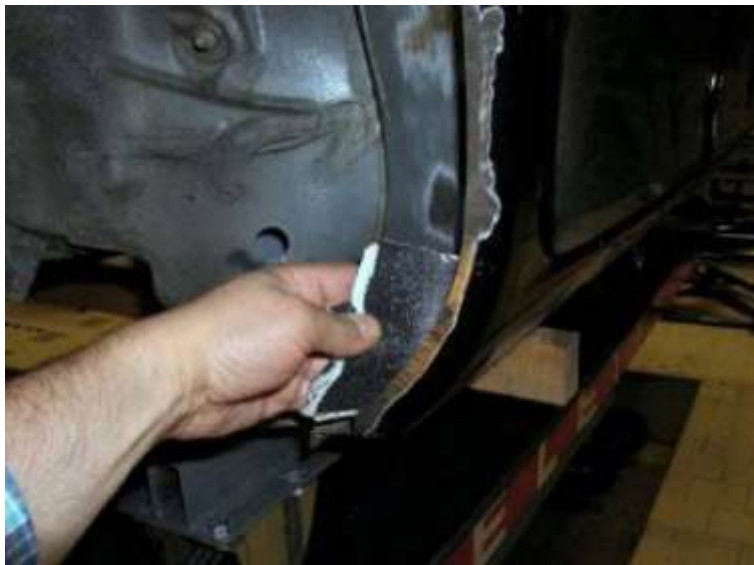
BL-1010\_02028

27. Carefully deburr the cut edges of all the panels (rear quarter panel, wheelhouse on the inside) using abrasive paper. This will improve the adhesion when paint sealer (IV) and varnish are applied to the edges of the panels later.

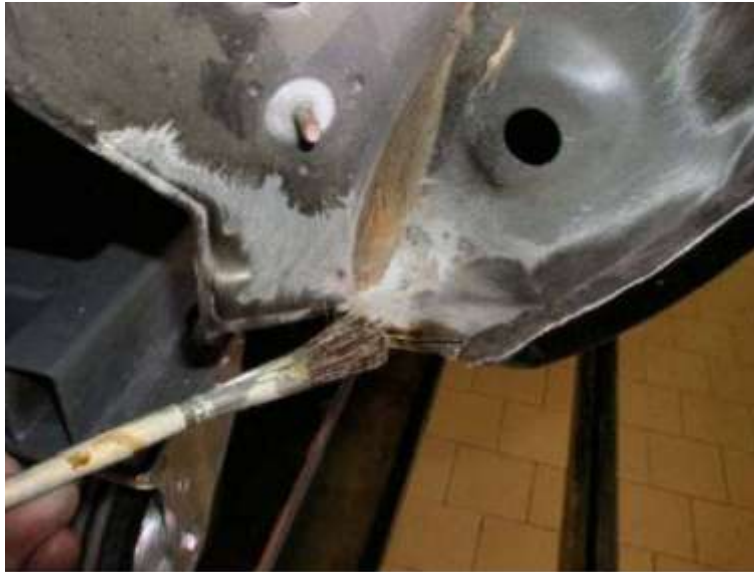
BL-1010\_02029

28. Apply pure hardener (XII) to the joined surface all along the rear fender panel. Allow the material to penetrate in between the panels.

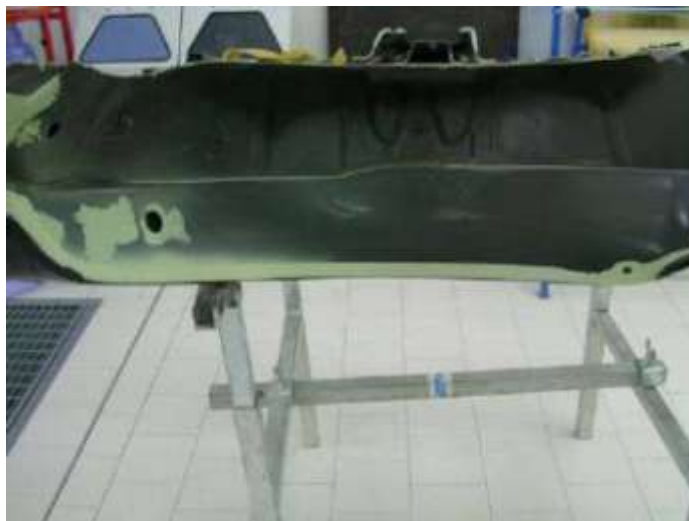
BL-1010\_02030

29. Wipe off surplus hardener (XI) by using a suitable cleaning agent (VIII).
30. Clean and degrease those surfaces where the corrosion has been removed.
31. Apply corrosion protection primer (I) over the entire repair area and make sure that all the bare surfaces are treated.

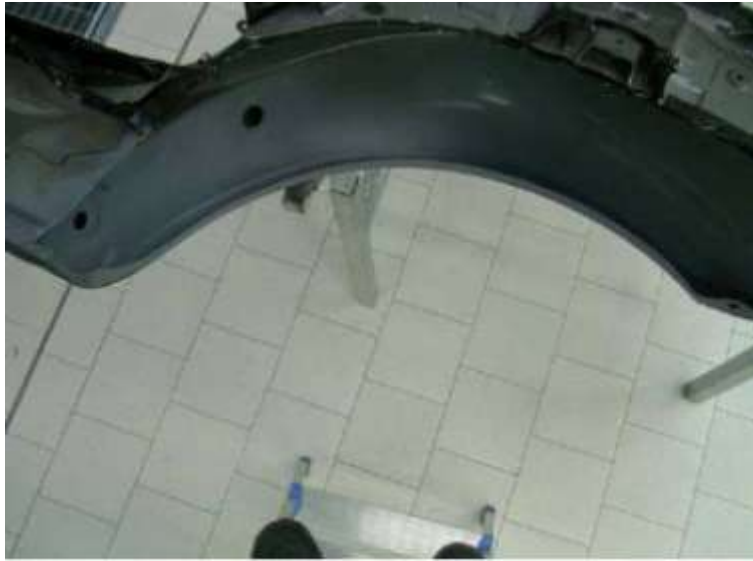
BL-1010\_02031

32. Apply primer surfacer (III) over the repair area and let it dry. Lightly sand the surface with (500 grit) abrasive paper and then clean it to remove any surface irregularities.

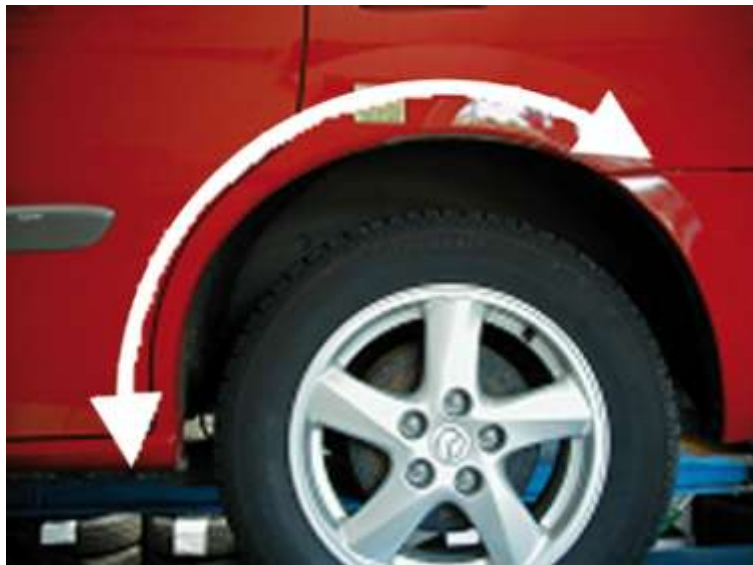
BL-1010\_02067

33. Apply paint sealer (IV) over the entire inner edge of the fender arch (from the rocker panel to the mounting point of the bumper).

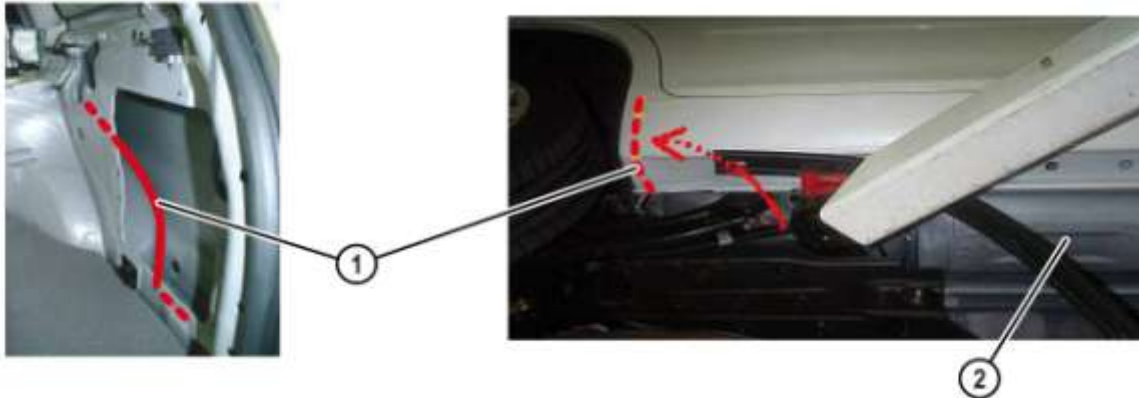
BL-1010\_02037

- Remove the trim.
- Treat the area between the inner wheelhouse and the rear quarter panel with anti-corrosion wax (V) from the inside. Guide a hose into the area between inner and outer panel.

1 Apply Anti-corrosion wax (V)

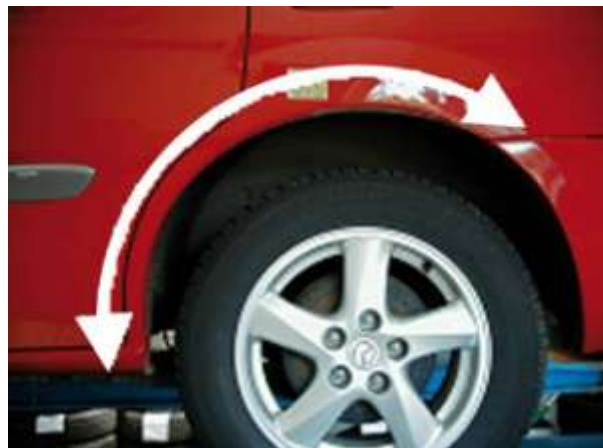
BL-1010\_02067

- Guide a hose into the opening in the rocker panel for cavity sealing and apply anti-corrosion wax (V) to the junction between the inner and outer panels.
- Allow the anti-corrosion wax (V) to penetrate to the areas between inner and outer panel from the inside over the entire length of the wheel arch.

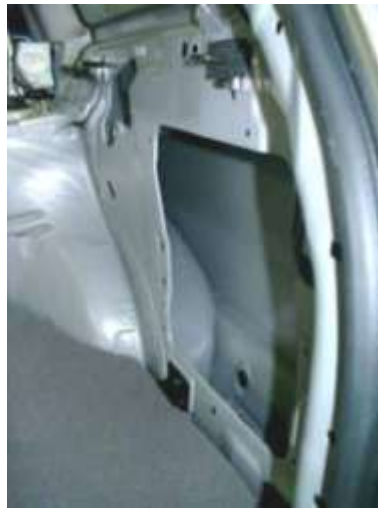
BL-1010\_02075

41. Detach the rear bumper, rear tire and mud guard on the side to be repaired.
42. Detach all the attached parts and trim, e.g. rear scuff plate, wheelhouse trim, inner side luggage compartment trim, upper side luggage compartment trim, lower side luggage compartment trim, etc. on the side to be repaired.

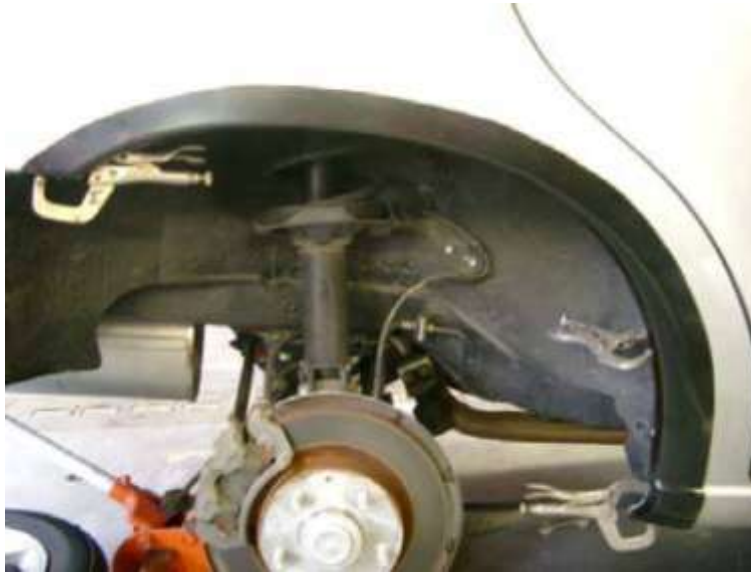
BL-1010\_02085

44. Fit outer repair panel onto remaining outer panel and secure in place.

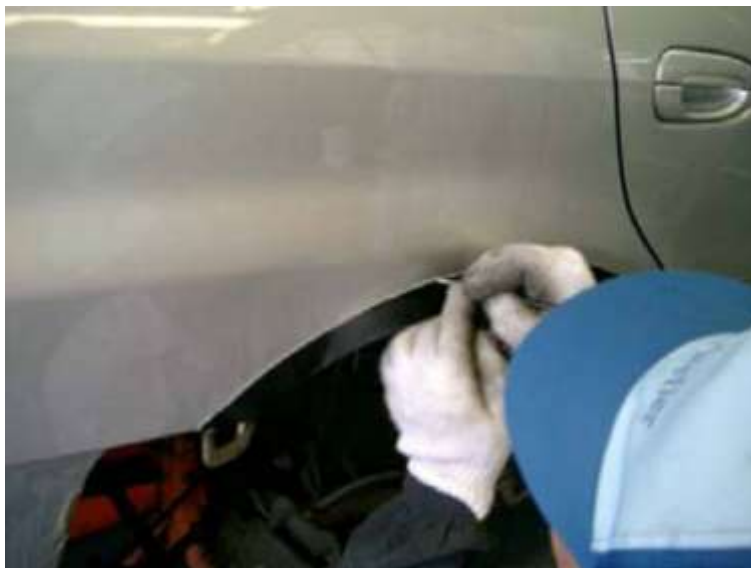
BL-1010\_02077

45. Mark cut line on remaining outer panel along repair panel.

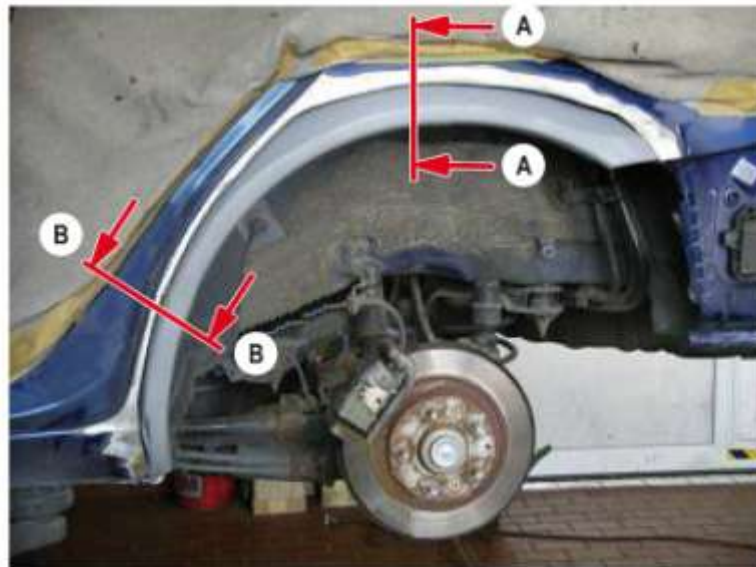
BL-1010\_02079

**NOTE:** The cut line varies from model to model. Therefore please make the cut as specified for the particular model. As an example, the cut line on the rear quarter panel of the Mazda 626 (GF/GW) is shown in the following diagram.

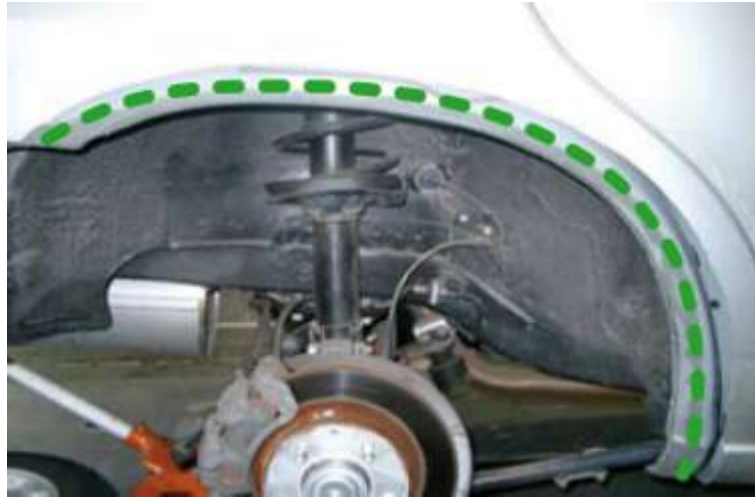
BL-1010\_02087

51. Remove all rust and sealer between the inner and outer panels using a wire brush or a knife so that the Hardener will spread better later.
52. Then clean the area. Work along the dotted line with a wire brush.

**NOTE:** If corrosion and/or sealer cannot be removed with a wire brush or knife, use sand blasting equipment.

**NOTE:** If you will discover black or grey spots on the bare sheet metal, remove them by grinding them off to the blank metal. Such spots are caused by a damaged phosphate coating and need to be removed accurate. Otherwise the corrosion protection measures are not sufficient.

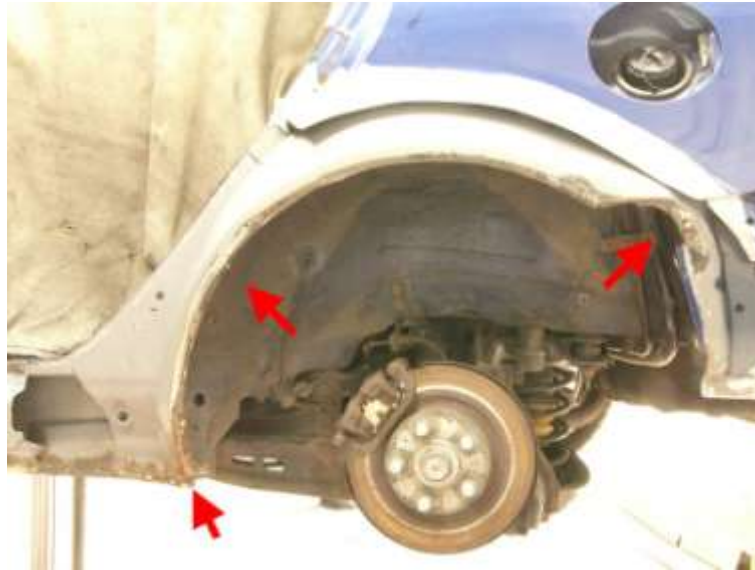
BL-1010\_02200

53. If you discover perforation or severe corrosion on the inner panel which cannot be removed completely, a sectional replacement of the inner panel might be necessary. Otherwise continue with step 27

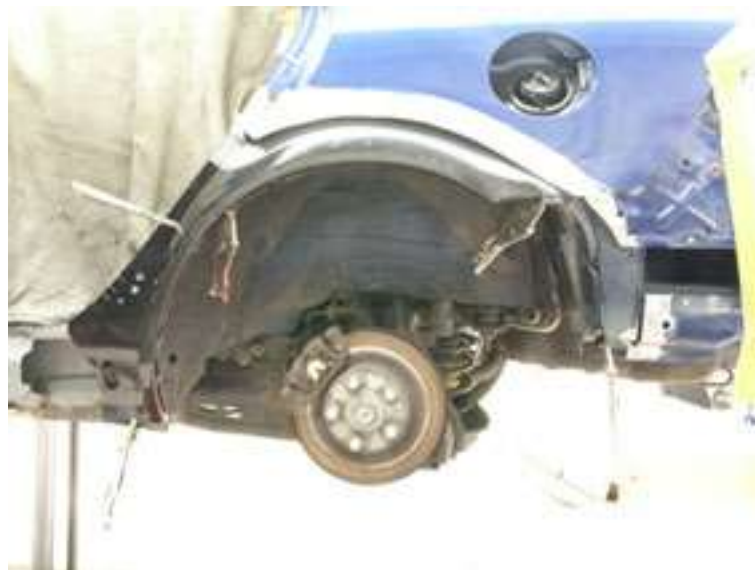
BL-1010\_02172

54. Cut inner repair panel out of inner panel service part to a size that covers all the affected areas.  
55. Fit the inner repair panel on top of the existing inner panel and secure it in place.

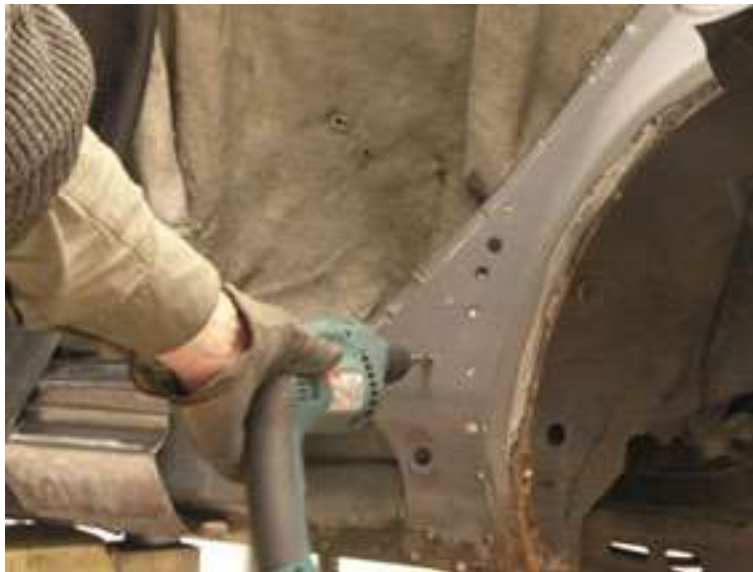
BL-1010\_02174

57. Drill out the spot welds from the inner panel which are necessary to remove the section to be replaced.

**NOTE:** Wherever possible it is recommended to use spot welding technique to fix the repair panels instead of MIG/MAG welding.

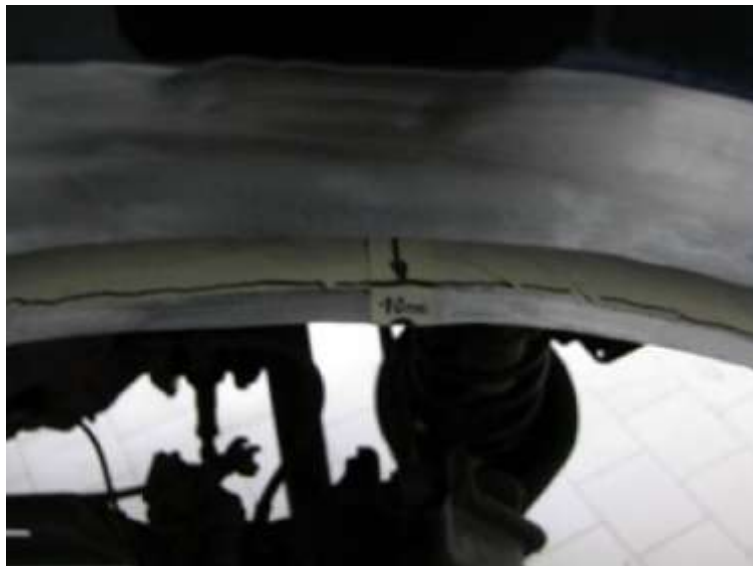
BL-1010\_02175

58. Cut out the section, but leave 10mm for overlapping in the spot welding areas.

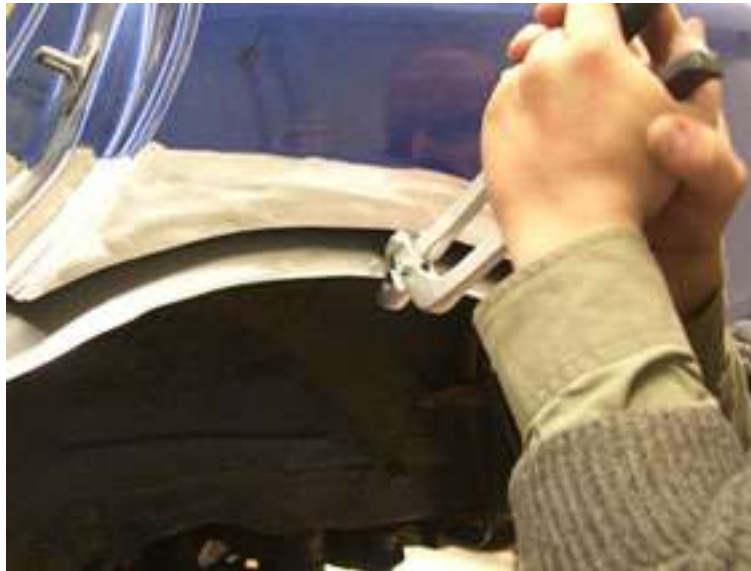
BL-1010\_02176

60. Prepare an joggled edge for the overlapping joint seam.

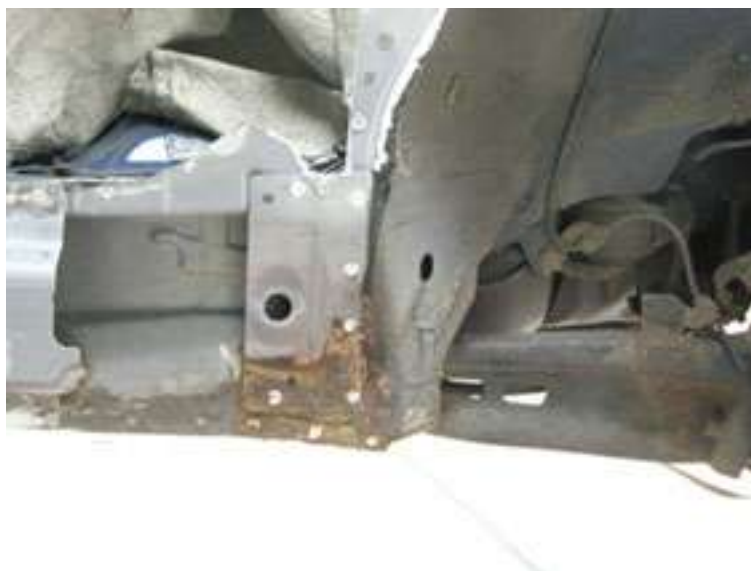
BL-1010\_02178

61. If you discover severe corrosion or perforation on the node plate renew also the node plate.

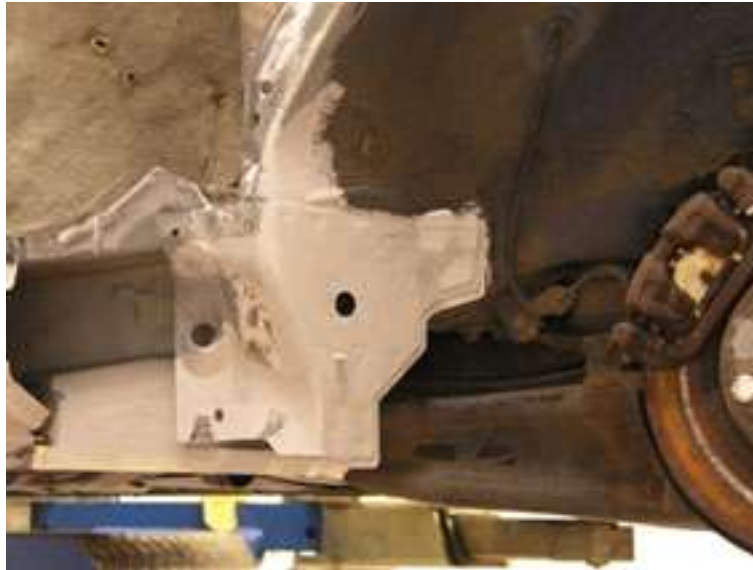
BL-1010\_02179

62. Remove residues of paint, underbody protection, sealer and surface corrosion by grinding and apply corrosion protection primer (I) to the node plate

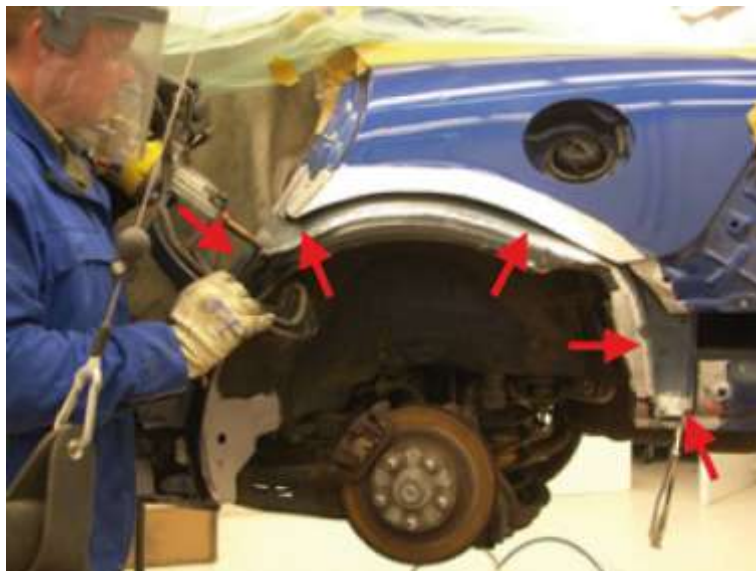
BL-1010\_02186

64. Fit inner repair panel and secure in place.  
65. Spot weld the inner repair panel. MIG/MAG weld all other locations.

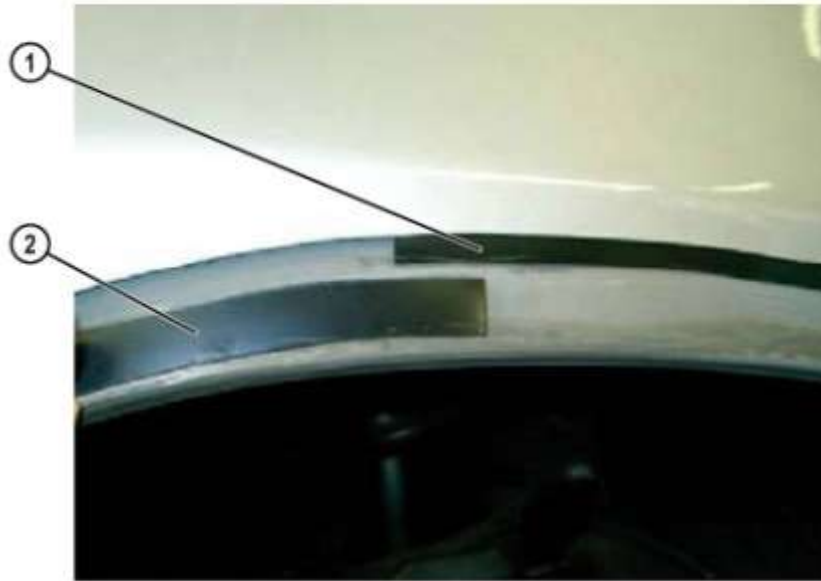
BL-1010\_02082

66. Clean weld seams on inner repair panel using cleaning agent (VIII).
67. Apply corrosion protection primer (I) to all bare metal surfaces that are not used to weld the outer repair panel.
68. Cut out the flange and bumper areas of the weld backing strip.
69. Cut the weld backing strip into two parts (weld backing strip A and weld backing strip B in the picture).
70. Remove all paint from the backing strips A and B
71. Secure weld backing strip A using a screw clamp.

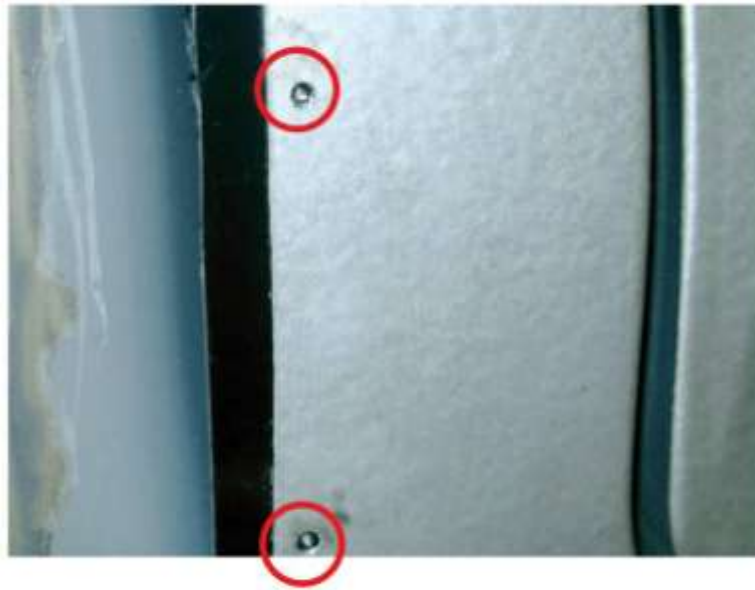
BL-1010\_02083

72. Drill holes (diameter: 3 mm) for welding with a spacing of 10 cm.

- 73. Remove the burrs from the holes drilled for welding.
- 74. Weld backing strip A in place, ensuring that it is not distorted.
- 75. Attach weld backing plate B as described in steps 31) to 34).

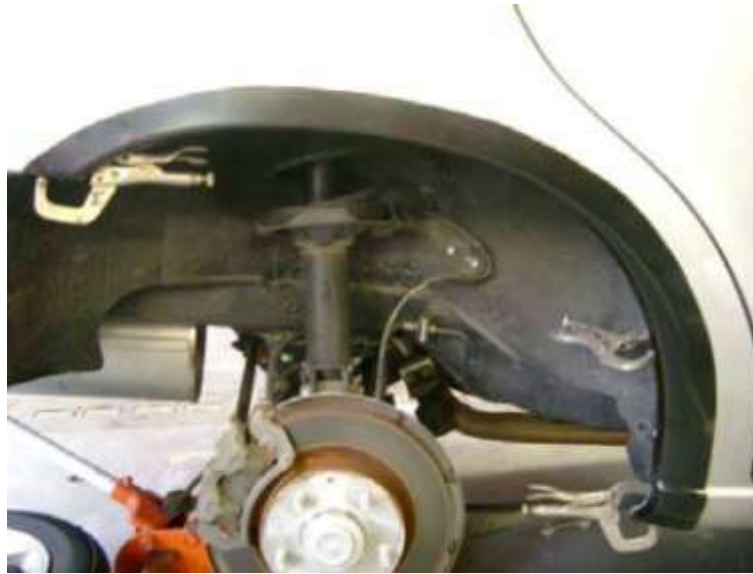
BL-1010\_02085

76. Attach the outer repair panel to the vehicle again.

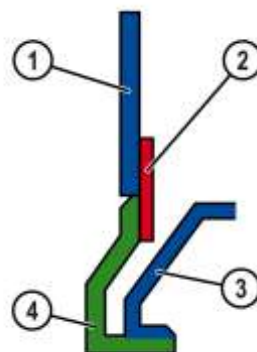
BL-1010\_02106

77. Secure the outer repair panel in the correct position with screw clamps.

- 3 Inner panel
- 4 Outer repair panel

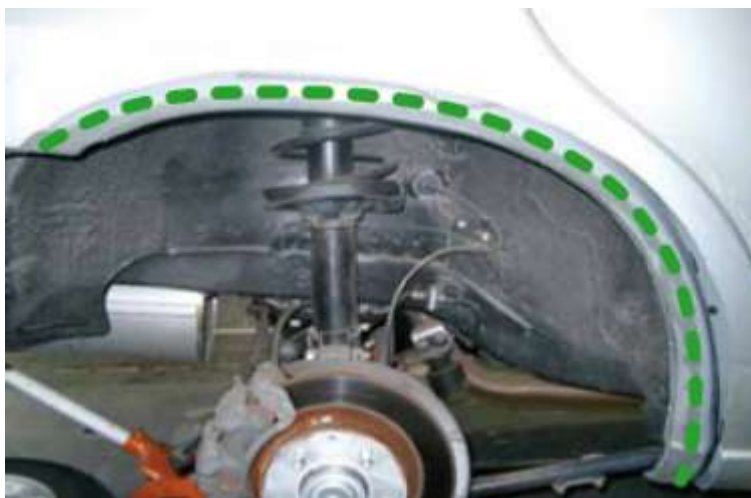
BL-1010\_02087

78. Degrease the welding area.

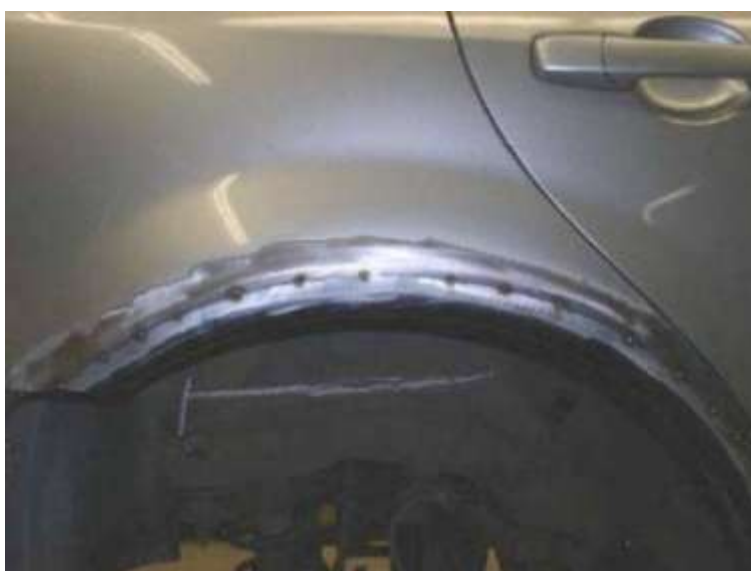
BL-1010\_02088

79. Tack weld the repair panel in the correct position. Remove the burrs from the tacking welds.

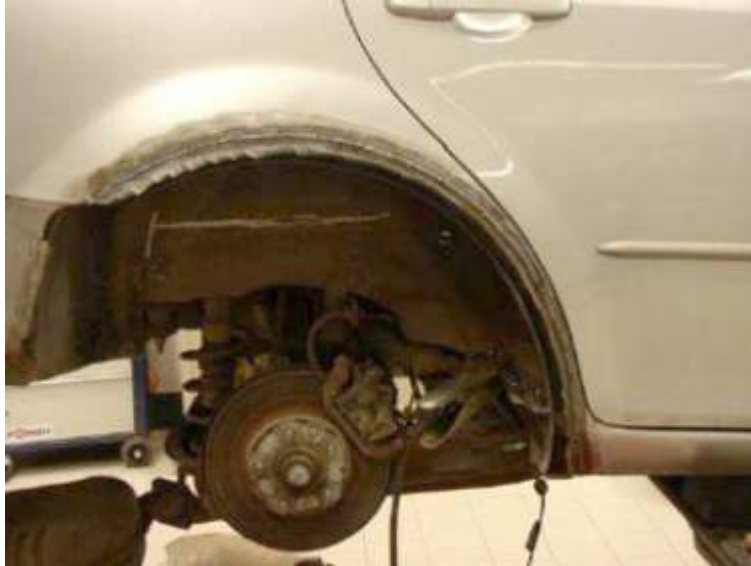
BL-1010\_02089

80. Weld the repair panel to the rear quarter panel with a stepped MIG/MAG weld seam.

**NOTE:** Make sure that the part is not distorted. If necessary, weld in a number of steps.

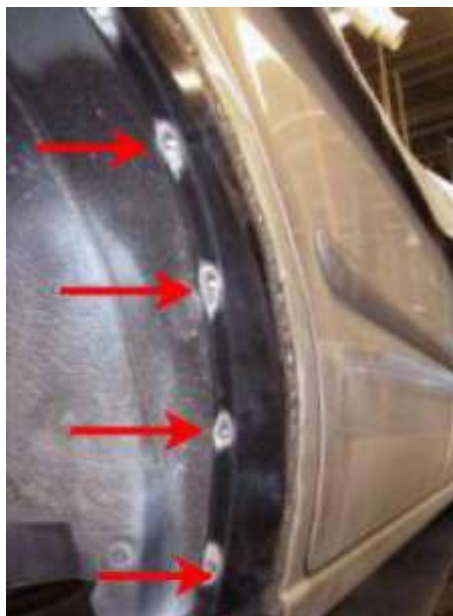
BL-1010\_02090

81. Spot weld the flange on the repair panel to the wheelhouse.

**NOTE:** Calculate the required spacing between the individual spot welds for a total of 10 spot welds on the entire flange.

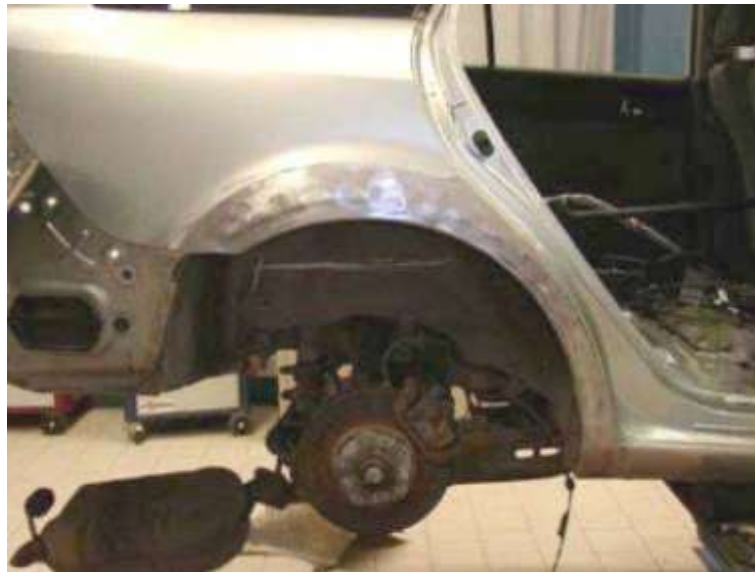
BL-1010\_02091

82. Restore the external contours in the repair area and if necessary remove the high points produced by the welding. Also dress the spot welds on the fender arch flange and when necessary remove burrs from the spot welds.

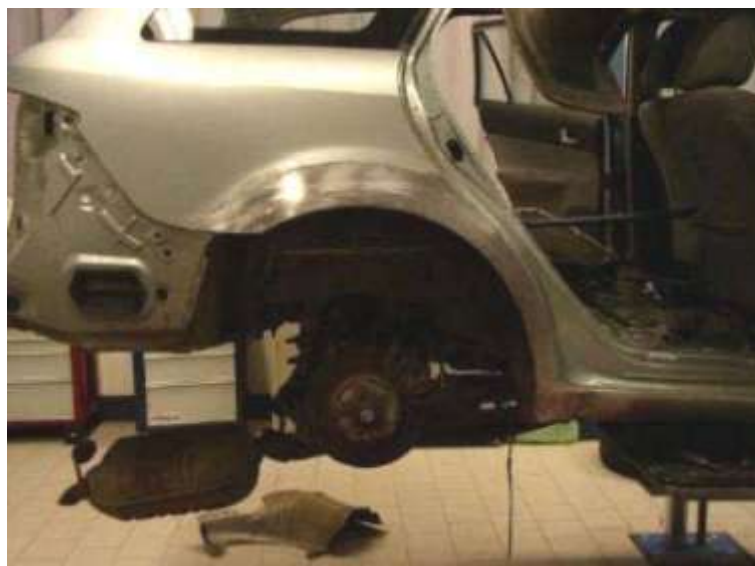
BL-1010\_02092

83. Tin the outer surface as shown in the following picture to prepare the repair area for the subsequent application of paint.

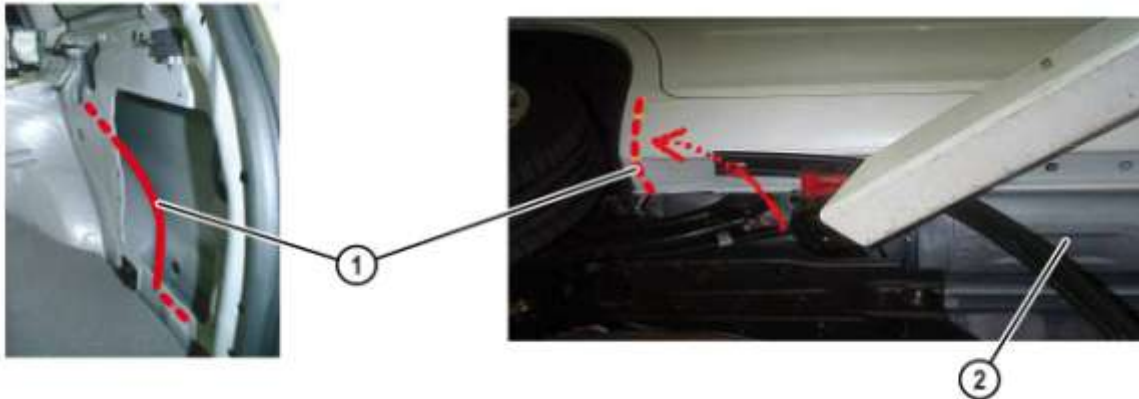
BL-1010\_02037

84. Arrange the top coat as per description of Level 2 Repair Procedure for Rear Fender Wheel Arch.
85. Apply anti-corrosion wax (V) from the inside:
- Remove the trim.
  - Treat the area between the inner wheelhouse and the rear quarter panel with anti-corrosion wax (V) from the inside. Guide a hose into the area between inner and outer panel.

1 Apply Anti-corrosion wax (V)

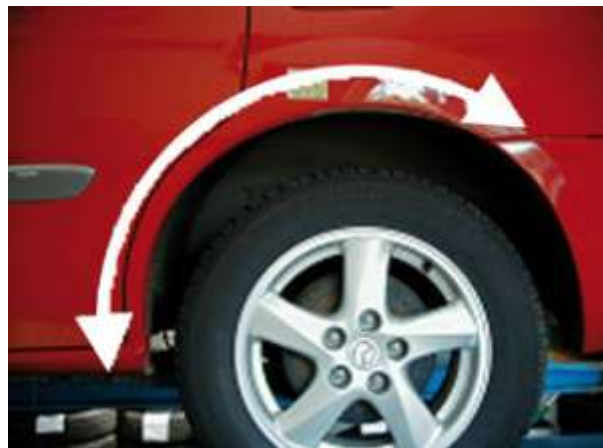
BL-1010\_02067

- Guide a hose into the opening in the rocker panel for cavity sealing and apply anti-corrosion wax (V) to the junction between the inner and outer panels.
- Allow the anti-corrosion wax (V) to penetrate to the areas between inner and outer panel from the inside over the entire length of the wheel arch.

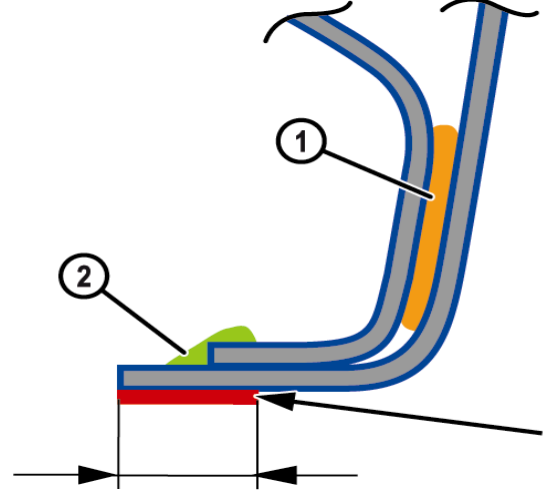
<p>① Adhesive Sealer, ② Paint Sealer</p>	<p><b>No damage at Paint Sealer ② along the inner wheel arch flange. (*Mazda 3 (BK), Mazda 6 (GG/GY) RX-8 (SE) only).</b></p> <p><b>AND / OR</b></p> <p><b>Visible blister in an area less than or equal to 10mm from the inner edge of the wheel arch flange, even if blisters already burst open or red rust is already visible.</b></p>
--	--

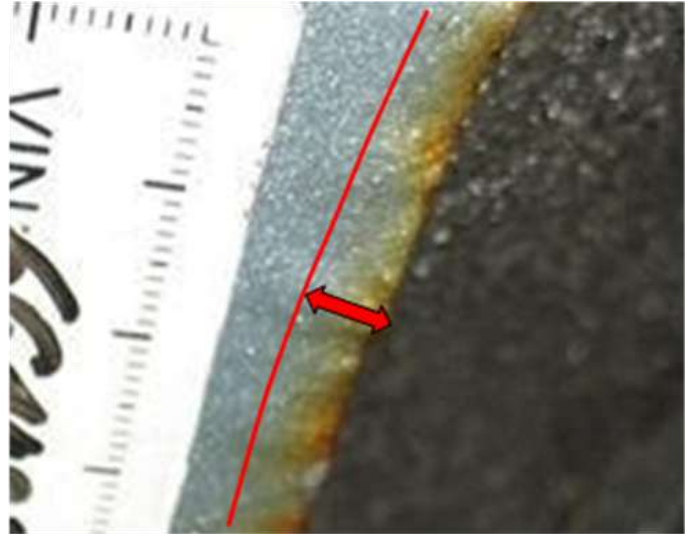
Photo #4

Gentle red rust appears starting from inner edge of flange, but spread is less than or equal to 10mm from the inner edge of wheel arch.

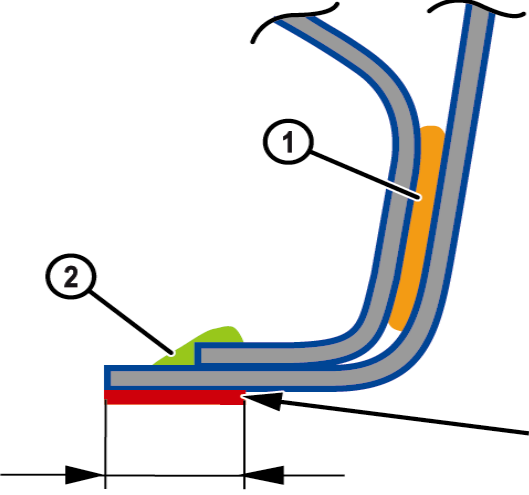
<p>① Adhesive Sealer, ② Paint Sealer</p>	<p><b>Paint Sealer ② broken or damaged.</b> <b>(*Mazda 3 (BK), Mazda 6 (GG/GY) RX-8 (SE) only).</b></p> <p><b>AND / OR</b></p> <p><b>Visible blister and/or red rust in an area more than 10mm from the inner edge of the wheel arch flange.</b></p> <p><b>(Please refer to below sample pictures)</b></p>
--	--
