# Service Information

Category <b>S</b>	<b>Technical</b>	Ref. No. E034/07B	Page 1 of <del>43</del> 49
Coverage <input type="checkbox"/> Distributor only <input checked="" type="checkbox"/> Please inform your dealers		Date Issued	July 30, 2007
Please convey this information to your <input type="checkbox"/> Director <input checked="" type="checkbox"/> General Manager <input checked="" type="checkbox"/> Warranty Dept. <input checked="" type="checkbox"/> Parts Dept. <input checked="" type="checkbox"/> Training Dept. <input checked="" type="checkbox"/> Field Rep.		Date Revised	July 28, 2010
Applicable Models  All model vehicles	Applicable Countries or Specifications  Europe

## Subject: Rust / Perforation Repair Procedure for Rear Fender Arch

This service information provides you with the repair criteria and the repair procedure against the rust / perforation on the rear fender arch, in order to promote the proper repair.

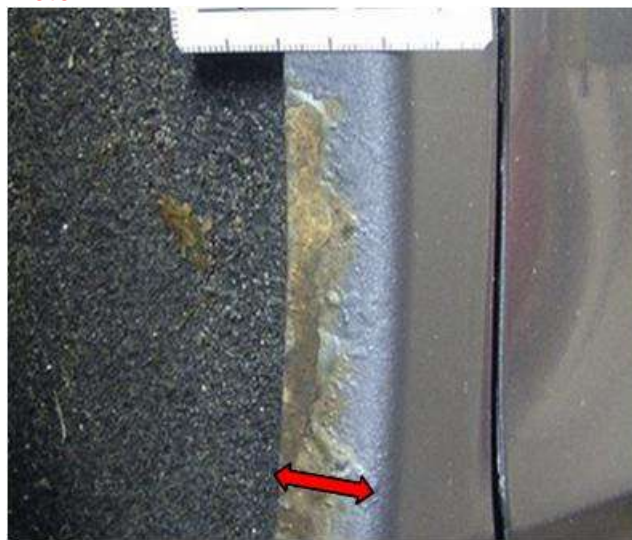
**Photo #2**

Visible blisters and red rust in an area more than 10mm from the inner edge of the wheel arch.

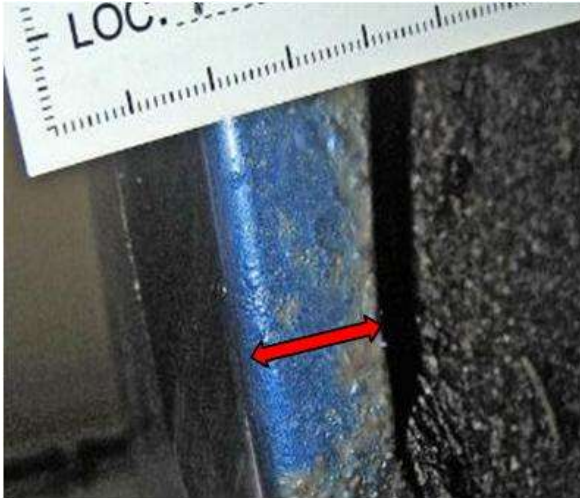
**Photo #3**

Visible blisters and red rust in an area more than 10mm from the inner edge of the wheel arch.

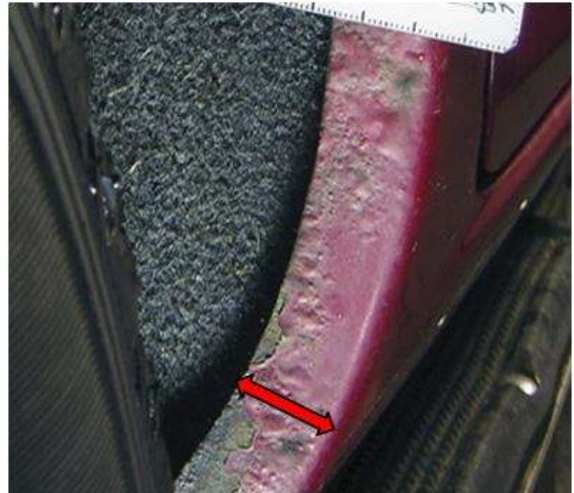
Visible blisters and red rust in an area more than 10mm from the inner edge of the wheel arch.

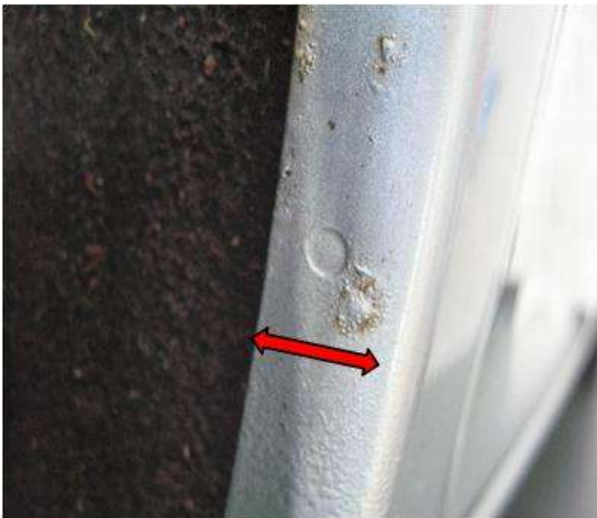
Single blister caused by chipping in an area more than 10mm from the inner edge of the wheel arch arch.

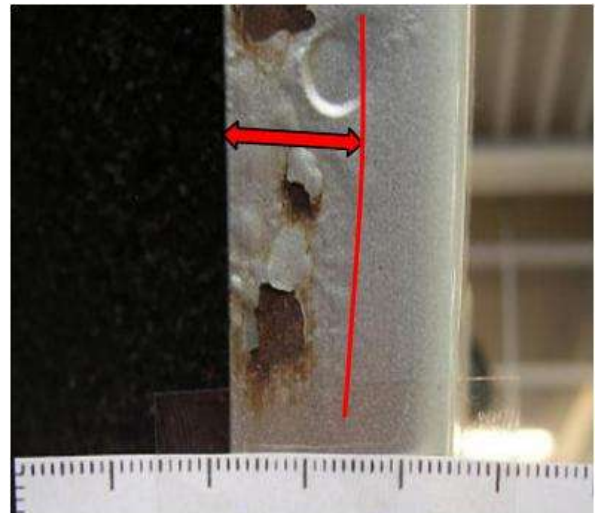
Paint peeling and red rust in an area more than 10mm from the inner edge of the wheel arch.

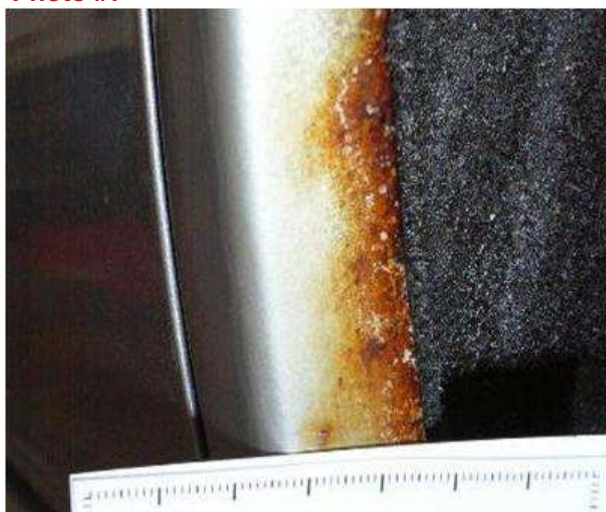
Red rust in an area more than 10mm from the inner edge of the wheel arch.

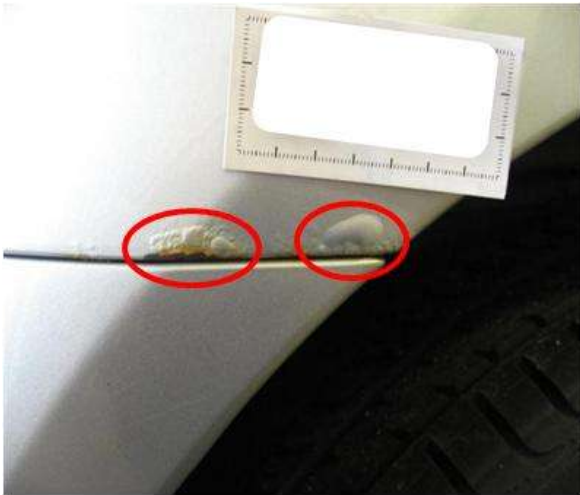
Visible blisters and red rust at vertical surfaces of wheel arch or rear bumper attachment area will not lead to level-3 as long as no proof for perforation can be detected.

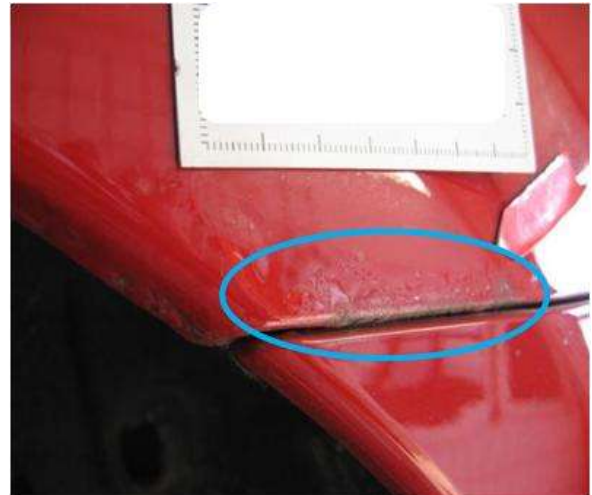
Visible blisters and red rust at vertical surfaces of wheel arch or rear bumper attachment area will not lead to level-3 as long as no proof for perforation can be detected.

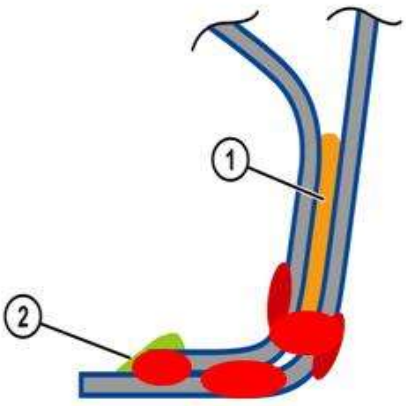
<p>① Adhesive Sealer, ② Paint Sealer</p>	<p><b>Perforation on outer rear fender panel.</b></p> <p><b>AND/OR</b></p> <p><b>Perforation on inner rear fender panel.</b></p> <p><b>AND/OR</b></p> <p><b>Severe corrosion in-between inner and outer panel which leads to a natural expansion of the metal sheets at the flange are.</b></p> <p><b>(Please refer to below sample photos)</b></p>
--	---

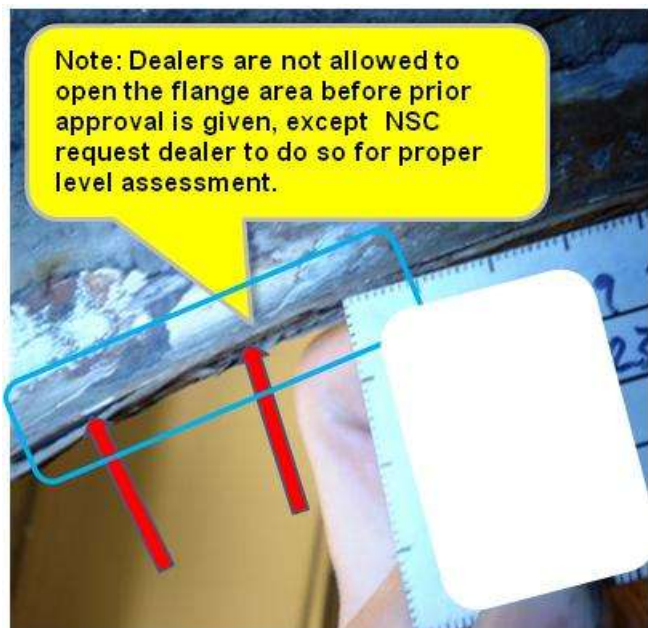
Severe corrosion between metal sheets which leads to a natural expansion of the flange area.

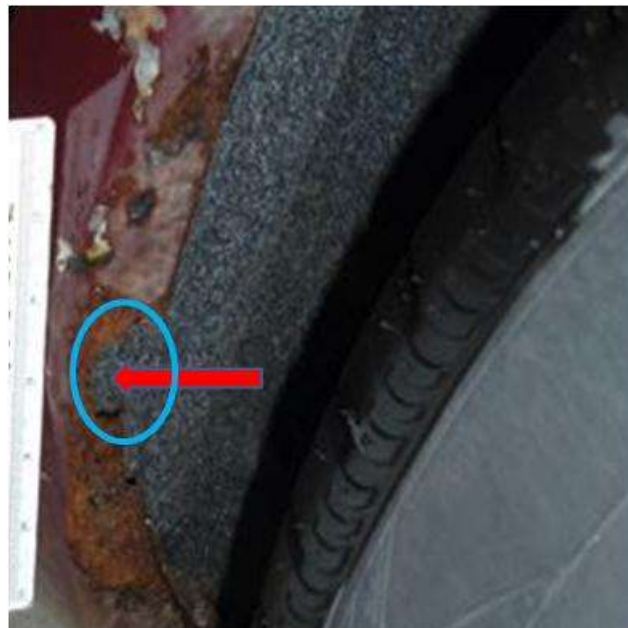
Visible blisters and red rust in an area more than 10mm from the inner edge of the wheel arch.

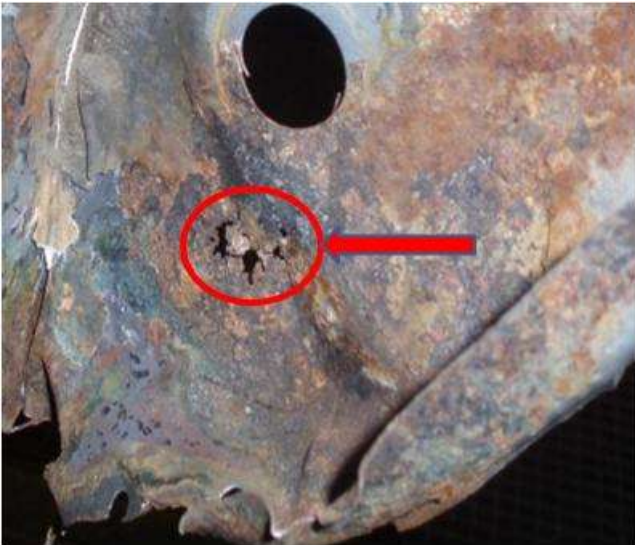
Part of the inner wheel house is perforated by corrosion from the outside.

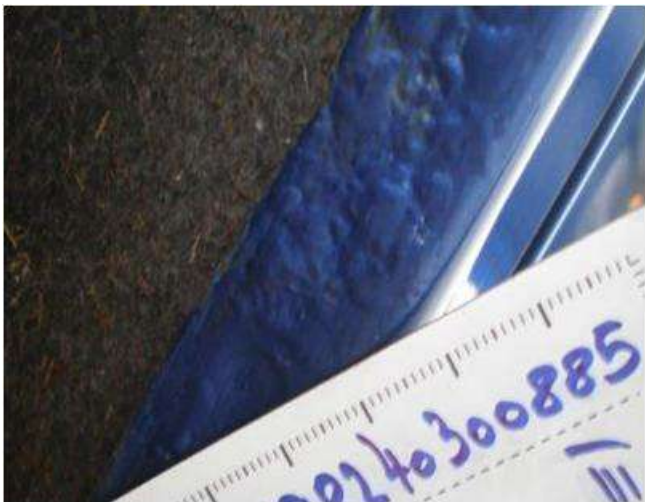
**<Before removing paint and corrosion>**

No visible perforation corrosion can be detected with the initial inspection, which leads to a level-2 assessment in the first step.
